U.S. Chemical Safety and Hazard Investigation Board

## Hoeganaes Corporation: Gallatin, TN Metal Dust Flash Fires and Hydrogen Explosion

January 31, 2011; March 29, 2011; May 27, 2011

No. 2011-4-I-TN

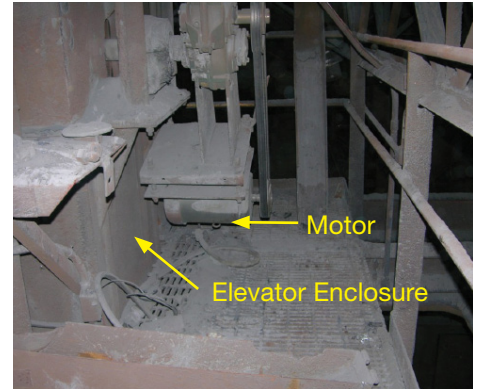
**FIGURE 4 (RIGHT)**

Scene of January 31, 2011, incident area.

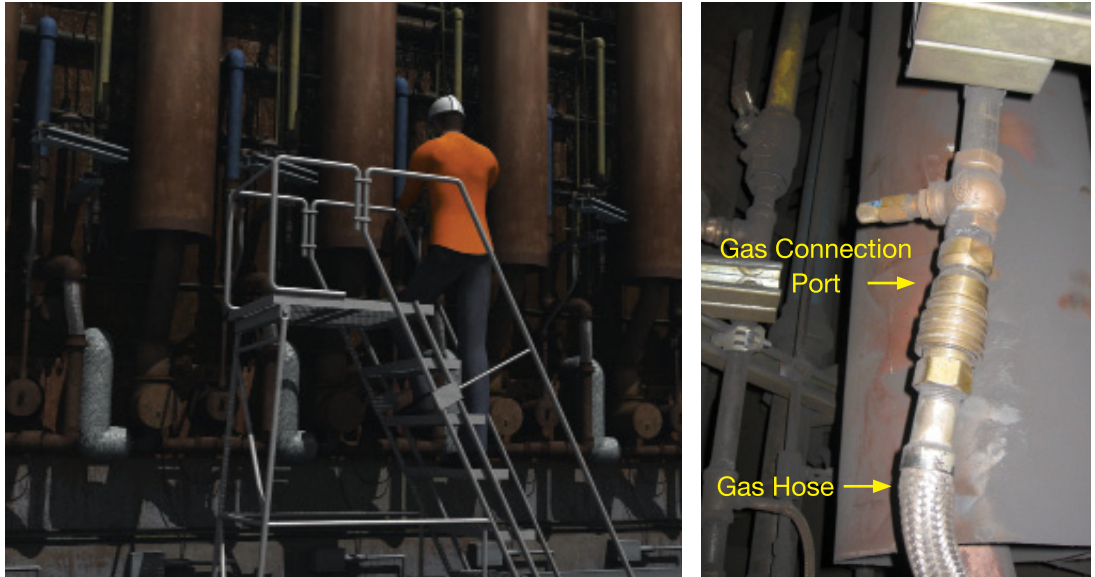
**FIGURE 7 (RIGHT)**

The gas line connection involved in March 29, 2011, incident.

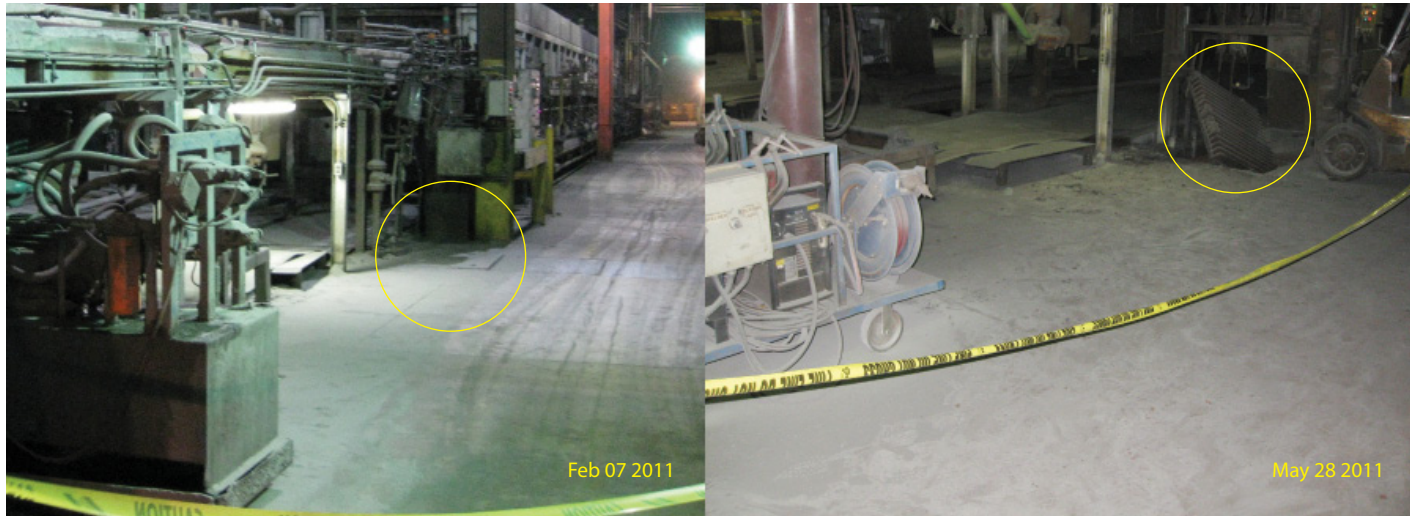
**FIGURE 9 (TOP)**

Scene of the May 27 incident before (left, taken during the CSB's January 31 incident investigation) and after (right). Note visible accumulations of iron powder on surfaces. Circled areas show trench cover location.

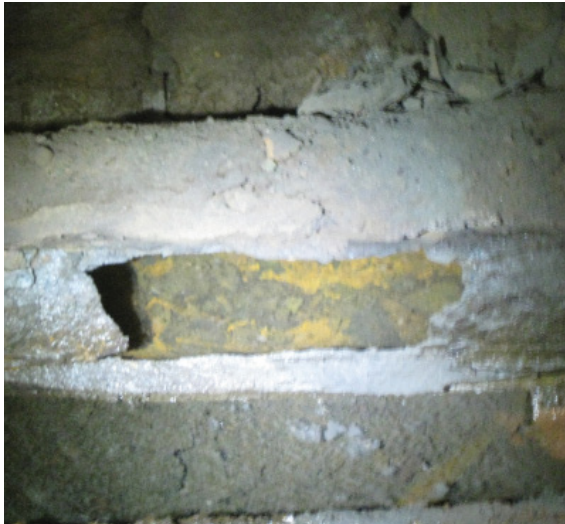
**FIGURE 11 (TOP LEFT)**

Interviews with eyewitnesses indicate that just as the first trench cover was wrenched from its position by the forklift, friction created sparks, followed by a powerful explosion. Several days after the explosion, CSB investigators observed a large hole (approximately 3 x 7 inches) in a corroded section of piping that carried hydrogen and ran through the trench (Figure 11).

Hole in 4-inch piping after the May 27, 2011, incident.

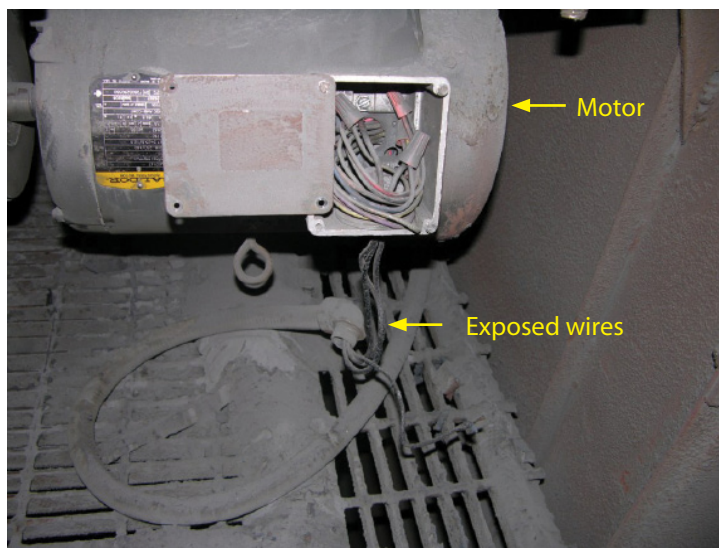
FIGURE 15

Exposed electrical wiring on elevator motor near January 2011 incident site (motor panel cover was rotated post incident by fire department).

The testing contracted by Hoeganaes in 2010 determined that the minimum ignition energy for representative iron dust samples was greater than 500 mJ, and that a continuous arc would ignite the samples. One witness at ground level reported hearing an “electric sound” at the time of the incident. The motor operating bucket elevator #12 was a likely source of ignition since it had exposed wiring, was not properly grounded, and was within a few feet of the dust cloud source. The wiring was exposed because the electrical conduit supplying power to this motor was not securely connected to the motor’s junction box.

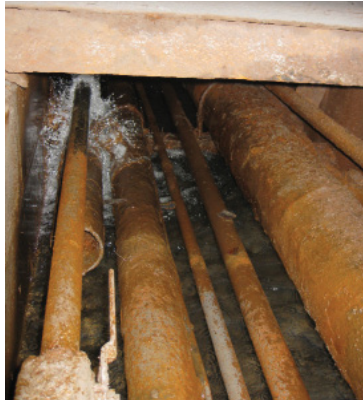
**FIGURE 17**

Water flow (upper left of photo) and externally corroded pipes in the trench involved in the May 27, 2011, incident.

According to ASME B31.3, design concerns about ambient conditions around process pipes focus on environments and changes that can create physical stresses in the piping. Section 10.5.3 of NFPA 55 requires annual maintenance including inspection for physical damage and leak tightness. CGA G-5.4 similarly requires regular inspection for physical damage and leak tightness. However, Hoeganaes did not regularly inspect the pipes in the trench. The design and maintenance of this trench, should have addressed the issue of slow corrosion over time caused by the hot water runoff and solids accumulation.

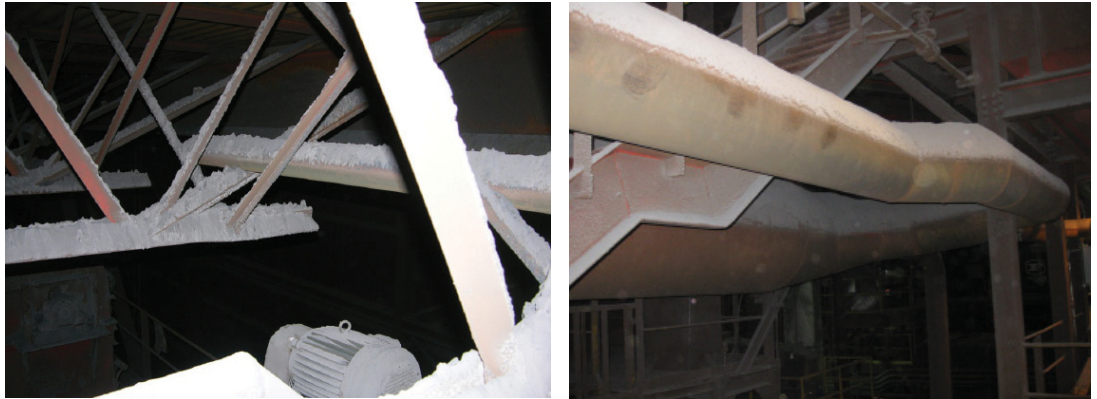
**FIGURE 19 (RIGHT)**

Iron dust on overhead  
surfaces, February 3, 2011.

surface up to 4 inches deep and was visible in the air. Mitigation of the combustible dust hazard by Hoeganaes was limited to a less-than-adequate vacuuming service, sparsely enclosed conveyance equipment, and an inadequate baghouse filtration system.

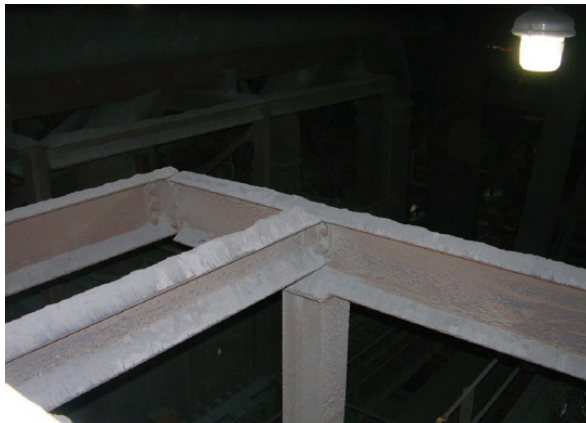
**FIGURE 20**

Although bucket elevators and some conveyance equipment were enclosed, fugitive dust emissions were evident throughout the facility. Moreover, the CSB investigators observed leaks of fugitive dust to the atmosphere when the bags used in the baghouse filtration system were pulsed, which allowed dust to escape into the work areas many times each hour. The baghouse filters are designed to collect the smallest, and consequently most dangerous, dust particles. Yet, the CSB found that the baghouses were often out of service. Employees reported that the baghouse associated with bucket elevator #12 was out of service sporadically for the 7 days leading up to the fatal incident on January 31, 2011, allowing fine combustible iron dust to remain in the area, from which it was dispersed when the elevator was restarted during maintenance.

Iron dust on structural  
supports, February 3, 2011.

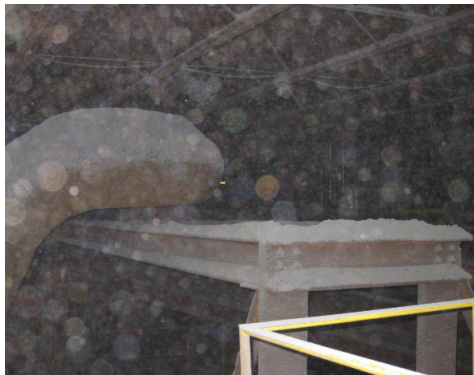
FIGURE 21

Practices at Hoeganaes did not conform to the safety recommendations set forth in NFPA 484. Under “Building Construction,” NFPA 484 requires that floors, elevated platforms, and gratings where dust can accumulate be designed to minimize dust accumulations and facilitate cleaning.<sup>29</sup> The Hoeganaes facility has numerous flat surfaces overhead upon which the CSB investigators observed significant accumulations of combustible iron dust. Since Hoeganaes has an iron powder-producing operation, specific engineering controls outlined in NFPA 484 apply to the machines that manufacture and convey the PM. All machines that produce fine particles of iron should be connected to a dust collection system that has the appropriate velocity to capture all dust. The CSB investigators observed that some of the PM conveyance equipment at

Photo of equipment obscured by airborne dust, taken by CSB investigators, February 7, 2011.

Hoeganaes's was not enclosed; as such, it was not designed to control significant dust emissions, and employees further reported that baghouse dust collectors were often down for maintenance. This section of the standard also requires that dust collection systems be located outdoors; at Hoeganaes, the baghouses are located inside, posing a serious fire and explosion hazard.
