VII. CASING JOINT DESIGN

(a) Introduction

(b) Probable Cause of Failure

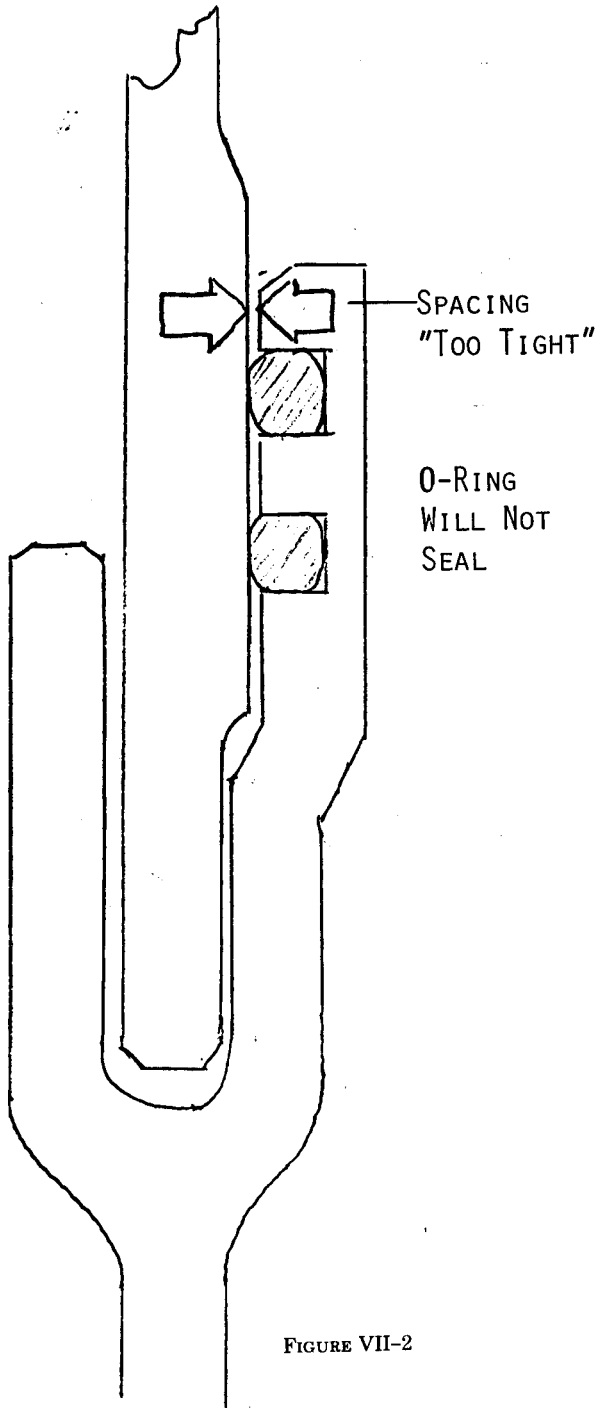
FIGURE VII-2

2. Upon ignition, the primary O-ring could not reseal at the 300 degree location in the downstream position, where it needed to be in time to prevent blowby. At this point there were too many deficiencies acting in unison which prevented the O-ring from reseating in that location. First, proper spacing between the inner face of the tang and the opposing face of the inner leg of the clevis approximately 0.020 inches, is critical. That spacing for Flight 51-L was too small, at the 300 degree location where the smoke was observed, to facilitate prompt reseating of the primary O-ring. Calculations of segment diameters indicate the gap spacing was only 0.004 inches, near metal-to-metal contact. The ignition gases passed the O-ring at this location (See Figure VII-2). This condition did not exist elsewhere in the joint around the casings since the primary O-ring was able to seat around the joint in other locations.

Second, the low temperature throughout the night prior to launch left the fluorocarbon elastomer primary O-ring stiff and lacking in ability to spring into the downstream (seated) position at the 300 degree location in time, relative to the buildup of motor pressure, to provide a tight seal. The temperature of the aft field joint at time of launch was calculated by Thiokol after the accident to be 16 degree F. Part of the reason for this low temperature was the heat transfer away from the joint, by conduction through the aft attachment strut. The conduction was driven by liquid hydrogen, which remained in the external tank overnight. The supercold fuel created a 430 degree temperature differential across the ship, drawing heat out of the joint and O-rings.

At ignition, blowby occurred, either with erosion of the primary O-ring or without erosion.
