**INVESTIGATION OF THE CHALLENGER
ACCIDENT**

**COMMITTEE ON
SCIENCE AND TECHNOLOGY
HOUSE OF REPRESENTATIVES**

**NINETY-NINTH CONGRESS
SECOND SESSION**

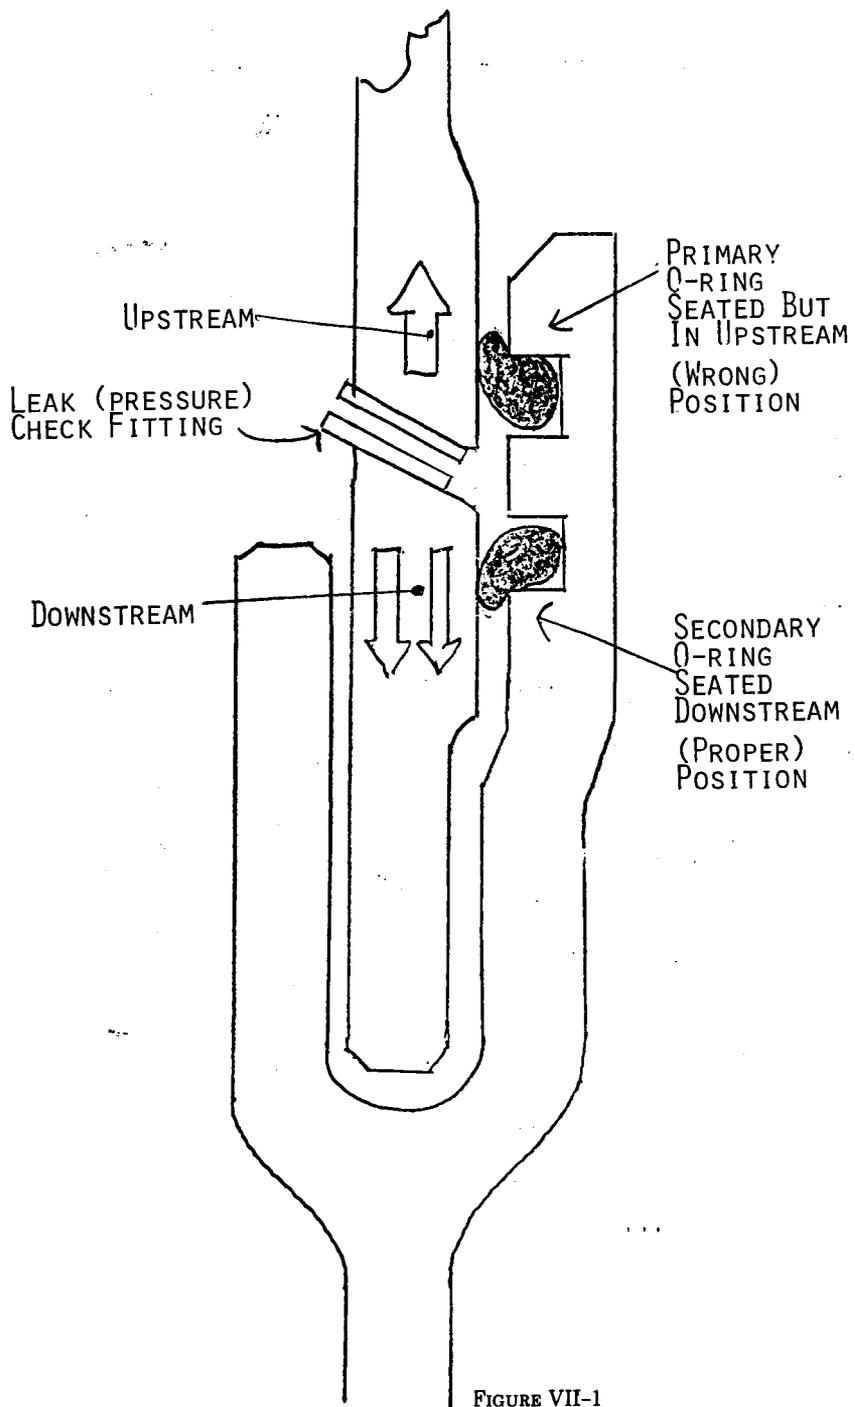
FIGURE VII-1

1. Both the primary O-ring and the secondary O-ring were seated when the steel casings were mated. The pressure check verified this fact. However, from experience, the primary O-ring was seated in the upstream position as had been previously recognized by NASA and Thiokol engineers. (See Figure VII-1.)

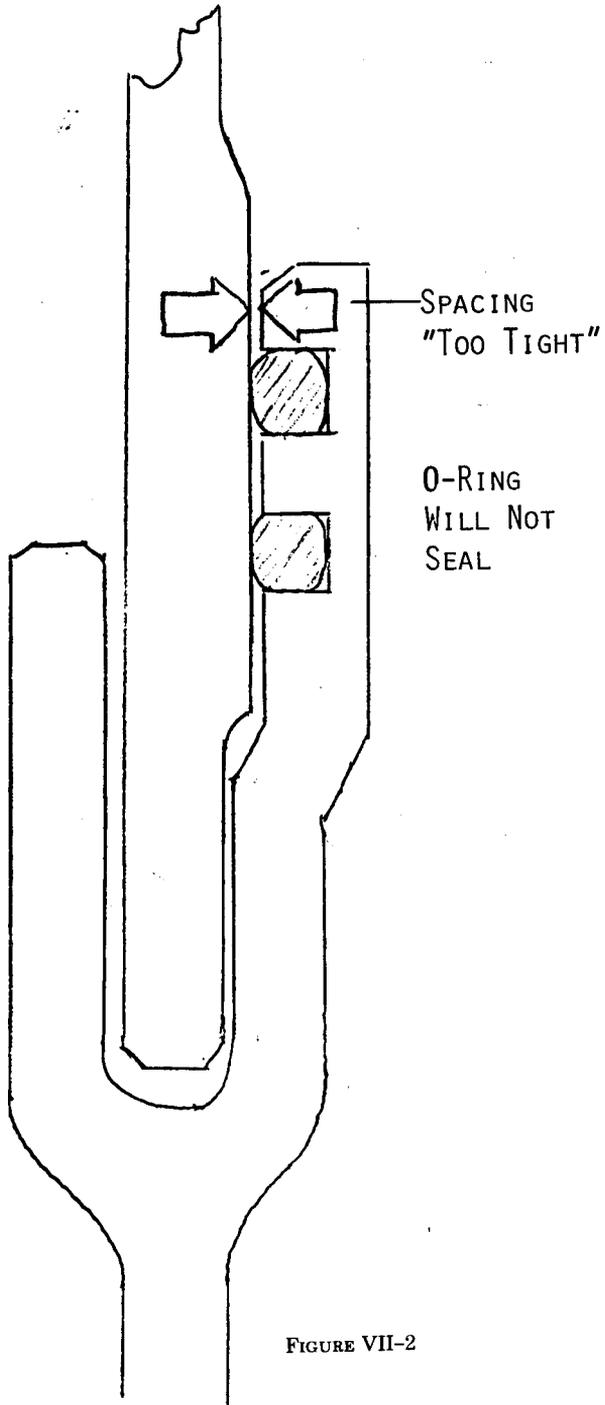
FIGURE VII-2

2. Upon ignition, the primary O-ring could not reseal at the 300 degree location in the downstream position, where it needed to be in time to prevent blowby. At this point there were too many deficiencies acting in unison which prevented the O-ring from reseating in that location. First, proper spacing between the inner face of the tang and the opposing face of the inner leg of the clevis approximately 0.020 inches, is critical. That spacing for Flight 51-L was too small, at the 300 degree location where the smoke was observed, to facilitate prompt reseating of the primary O-ring. Calculations of segment diameters indicate the gap spacing was only 0.004 inches, near metal-to-metal contact. The ignition gases passed the O-ring at this location (See Figure VII-2). This condition did not exist elsewhere in the joint around the casings since the primary O-ring was able to seat around the joint in other locations.

Second, the low temperature throughout the night prior to launch left the fluorocarbon elastomer primary O-ring stiff and lacking in ability to spring into the downstream (seated) position at the 300 degree location in time, relative to the buildup of motor pressure, to provide a tight seal. The temperature of the aft field joint at time of launch was calculated by Thiokol after the accident to be 16 degree F. Part of the reason for this low temperature was the heat transfer away from the joint, by conduction through the aft attachment strut. The conduction was driven by liquid hydrogen, which remained in the external tank overnight. The supercold fuel created a 430 degree temperature differential across the ship, drawing heat out of the joint and O-rings.

At ignition, blowby occurred, either with erosion of the primary O-ring or without erosion.
