[Docket No. 2000-SW-33-AD; Amendment 39-11881; AD 2000-17-07]

Airworthiness Directives; Eurocopter France Model EC120B Helicopters

2000-17-07 Eurocopter France:

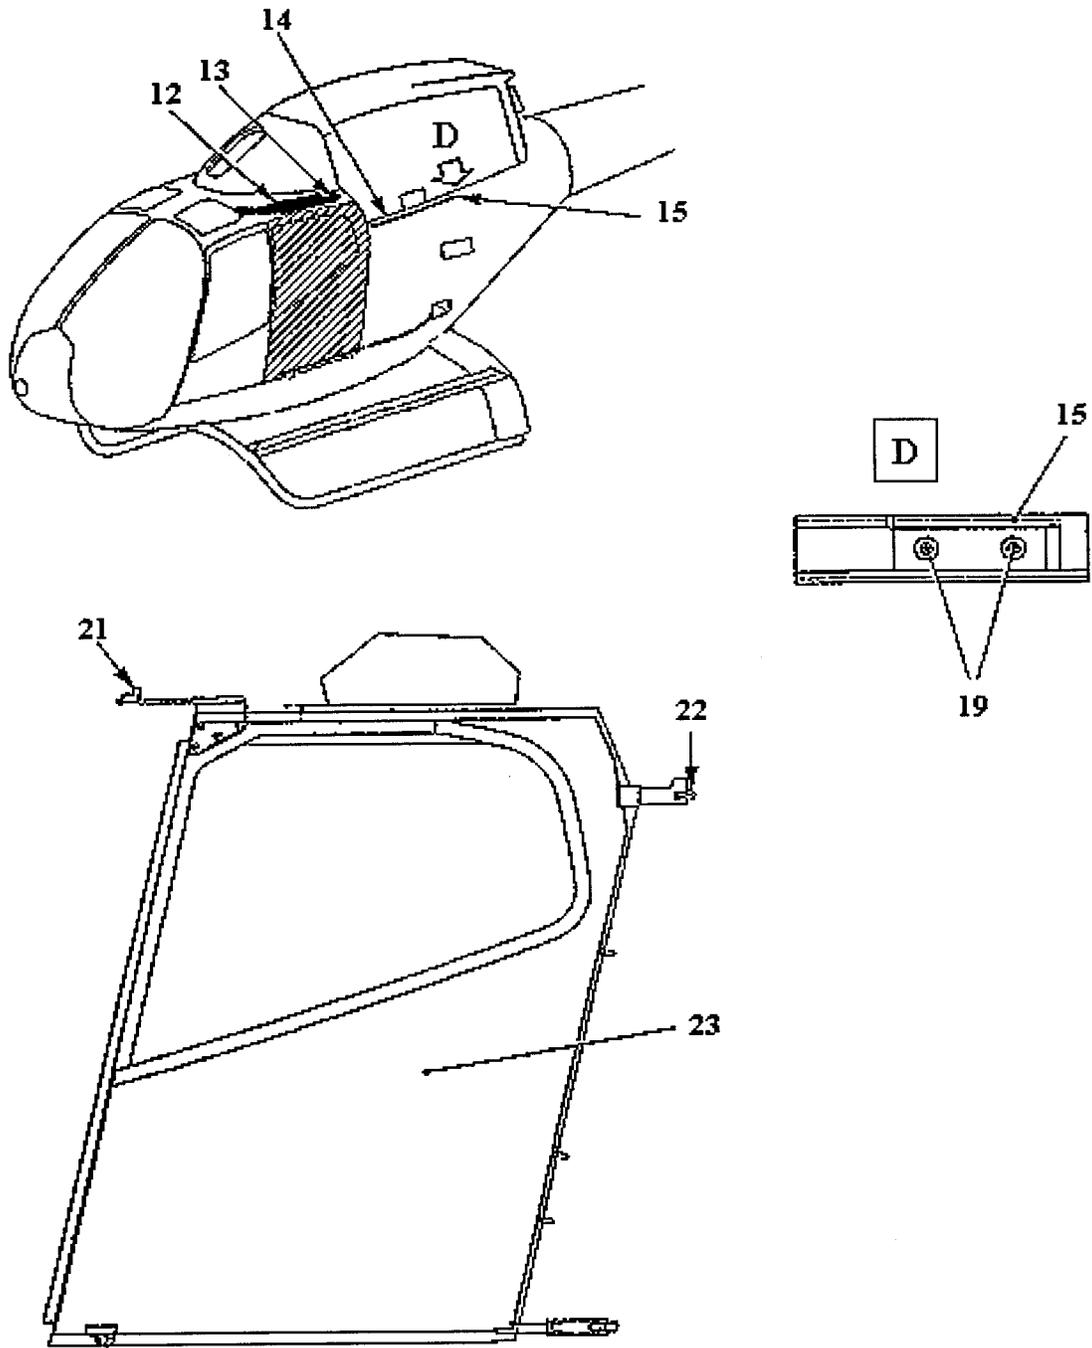
Figure 1

SUMMARY: This amendment adopts a new airworthiness directive (AD) for Eurocopter France Model EC120B helicopters. This action requires adjusting the clearance of the cabin sliding door if necessary. This amendment is prompted by an in-flight loss of a cabin sliding door, which had been locked in the fully opened position. The actions specified in this AD are intended to prevent in-flight loss of a cabin sliding door, impact with the horizontal stabilizer, main rotor, or fenestron tail rotor, and subsequent loss of control of the helicopter.

Eurocopter France has issued Service Telex No. 05-005, dated June 30, 2000, which specifies adjusting any cabin sliding door if a roller is not completely inside its rail with a minimum clearance of 3 mm. Eurocopter France received a report of an in-flight loss of the cabin sliding door. An investigation shows that the loss of the door was due to the forward upper roller being out of its guide rail. The door edge thus exposed to the slipstream caused the forward lower roller train to be driven out of the guide rail due to the aerodynamic loads. The door aft hinges failed, and the door departed from the aircraft. The DGAC classified this service telex as mandatory and issued AD T2000-285-005(A), dated June 30, 2000, to ensure the continued airworthiness of these helicopters in France.

(a) Adjust the cabin sliding door (23) (see Figure 1) in accordance with the following:

(1) Loosen the screws (19) and the stop (15).

(2) Open and push the cabin sliding door aft until the roller goes past the locking pin (13) while keeping the roller (21) inside the rail (12).

(3) Move the cabin sliding door forward to bring the roller (21) into contact with the locking pin (13).

(4) Move the stop (15) as far forward as possible toward the nose of the aircraft.

(5) Mark the location of the stop (15) with respect to the rail (14).

(6) Unlock the cabin sliding door and move it forward to gain access to the screws (19).

(7) Hold the stop (15) aligned with the rail (14), and secure the stop (15) and the screws (19) at the location previously marked.

(8) Ensure that the pin (13) locking mechanism (pin) locks the cabin sliding door in the open position. If the pin does not lock the door in the open position, before further flight, repair or replace the pin with an airworthy pin.

(9) Bring the roller (22) into contact with the stop (15) of the rail (14).

(10) If the roller (21) is completely inside the rail (12) with a minimum clearance of 3 mm from the aft end of the rail (12), the cabin door is properly adjusted and no further action is required by this AD.

(11) If the roller (21) is less than 3 mm from the aft end of the rail (12), before further flight, repeat steps (1) through (10) until a minimum clearance of 3 mm is obtained.
