[Docket No. 2000-SW-65-AD; Amendment 39-12106; AD 2000-25-54]

Airworthiness Directives; Agusta S.p.A. Model A109E Helicopters

2000-25-54 Agusta S.p.A.: Amendment 39-12106. Docket No. 2000-SW-65-AD.

Applicability: Model A109E helicopters, with tail rotor blade (blade), part number 109-8132-01-109, installed, certificated in any category.

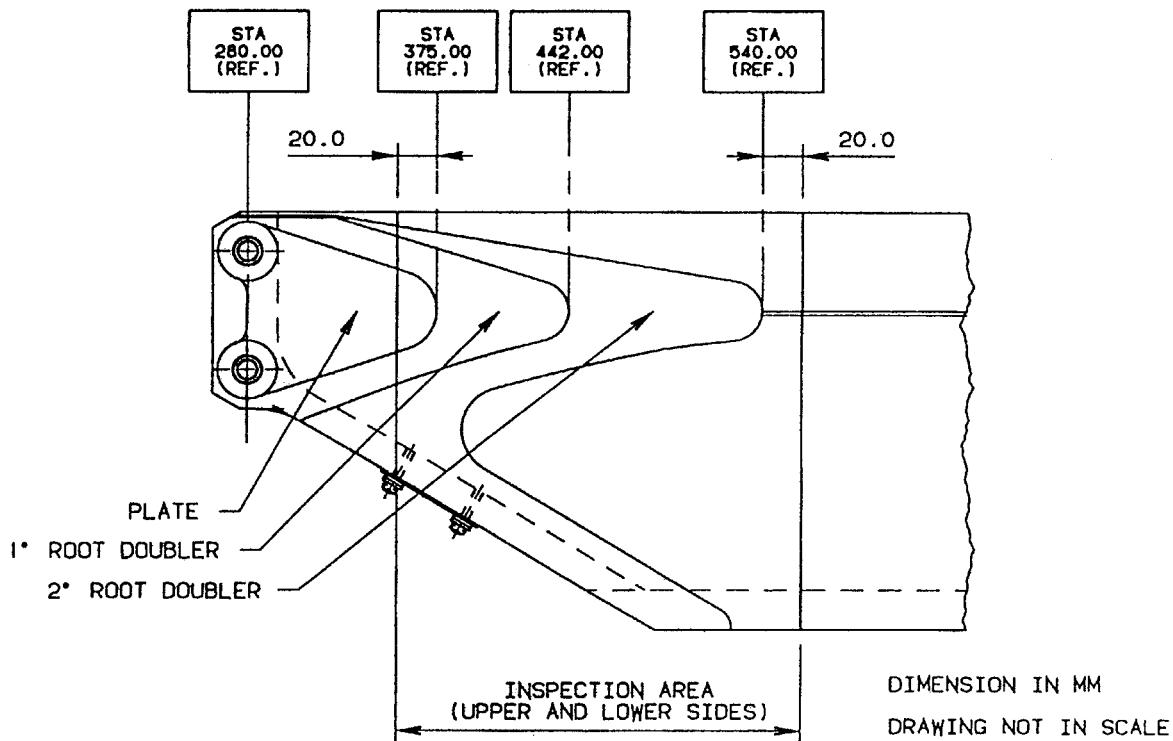
FIGURE 1

- (a) Before each start of the engines, visually check both sides of each blade for a crack, in the area shown in Figure 1. An owner/operator (pilot), holding at least a private pilot certificate, may perform the visual check required by this paragraph and must enter compliance into the aircraft maintenance records in accordance with 14 CFR 43.11 and 91.417(a)(2)(v).

Note: Paint irregularities may be due to cracks.

(d) If a crack is found, replace the blade with an airworthy blade before further flight.
