[Docket No. 2001-SW-28-AD; Amendment 39-12479; AD 2001-22-01]

### Airworthiness Directives; Enstrom Helicopter Corporation Model F-28, F-28A, F-28C, F-28F, 280, 280C, 280F and 280FX Helicopters

#### 2001-22-01 Enstrom Helicopter

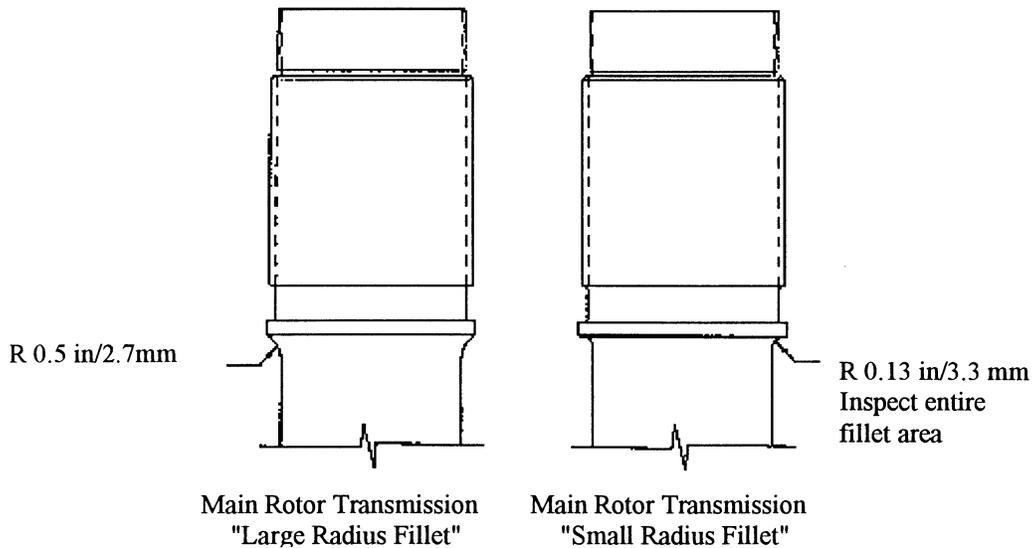
**Figure 1. Main Rotor Shaft Inspection**

The FAA and the National Transportation Safety Board (NTSB) investigated the accident involving the failure of a shaft on the EHC Model F28A helicopter. The shaft was designed with a small upper fillet radius of 0.13 inch and failed due to a fatigue crack. Such a shaft design causes a high stress concentration. That, coupled with the occurrence of more frequent than anticipated high flight load conditions, can accelerate the development of fatigue cracks. Preliminary investigation revealed that the shaft installed in the transmission, P/N 28-13101-1-R, failed because of a fatigue crack in the fillet area of the shaft directly beneath the main rotor hub. The FAA concluded, based on its investigation and after reviewing NTSB Report 01-052, dated April 13, 2001, that an inspection should be made of such shafts for cracks before further flight. The FAA determined that since inspections for cracks are imprecise and detection of all existing cracks is uncertain, a shaft with a small radius fillet should be replaced with an airworthy shaft with a large radius fillet on certain model helicopters within 300 hours time-in-service (TIS).

(a) Before further flight, determine the part number (P/N) of the main rotor transmission (transmission) and the radius of the upper fillet of the shaft (see Figure 1).

(b) For EHC Model F-28C, F-28F, 280C, 280F, and 280FX helicopters, before further flight, replace any transmission having a small radius shaft fillet with an airworthy

(2) If the installed transmission is P/N 28-13101-1 or -1-R and has a small radius shaft, before further flight and thereafter at intervals not to exceed 25 hours TIS, visually inspect each transmission for a crack in the shaft upper fillet using a 10X or higher magnifying glass.

(i) Dye-penetrant inspect the shaft upper fillet for a crack, a nick, or a scratch.

(ii) Polish out nicks or scratches less than 0.005-inch deep.

(iii) If the shaft is cracked or has a nick or scratch 0.005 inch or more deep, replace the transmission with an airworthy transmission having a large radius shaft fillet before further flight.

(4) Within 300 hours TIS or at the next overhaul after the effective date of this AD, whichever occurs first, replace transmission, P/N 28-13101-1 or -1-R, with an airworthy transmission having a large radius shaft fillet.
