**[Docket No. 2001-SW-17-AD; Amendment 39-12657; AD 2002-03-16]**

**Airworthiness Directives; Bell Helicopter Textron, Inc.-Manufactured Model OH-13E, OH-13H, and OH-13S Helicopters**

**ACTION:** Final rule.

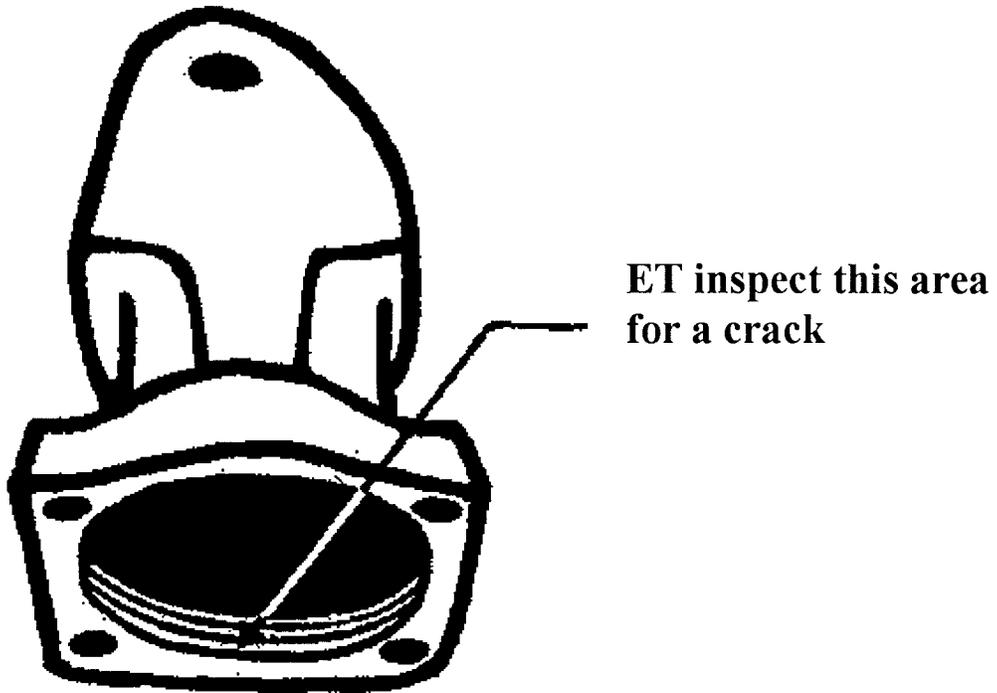
Figure 1, Appendix 1

1.1 The inboard inside diameter machined threads (reference Figure 1).

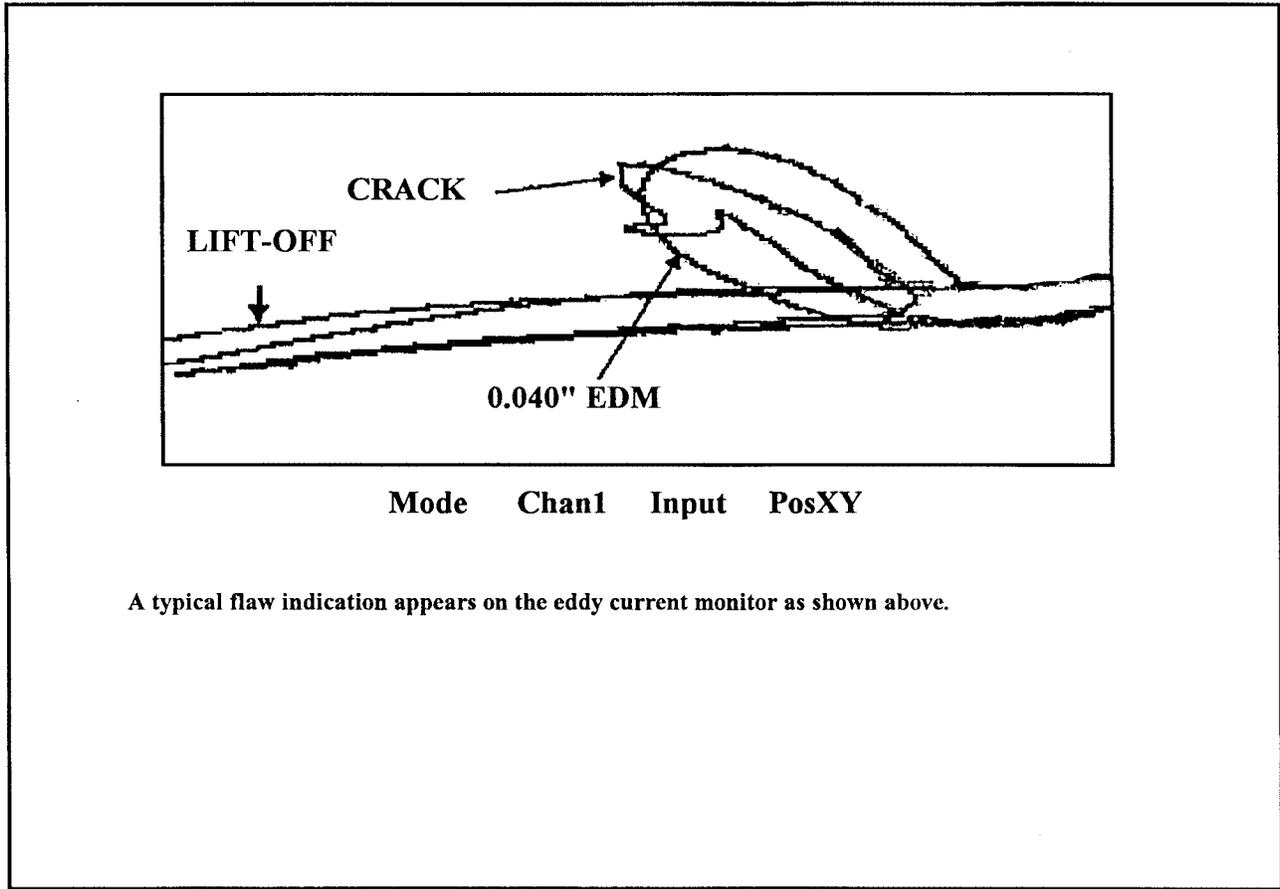
Figure 2, Appendix 1

6.1 Place the probe into the threaded area and slide it in the same direction as was done on the standard while monitoring the screen for root cracks. Moving the probe in the same direction produces a repeatable display that allows for more accurate flaw size determination. Scan the probe along each individual thread until all the threads are inspected. (See Figures 2 and 3.)

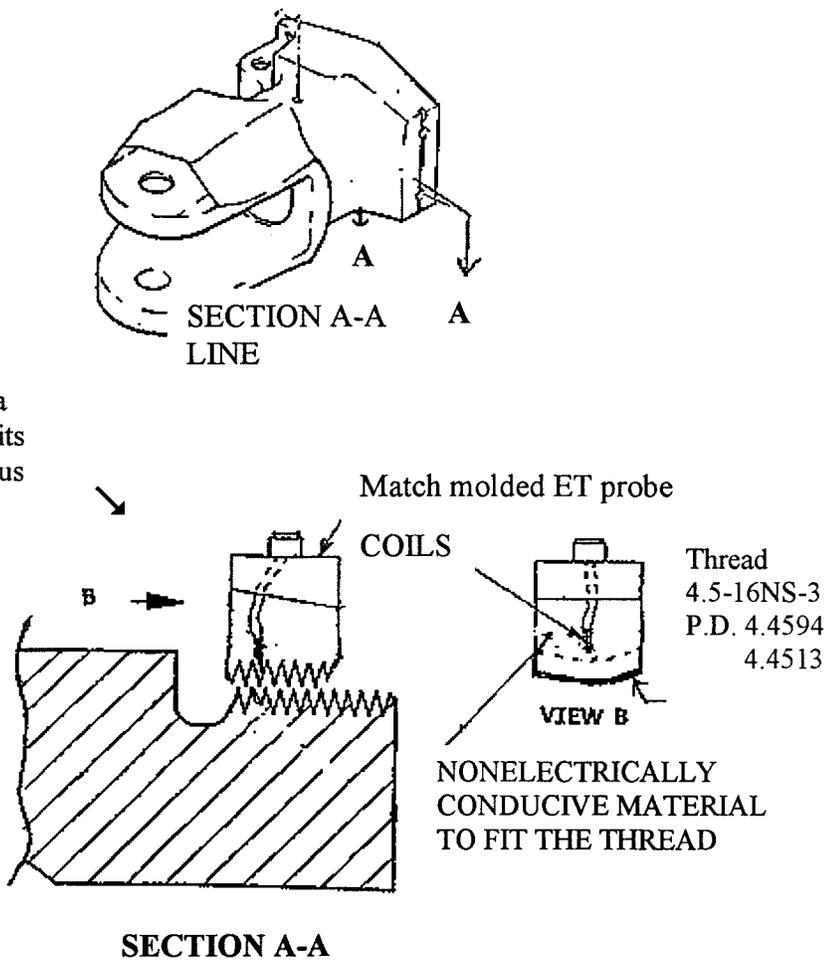
Figure 3, Appendix 1

2.2 Match molded ET probe SPC-193 (100kHz) or equivalent. (See Figure 3.)

A special eddy current probe shaped to fit the thread and containing a coil positioned so that its ferrite core is contiguous with the root of the thread.

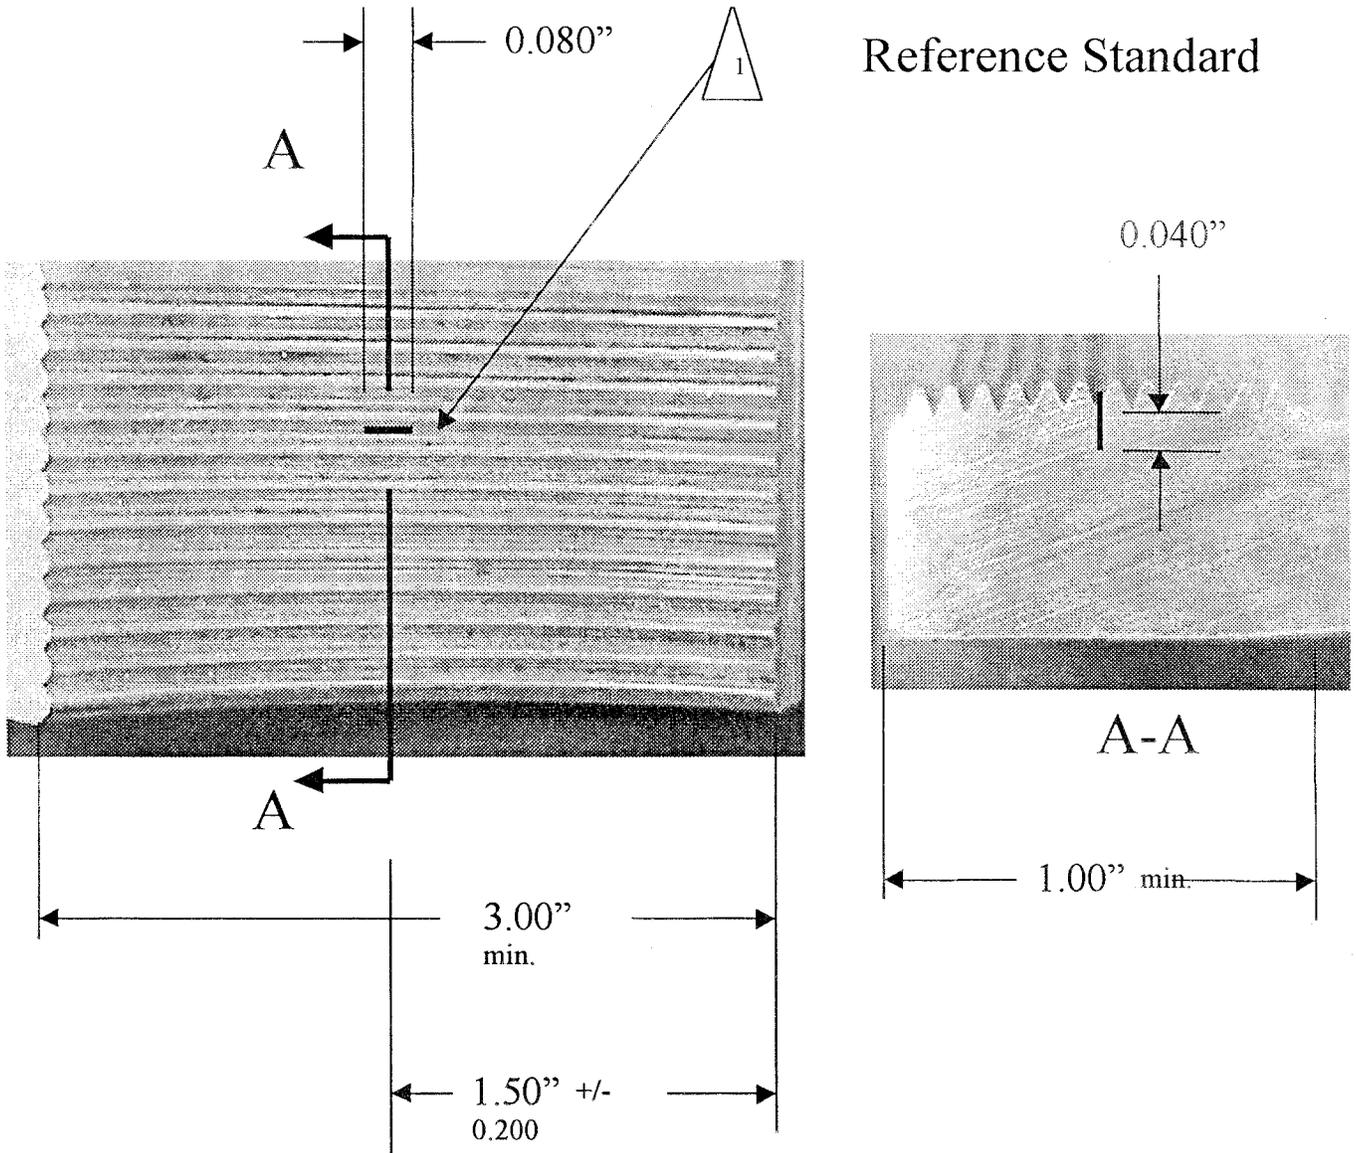
Figure 4, Appendix 1

2.3 Reference standard EC-010-021, or equivalent. (See Figures 4 and 5.)

EDM 1 place only in thread root.  
Notch width shall be 0.004 max.  
All other dimensions to be +/- 0.004 from indicated.

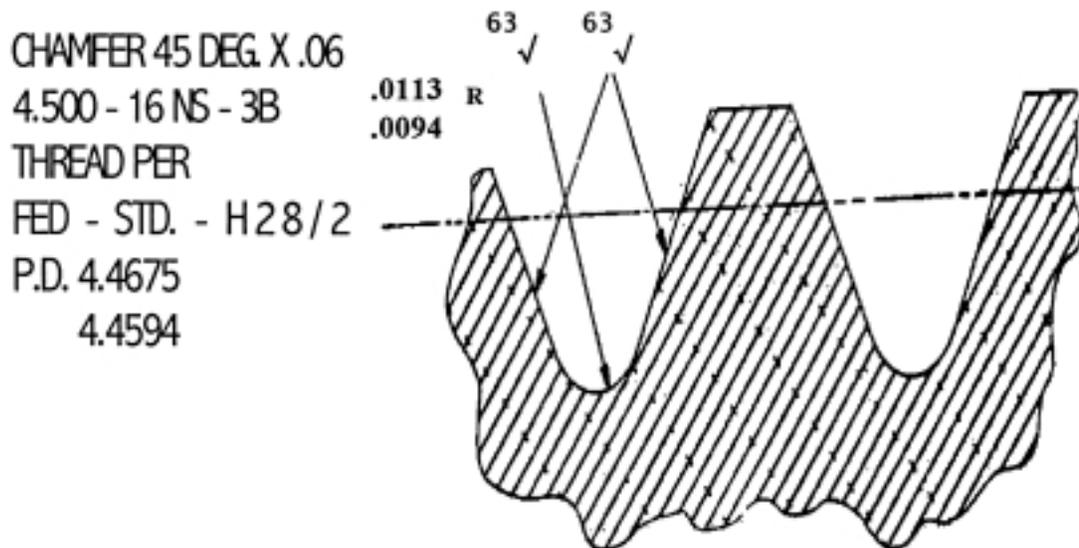
Figure 5, Appendix 1

1. Standard may be machined from aluminum tube stock.
2. The standard shall contain a minimum of four teeth per the tooth dimensions specified.
3. The EDM notch shall be placed in the center most tooth root as measured across the width of the standards. There shall be no less than two teeth and one root on either side of the EDM notch.
