[Docket No. 2002-SW-14-AD; Amendment 39-13015; AD 2003-01-04]

Airworthiness Directives; Bell Helicopter Textron, Inc. Model 204B, 205A, 205A-1, 205B and 212 Helicopters

2003-01-04 Bell Helicopter Textron, Inc.:
Amendment 39-13015. Docket No. 2002-SW-14-AD.

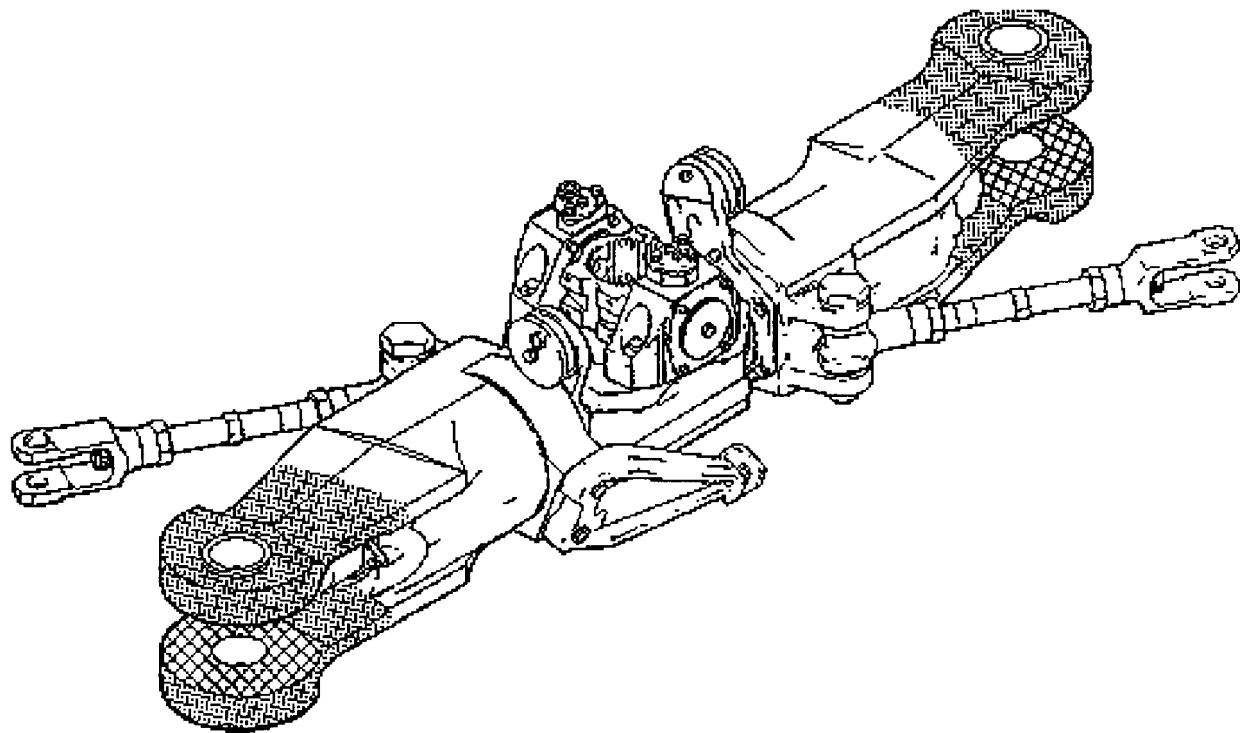
Figure 1. Inspection of Main Rotor Hub Grip Tangs

(2) Using a 10-power or higher magnifying glass, visually inspect the exposed surfaces of the upper and lower tangs of each grip for a crack. Pay particular attention to the lower surface of each lower grip tang from the main rotor blade bolt-bushing flange to the leading and trailing edge of each grip tang. See Figure 1 as follows:

■ INSPECT BUFFER PAD
FOR DELAMINATION (IF
INSTALLED)

■ AREA TO BE INSPECTED
UPPER AND LOWER
TANGS ALL EXPOSED
SURFACES

(2) Inspect each grip buffer pad on the inner surfaces of each grip tang for delamination (see Figure 1 of this AD). If there is any delamination, remove the buffer pad and inspect the grip surface for corrosion or other damage.

(1) Replace with an airworthy grip any grip with a crack.

(2) Replace with an airworthy grip or repair, if within maximum repair damage limits, any grip with any corrosion or other damage.
