[Docket No. FAA-2006-24074; Directorate Identifier 2005-NM-213-AD]

Airworthiness Directives; Bombardier Model CL-600-2C10 (Regional Jet Series 700, 701, & 702) Airplanes, Model CL-600-2D15 (Regional Jet Series 705) Airplanes, and Model CL-600-2D24 (Regional Jet Series 900) Airplanes

ACTION: Notice of proposed rulemaking (NPRM).

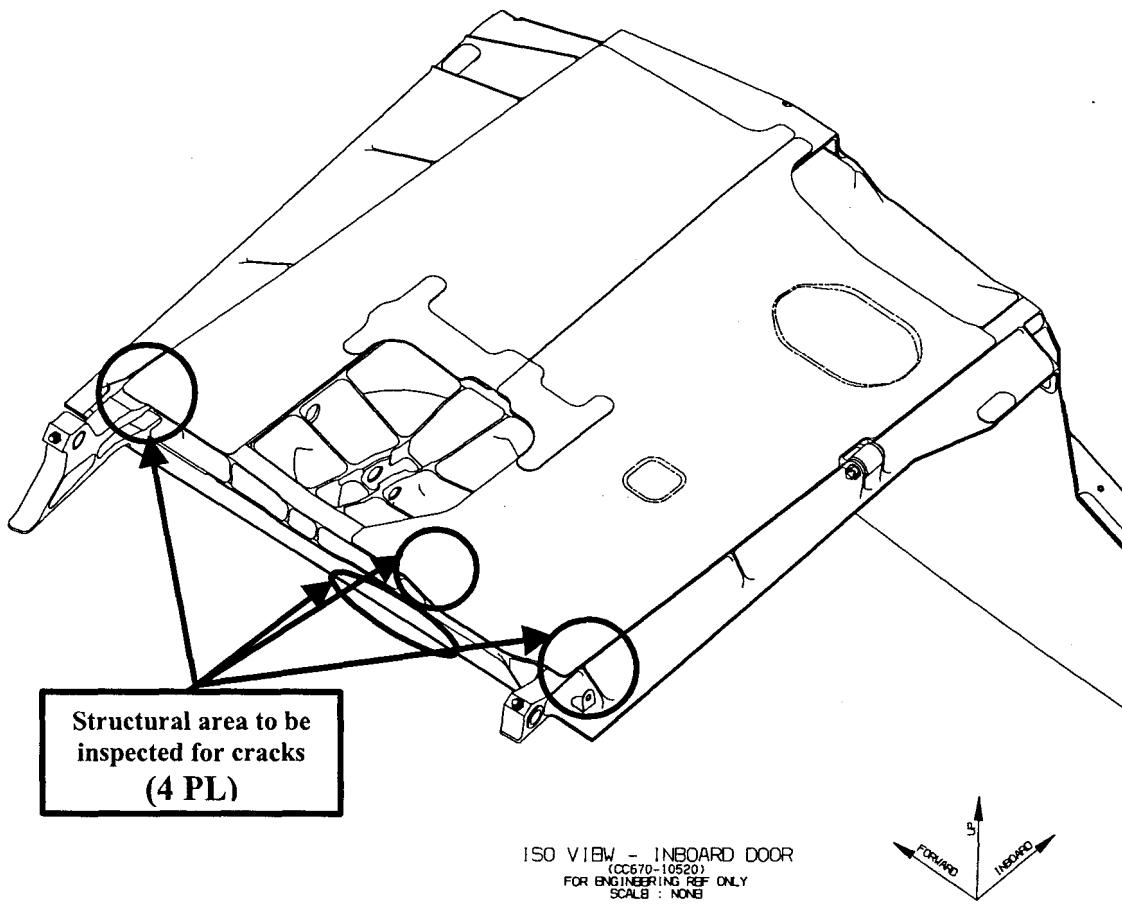
Figure 1
LH side shown
RH side opposite

(g) For Model CL-600-2C10 (Regional Jet series 700 & 701) series airplanes, S/Ns 10003 through 10999 inclusive; and Model CL-600-2D24 (Regional Jet series 900) series airplanes, S/Ns 15002 through 15990 inclusive: At the applicable time specified in paragraph (f) of this AD, perform detailed inspections of the lower panel, part number (P/N) CC670-10520, of the left- and right-hand MLG doors for the conditions and in the areas specified in paragraphs (g)(1), (g)(2), (g)(3), and (g)(4) of this AD; and Figures 1, 2, and 3 of this AD.

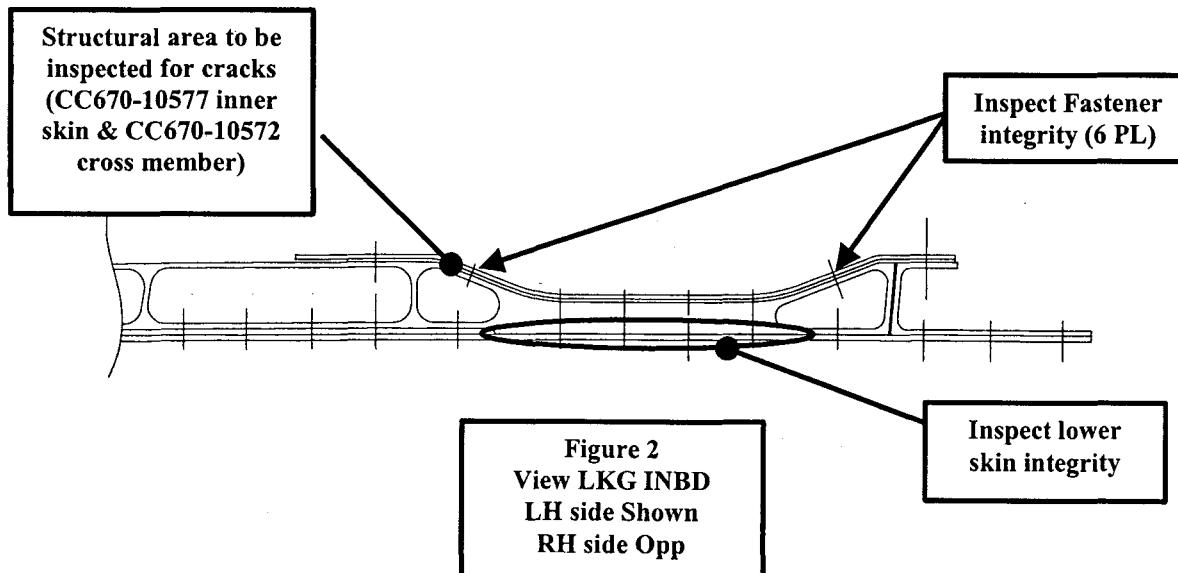
(1) Inspect the cross member, P/N CC670-10572, of the MLG door lower panel for cracking or deformation, in accordance with Figure 2 of this AD.

cross member (P/N CC670-10572) for cracking or deformation, or pulled or missing fasteners, in accordance with Figure 2 of this AD.

fasteners, in accordance with Figure 2 of this AD.

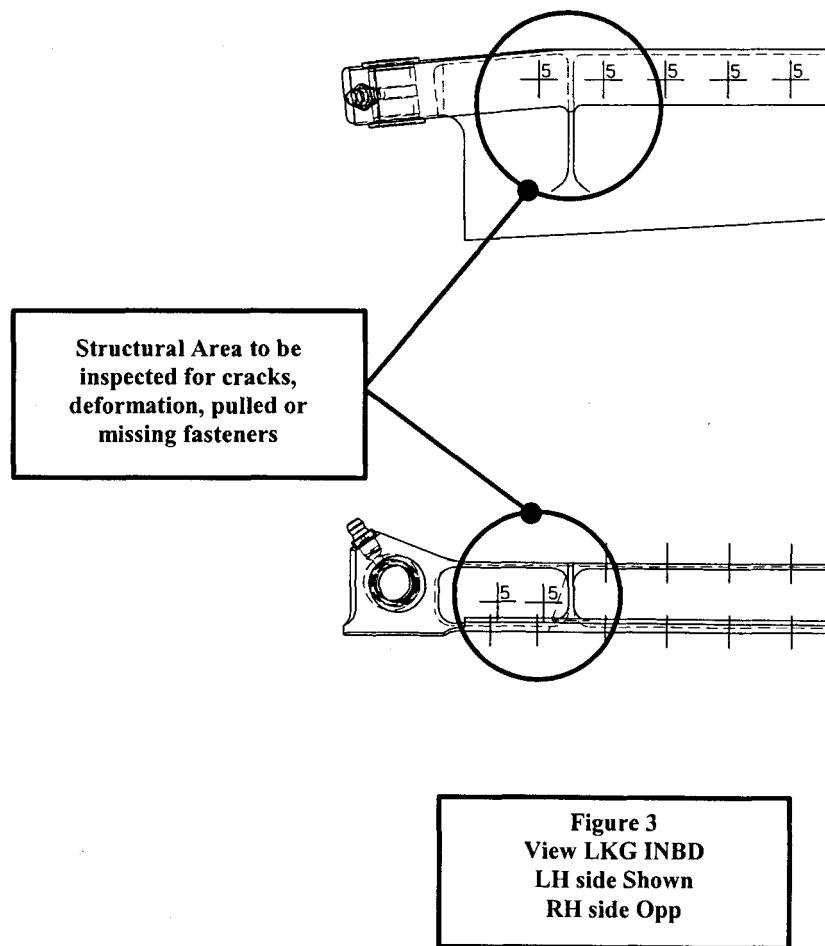
(4) Inspect the forward member, P/N CC670-10570, and aft member, P/N CC670-10571, of the MLG door lower panel, for cracking or deformation, or pulled or missing fasteners, in accordance with Figure 3 of this AD. Figures 1 through 3 of this AD follow.
