[Docket No. FAA-2006-25773; Directorate Identifier 2006-SW-16-AD; Amendment 39-14758; AD 2006-19-01]

**Airworthiness Directives; Eurocopter Model AS350B, B1, B2, B3, BA, D, and AS355E Helicopters**

**ACTION:** Final rule; request for comments.

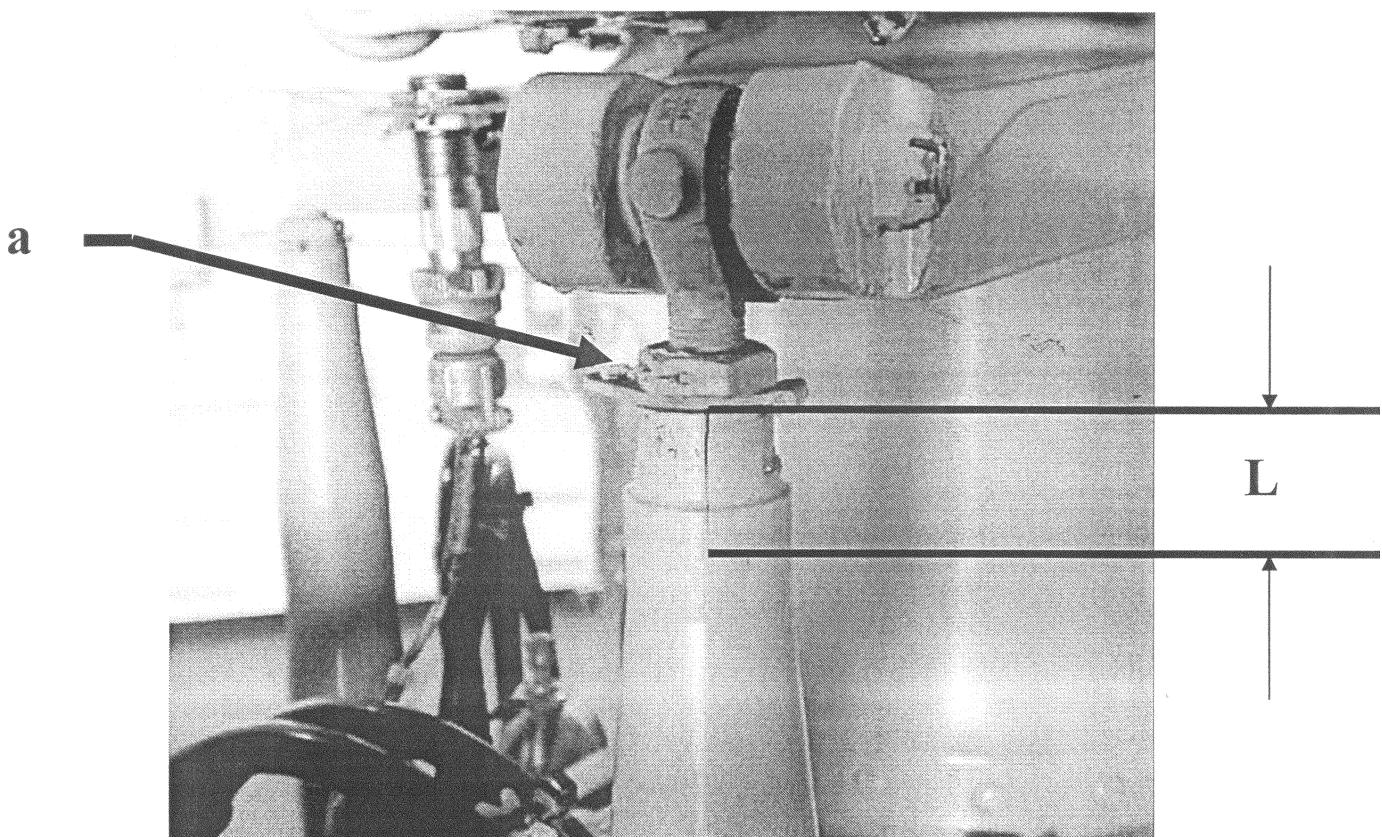
**Figure 1**

The European Aviation Safety Agency (EASA) notified us that an unsafe condition may exist on Eurocopter Model AS 350 and AS 355 helicopters. EASA advises of the discovery of cracks in the tapered housings of MSCs during scheduled inspections. EASA also advises that a very long crack in the tapered housing of an MSC can lead to loss of the attachment of the MSC concerned (sic) to the nonrotating swashplate and consequently loss of the helicopter.

(3) Loosen attachment nut "a" shown in Figure 1 of this AD and lift the positioning lock washer under the attachment nut so the edge below the lock washer at the top of the tapered housing is visible around the entire periphery.

(4) Visually inspect each MSC tapered housing for a crack using a 10-power or higher magnifying glass paying particular attention to area "L" and to the edge of the tapered housing located under the lock washer under attachment nut "a" as depicted in Figure 1 of this AD.

(1) Adjust the tightening torque on the attachment nut that secures the upper ball end of the MSC to between 177–199 in-lbs (2–2.25 decanewton meters (daN·m)).

(c) If you find any crack (oblique, horizontal, or vertical), before further flight, replace the MSC with an airworthy MSC and adjust the tightening torque of the attachment nut to between 177–199 in-lb (2–2.25 daN·m)).
