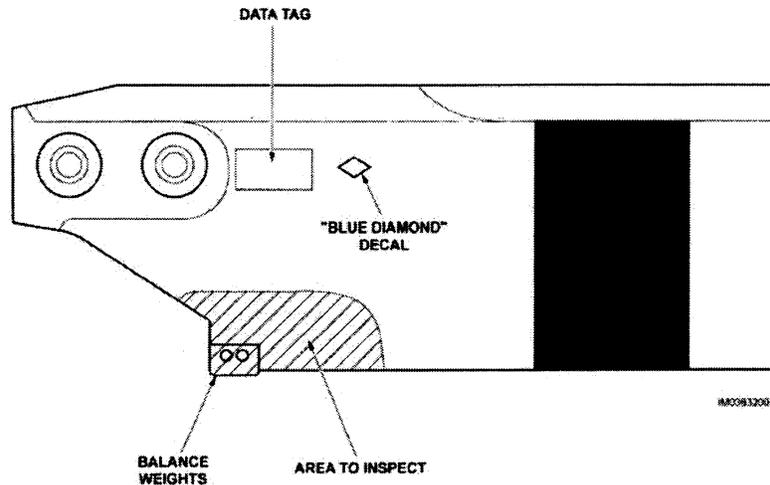
Figure 1. Tail rotor blade inspection.

(1) At intervals not to exceed 12 hours time-in-service (TIS), using a 10X or higher magnifying glass, inspect both sides of each blade for a deformation, a crack, and a bent or deformed weight in the area shown in Figure 1 of this AD, or

(2) Inspect and check both sides of each blade for a deformation, a crack, and a bent or deformed weight in the area shown in Figure 1 of this AD as follows:

(c) Before further flight, replace any blade that has a deformation, a crack, or a bent or deformed weight with an airworthy blade.
