[Docket No. FAA-2007-27229; Directorate Identifier 2007-NE-03-AD; Amendment 39-15359; AD 2008-03-09]

Airworthiness Directives; CFM International, S.A. CFM56-7B Series Turbofan Engines

2008-03-09 CFM International, S.A.:

TURBINE REAR FRAME WITH TANGENTIAL STRUTS—MANDATORY INSPECTIONS—LIFE LIMITS

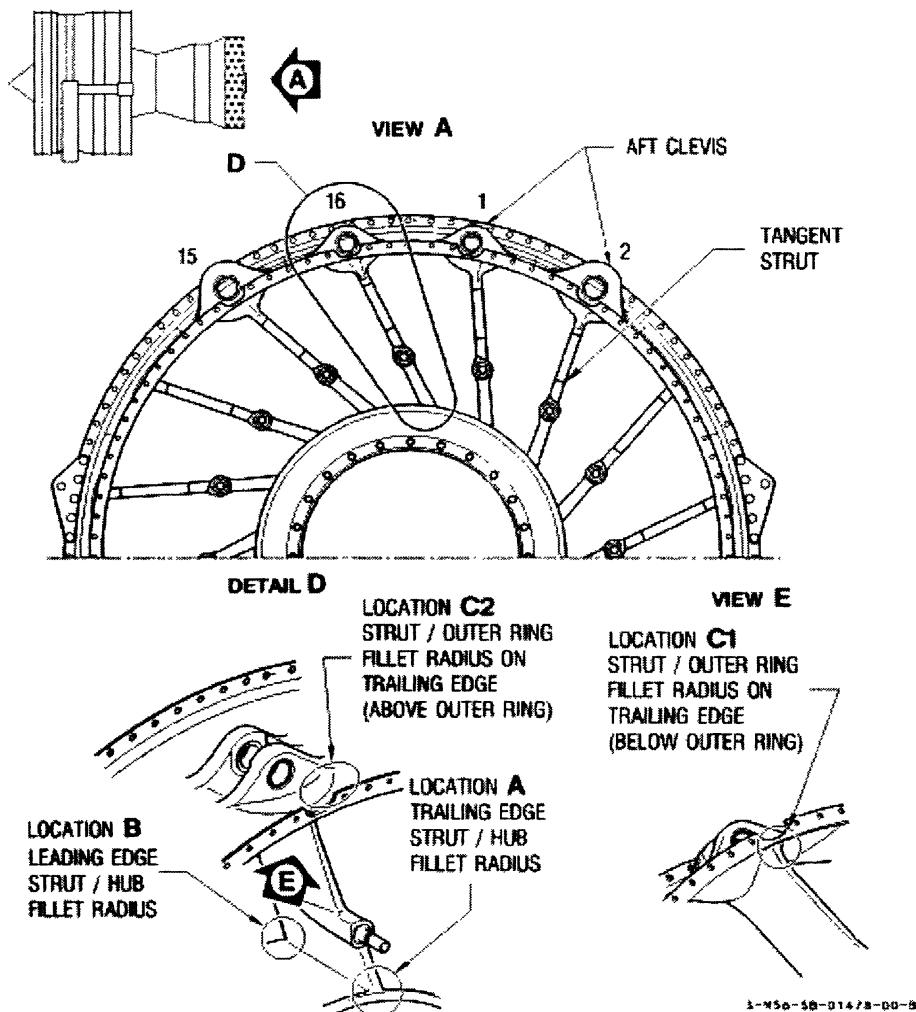
Figure 805

threshold for inspecting certain TRFs. We are issuing this AD to prevent failure of the TRF from low-cycle fatigue cracks. Failure of the TRF could result in engine separation from the airplane, which could lead to loss of control of the airplane.

2. Mandatory Inspection Intervals for the Critical Areas of the Turbine Rear Frame with Tangential Struts (4 Mount Struts, No. 1, 2, 15, and 16).

C. Turbine Rear Frame Part Numbers 340-166-205-0, 340-166-206-0, 340-166-207-0, 340-166-208-0, 340-166-209-0, 340-166-210-0, for all CFM56-7B SAC engine models (except -7B27A engine models). Refer to figure 805.

Figure index No.	Inspection location	Inspection threshold (cycles since new)	Inspection intervals (cycles)	Inspection reference
805	Strut/outer ring fillet radius on trailing edge (A). Strut/hub fillet radius on leading edge (B). Strut/outer ring fillet radius on trailing edge (C1 below outer ring). Strut/outer ring fillet radius on trailing edge (C2 above outer ring).	25,000* for -7B SAC (except business jet) engine models. 19,000* for -7B SAC business jet engine models.	Refer to Figure 806* for -7B SAC (except business jet) engine models. Refer to Figure 807* for -7B SAC business jet engine models.	Refer to SB 72-0579.*

**Turbine Rear Frame with Tangential Struts P/N 340-166-205-0,
340-166-206-0, 340-166-207-0, 340-166-208-0, 340-166-209-0, 340-166-210-0 –
Areas to Be Inspected**

If no crack is found on any of the four mount struts, the turbine rear frame is serviceable and must be re-inspected at 4,700 cycle repetitive intervals. If cracks are found on the mount struts, the TRF must be re-inspected according to the following repetitive intervals:

TOTAL CUMULATED CRACK LENGTH AT EACH LOCATION	RE-INSPECT WITHIN
$L < 0.20$ (5)	4,700
0.20 (5) $\leq L < 0.28$ (7)	3,300
0.28 (7) $\leq L < 0.39$ (10)	1,300
0.39 (10) $\leq L < 0.59$ (15)	700
0.59 (15) $\leq L < 0.79$ (20)	120
$L \geq 0.79$ (20)	IMMEDIATELY REMOVE THE TURBINE FRAME

During each inspection, all the locations must be inspected. If cracks are found at different locations, the repetitive inspection interval is the minimum interval corresponding to the max. cumulated crack lengths.
