[Docket No. FAA-2010-0342; Directorate Identifier 2002-NE-08-AD]

**Airworthiness Directives; Bombardier-Rotax GmbH Type 912 F, 912 S, and 914 F Series Reciprocating Engines**

**ACTION:** Notice of proposed rulemaking (NPRM).

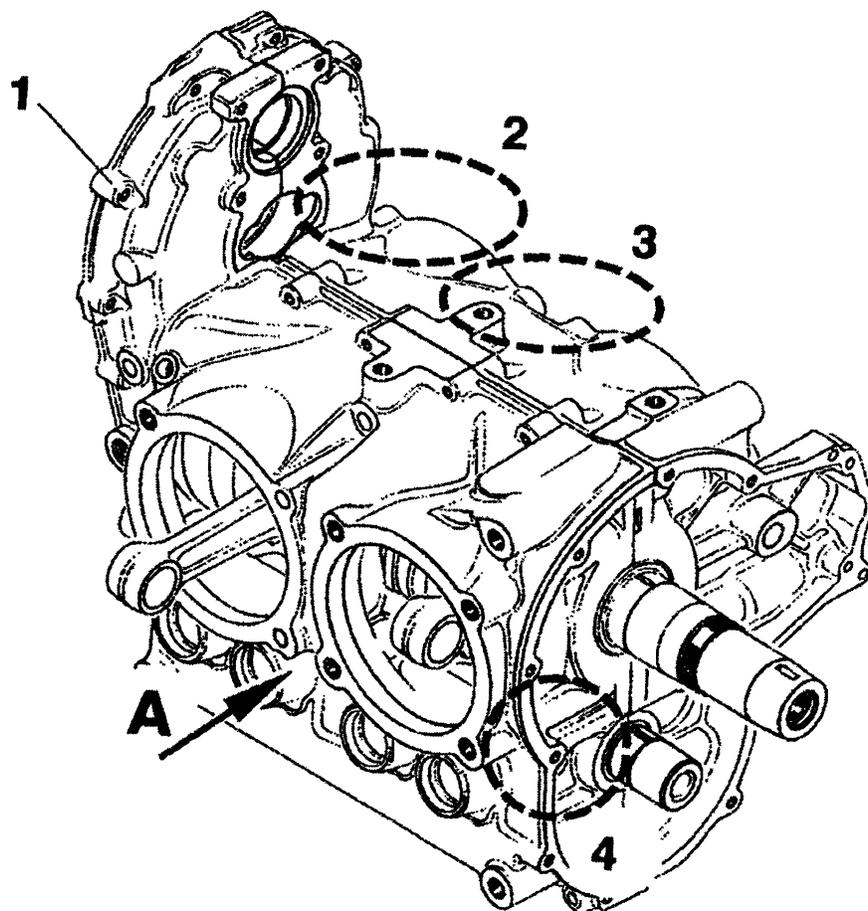
**Figure 1. Engine Crankcase Inspection Areas**

(1) Inspect the engine crankcase (item 1, Figure 1 of this AD) for cracks, especially in the area of cylinder 1 upper side (item 2), between cylinder 1 and 3 upper side (item 3), cylinder 4 lower-right side (item 4) and detailed inspection in the area identified in Figure 2 (item 5) of this AD. Information concerning this inspection can be found in Bombardier-Rotax Mandatory Service Bulletins No. SB–912–029, Revision 3, dated July 11, 2006 and No. SB–914–018, Revision 3, dated July 11, 2006.

(2) Cracks in crankcases of engines with a ROTAX cooling air baffle may not be easily visible, and oil leaks may be an indication of cracks. Visually inspect for oil leaks in areas of (item 2, Figure 1 of this AD) and (item 3).

(h) Visually inspect the engine crankcase (item 1, Figure 1 of this AD) for cracks at each 100-hour, annual, or progressive inspection, or within 110 hours TIS since last inspection, whichever occurs first, in accordance with paragraphs (g)(1) through (g)(4) of this AD.

(4) If the engine crankcase is cracked, replace the engine before further flight.

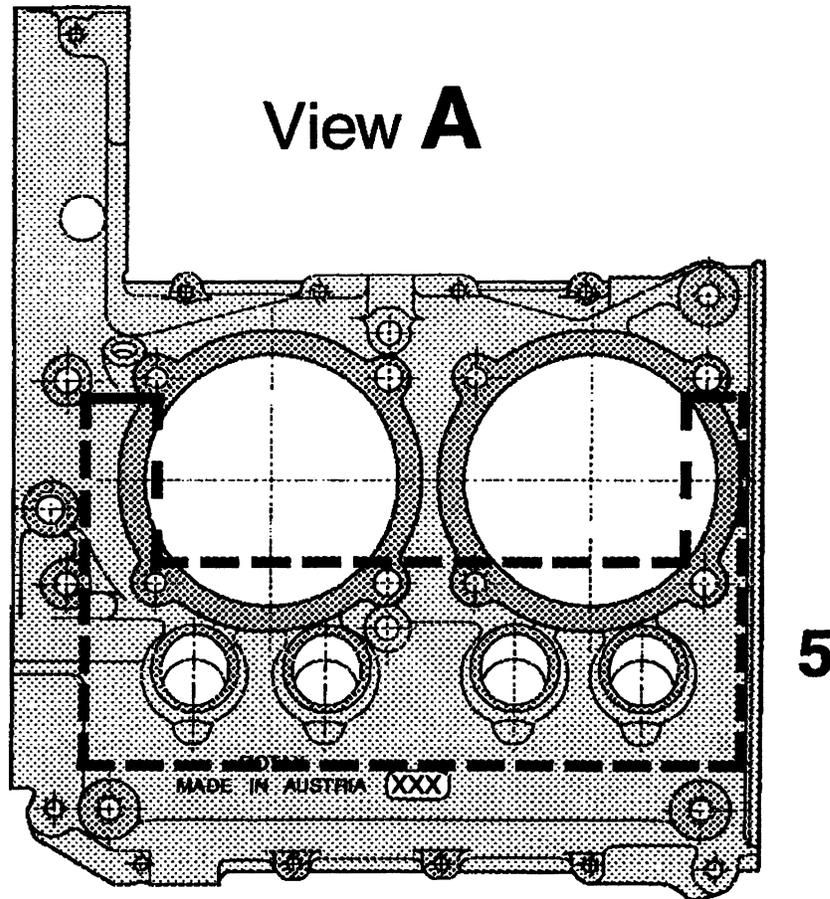
**Figure 2. Engine Crankcase Inspection Areas – View A**

(f) Determine if your crankcase is affected by looking at the S/N in the area indicated by XXX, following “Made in Austria,” as shown on Figure 2 of this AD. The marking is on both crankcase halves.
