[Docket No. FAA-2011-0450; Directorate Identifier 2011-CE-010-AD]

Airworthiness Directives; Cessna Aircraft Company (Cessna) Models 337, 337A (USAF 02B), 337B, 337C, 337D, 337E, T337E, 337F, T337F, 337G, T337G, M337B, F 337E, FT337E, F 337F, FT337F, F 337G, and FT337GP Airplanes

ACTION: Notice of proposed rulemaking (NPRM).

Appendix 1 to Docket No. FAA–2011–0450**General and Focused Inspection Procedures**

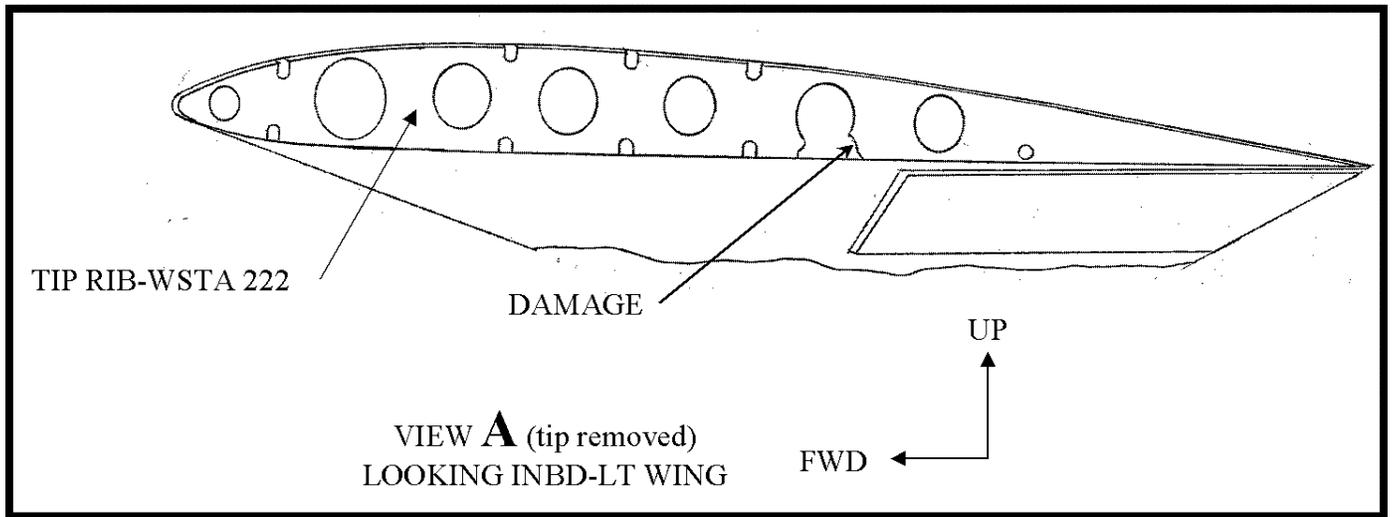
Figure 2

(11) Inspect rib at WSTA 222 for damage. Trimming of the rib may have been done to allow installation of fuel lines (See View A, Figure 2). Repair in accordance with AC 43.13–1B, Chapter 4, paragraph 4–58(g) and Figure 4–14, or by using another FAA-approved method that restores equivalent strength of the wing rib.

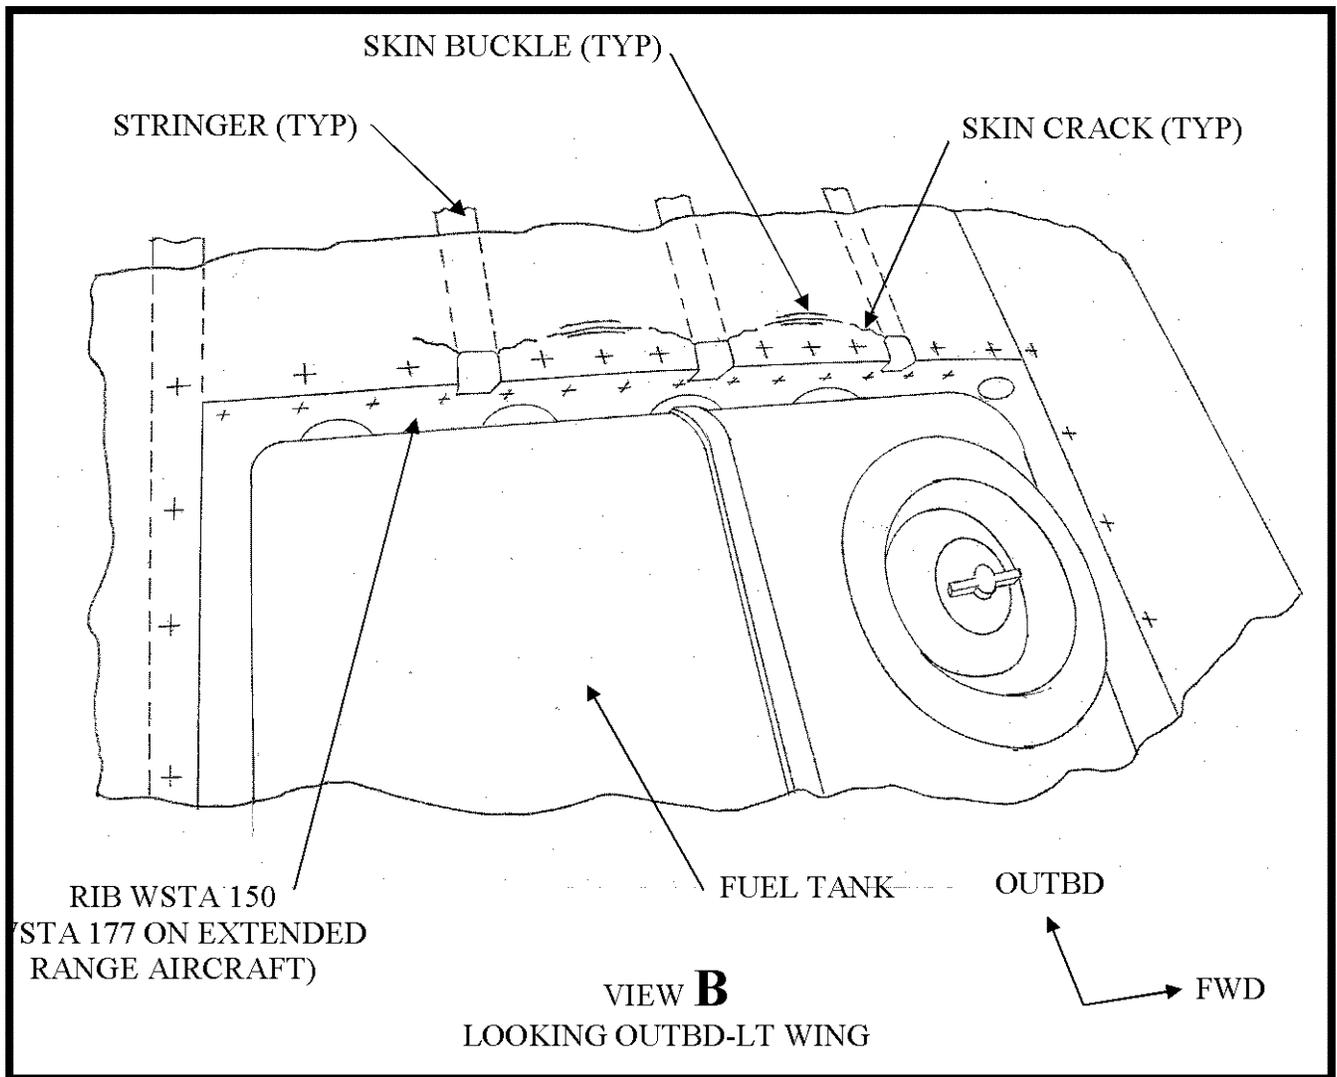
Figure 3

(1) Wrinkles in upper wing skins, from the outboard edge on the fuel tank access covers (WSTA 150 or 177) to the WSTA 222 (See View B, Figure 3).

(3) Cracking of the upper wing skins. Pay particular attention to any wrinkles, the radius between stiffeners at WSTA 150

(under fuel tank covers), and unreinforced access holes (See View B, Figure 3).

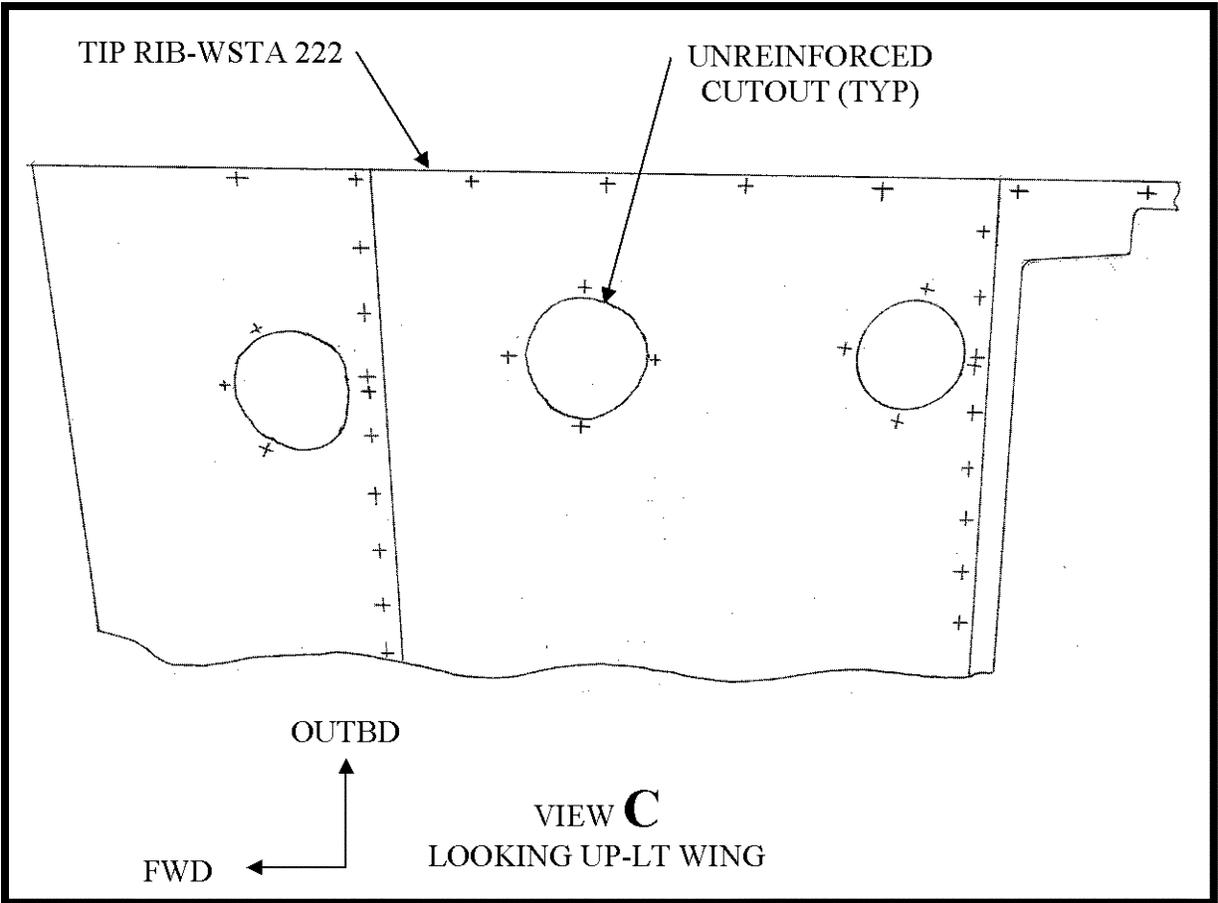
Figure 4

(13) Inspect wing skins for unreinforced cutouts. (See View C, Figure 4).

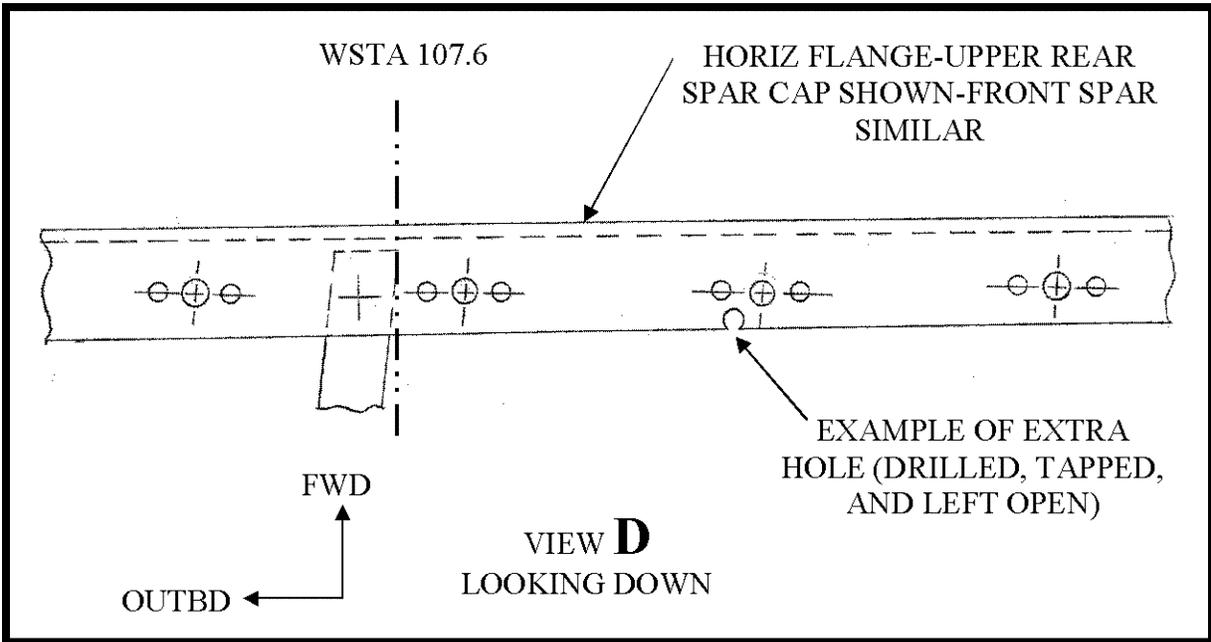
Figure 5

(14) Inspect the upper spar cap horizontal flanges for open holes (See View D, Figure 5).

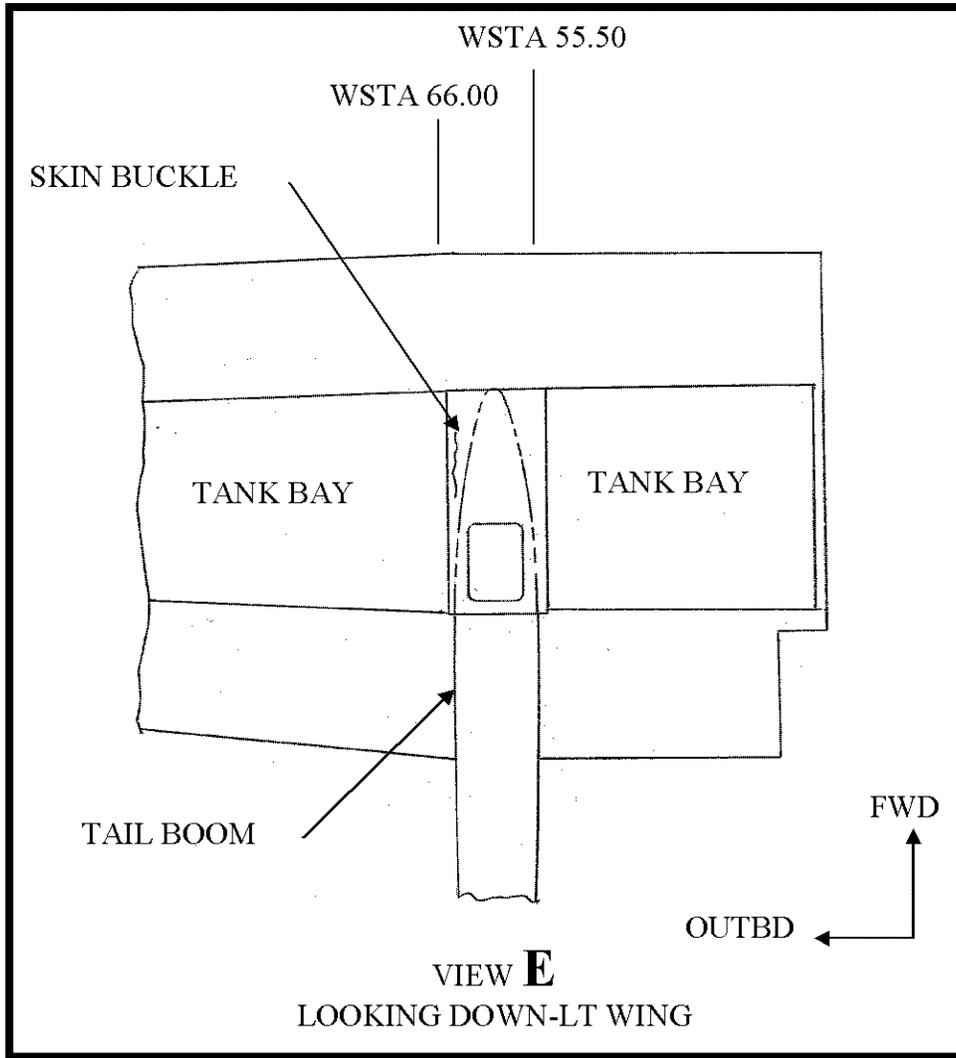
Figure 6

(2) Wrinkles in the upper wing skins from WSTA 55 to 66, adjacent to the booms (See View E, Figure 6).

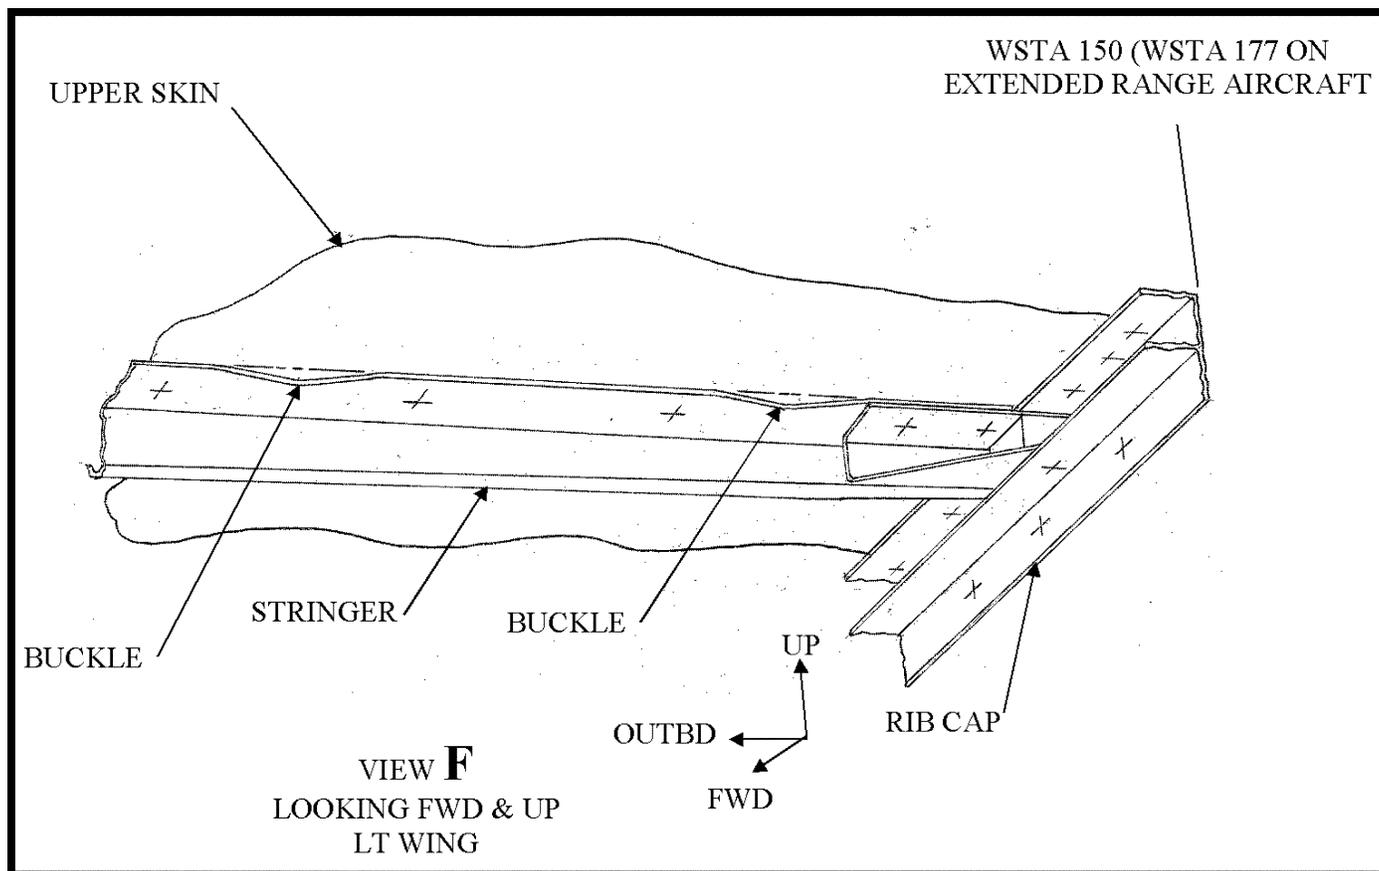
Figure 7

(10) Inter-rivet buckling of the stringers attached to the upper surface skin, outboard of the fuel tank access covers (See View F, Figure 7).
