[Docket No. FAA-2011-0450; Directorate Identifier 2011-CE-010-AD; Amendment 39-16758; AD 2011-15-11]

Airworthiness Directives; Cessna Aircraft Company (Cessna) Models 337, 337A (USAF 02B), 337B, 337C, 337D, 337E, T337E, 337F, T337F, 337G, T337G, M337B, F 337E, FT337E, F 337F, FT337F, F 337G, and FT337GP Airplanes

2011–15–11 Cessna Aircraft Company:

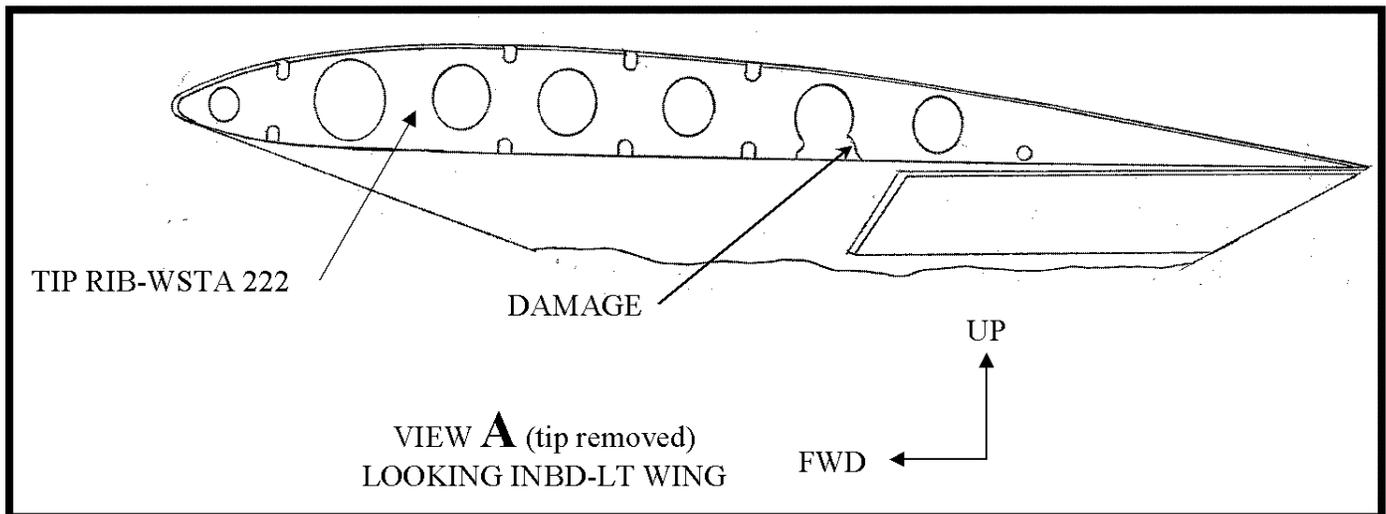
Figure 2

(11) Inspect rib at WSTA 222 for damage. Trimming of the rib may have been done to allow installation of fuel lines (See View A, Figure 2). Repair in accordance with AC 43.13-1B, Chapter 4, paragraph 4-58(g) and Figure 4-14, or by using another FAA-approved method that restores equivalent strength of the wing rib.

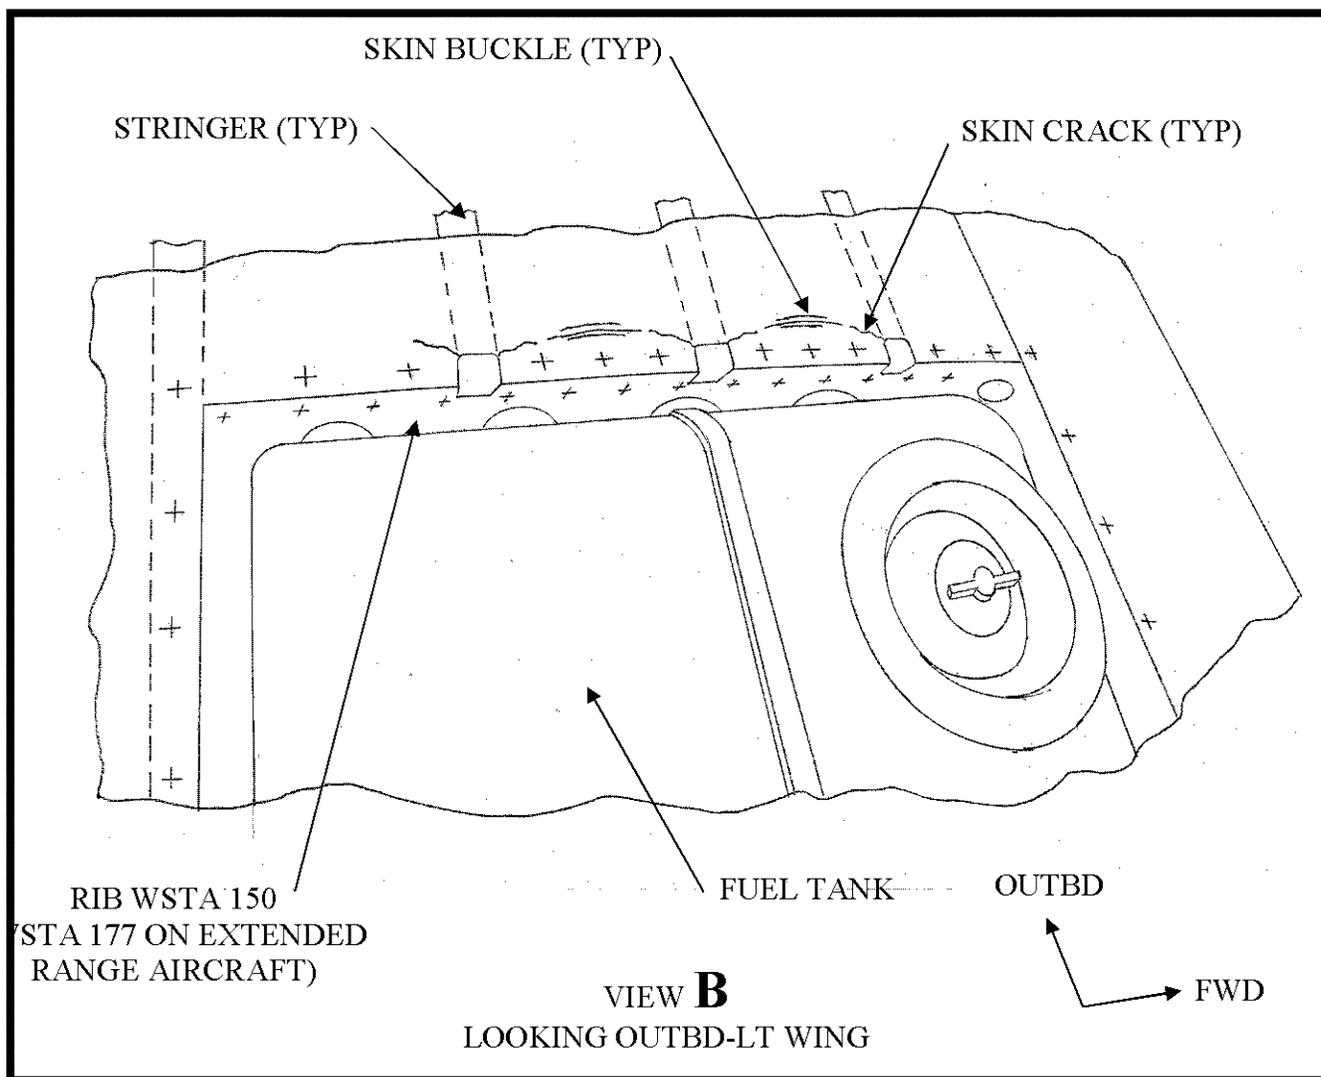
Figure 3

(1) Wrinkles in upper wing skins, from the outboard edge on the fuel tank access covers (WSTA 150 or 177) to the WSTA 222 (See View B, Figure 3).

(3) Cracking of the upper wing skins. Pay particular attention to any wrinkles, the radius between stiffeners at WSTA 150 (under fuel tank covers), and unreinforced access holes (See View B, Figure 3).

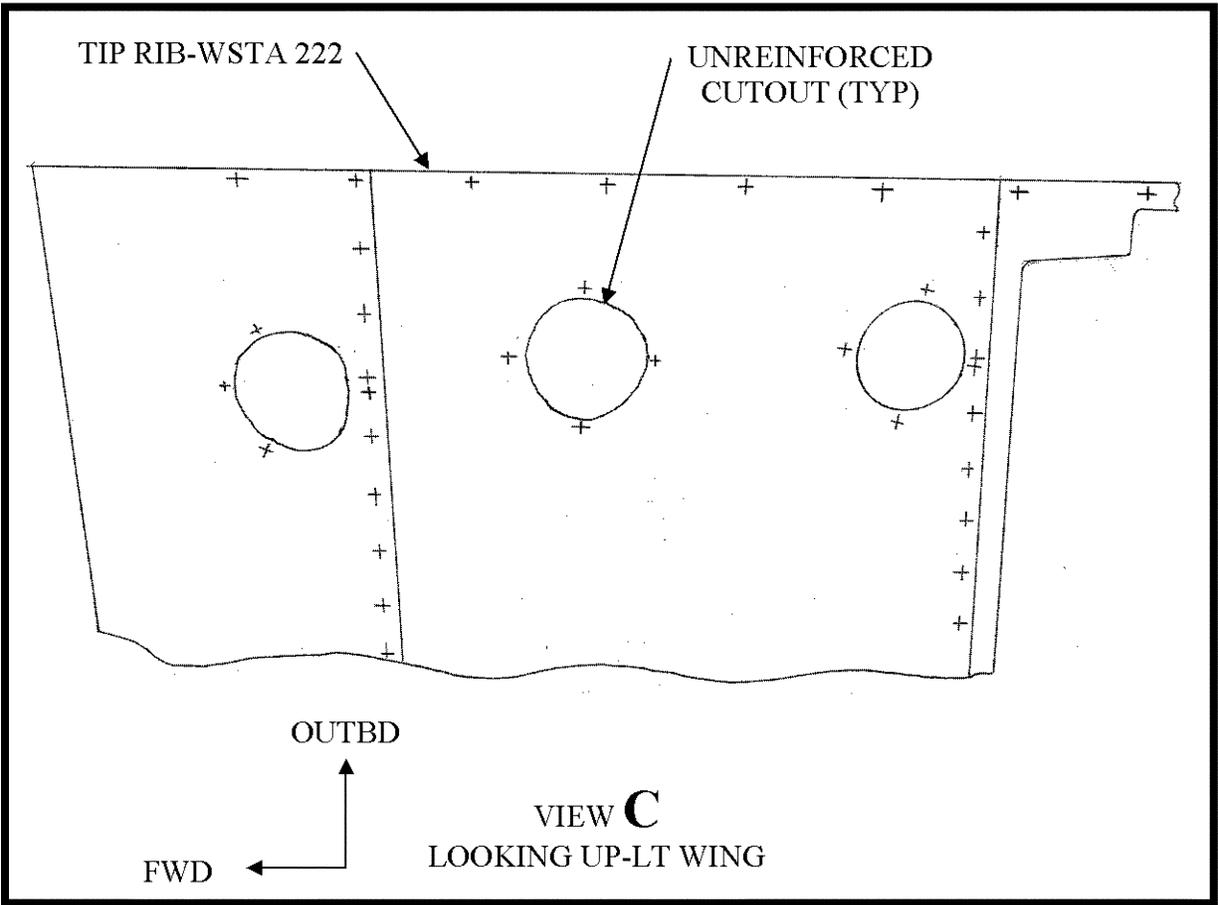
Figure 4

(13) Inspect wing skins for unreinforced cutouts. (See View C, Figure 4).

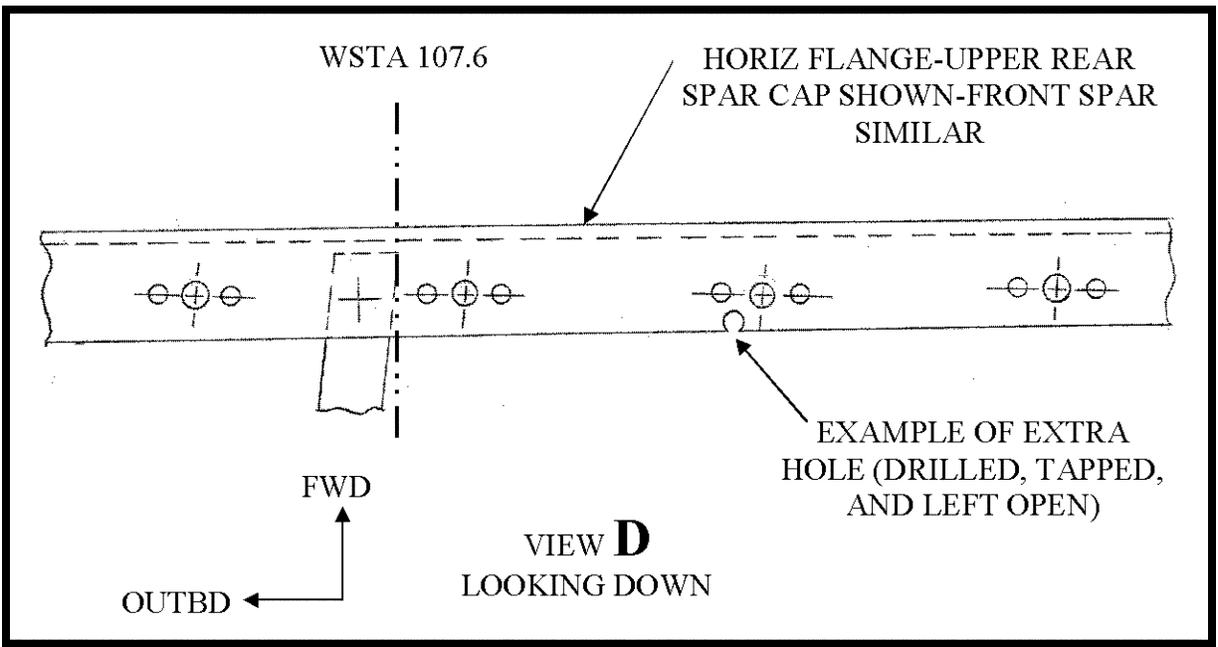
Figure 5

(14) Inspect the upper spar cap horizontal flanges for open holes (See View D, Figure 5).

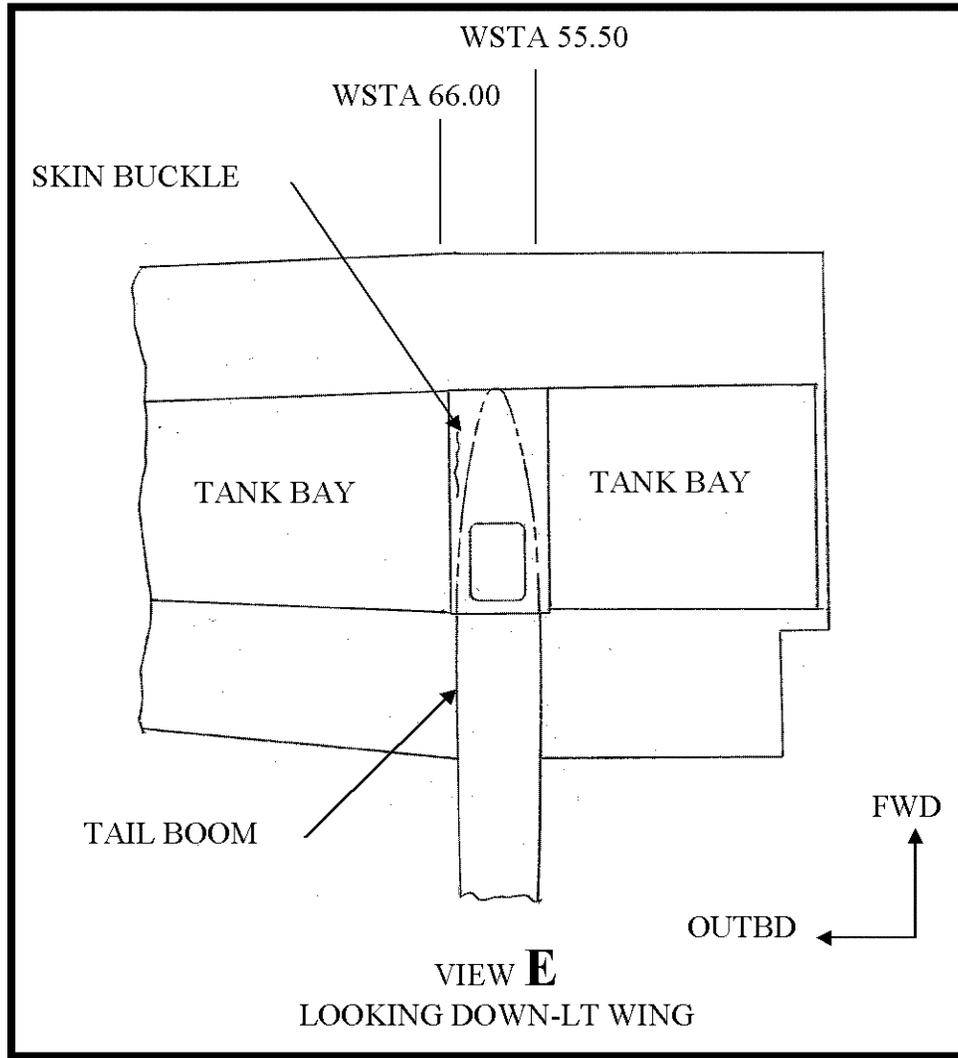
Figure 6

(2) Wrinkles in the upper wing skins from WSTA 55 to 66, adjacent to the booms (See View E, Figure 6).

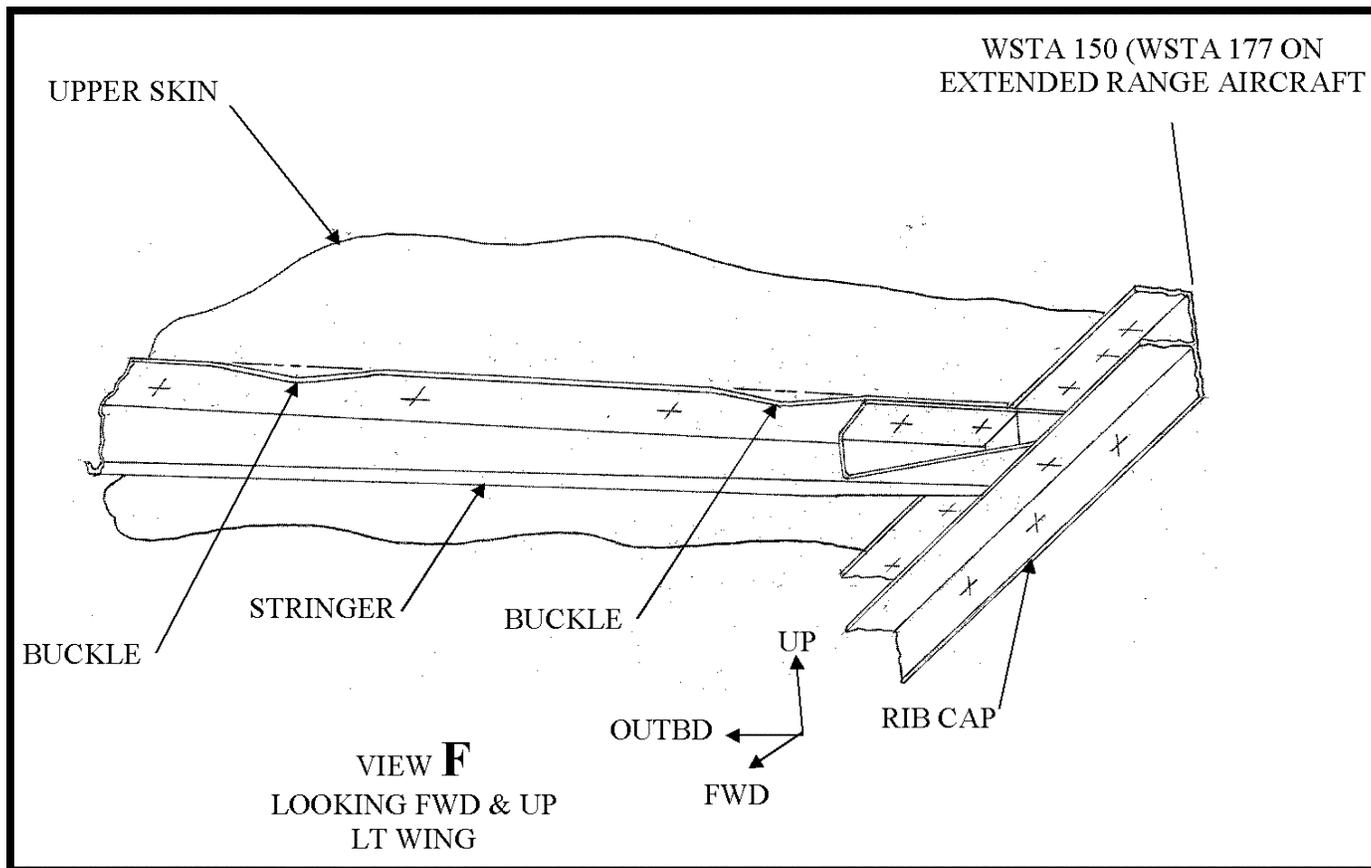
Figure 7

(10) Inter-rivet buckling of the stringers attached to the upper surface skin, outboard of the fuel tank access covers (See View F, Figure 7).
