[Docket No. FAA–2011–0939; Directorate Identifier 2010–SW–067–AD; Amendment 39 16798; AD 2011–18–16]

Airworthiness Directives; Eurocopter France (Eurocopter) Model AS332C, AS332L, AS332L1, and AS332L2 Helicopters

ACTION: Final rule; request for comments.

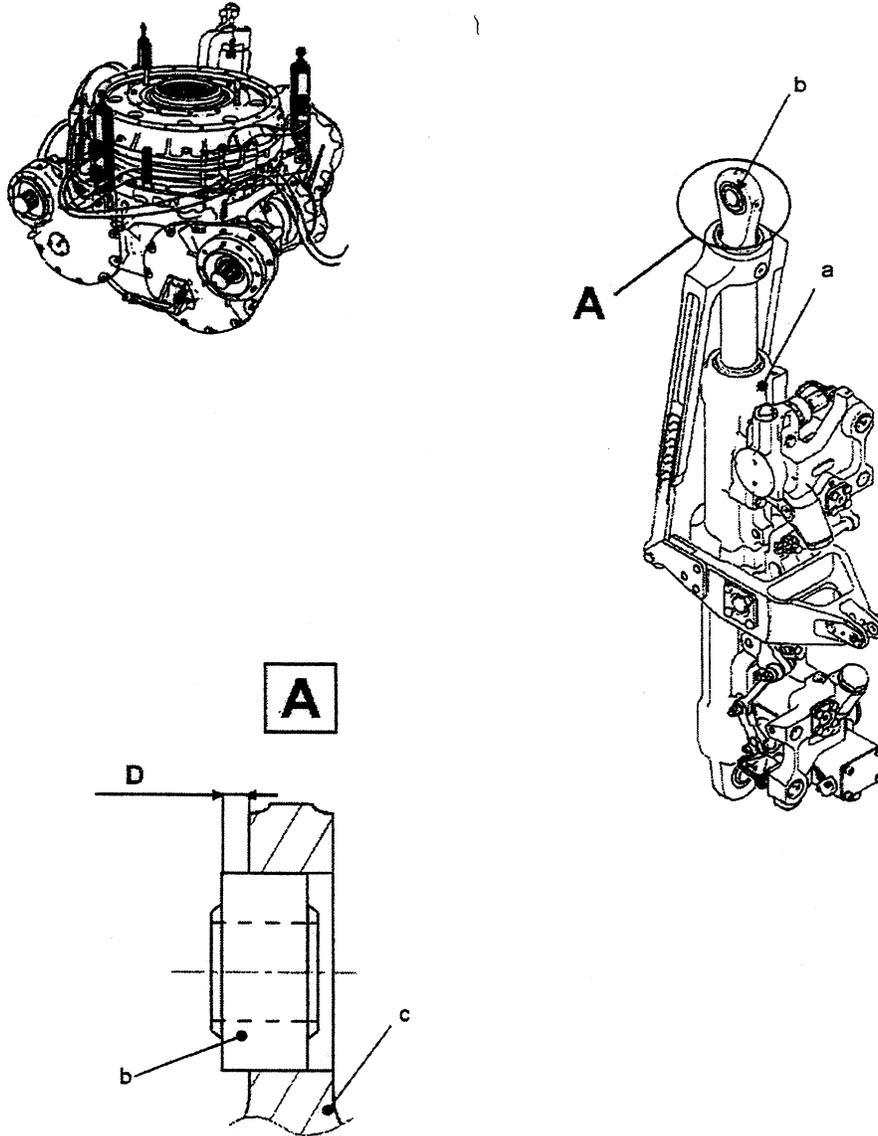
Investigation has shown that the swaging load applied to the ball joints was 1.3 metric tons instead of the specified 13 metric tons. The actions specified in this AD are intended to prevent failure of the upper end fitting ball joints of the main rotor servocontrols, failure of the upper end fittings, and loss of control of the helicopter.

(a) Within 15 hours time-in-service (TIS), unless accomplished previously, using a feeler gage, measure the lateral play between the outer ring of the ball joint and each of the two faces of the upper end fitting as depicted in Figure 1 of this AD.

(b) If the lateral play is greater than or equal to 1 millimeter (MM) (0.04 inch) and the servocontrol has accumulated 825 or more hours TIS, before further flight, replace it with an airworthy servocontrol.

servocontrol has accumulated less than 825 hours TIS, on or before the servocontrol accumulates 825 hours TIS, replace it with an airworthy servocontrol.

(d) If the lateral play is less than 1 mm (0.04 inch), at intervals not to exceed 300 hours TIS, repeat the inspection required by

paragraph (a) of this AD. At each 300 hour TIS interval inspection, if the lateral play is greater than or equal to 1 mm (0.04 inch), within 525 hours TIS, replace the servocontrol with an airworthy servocontrol.
