[Docket No. FAA-2012-0409; Directorate Identifier 2011-SW-055-AD; Amendment 39-17020; AD 2011-18-52]

#### Airworthiness Directives; Agusta S.p.A. Helicopters

**2011-18-52 AGUSTA S.p.A. (AGUSTA):**  
Amendment 39-17020; Docket No.  
FAA-2012-0409; Directorate Identifier  
2011-SW-055-AD.

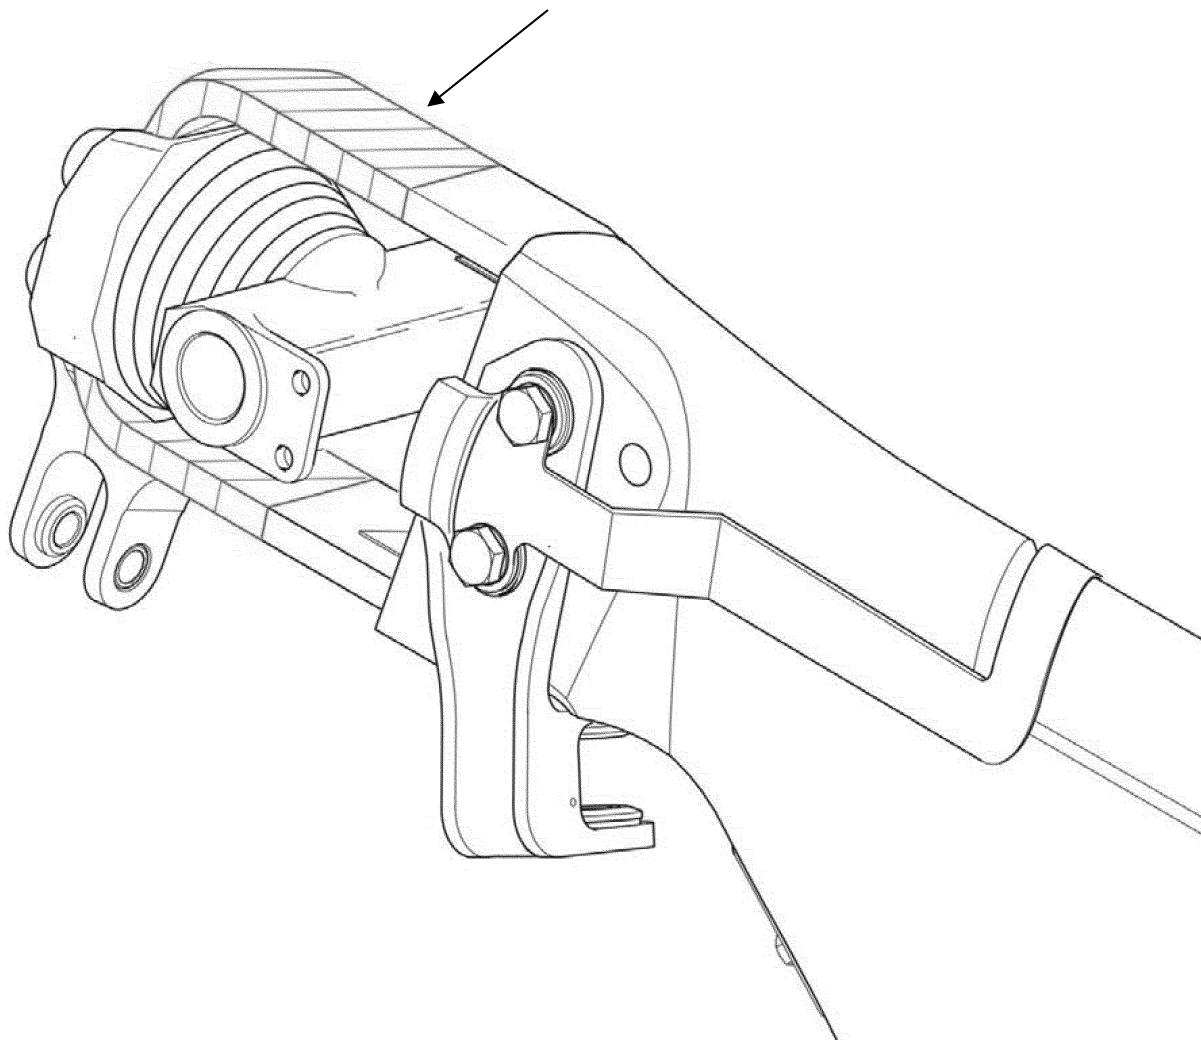
This AD defines the unsafe condition as cracks in a T/R blade. The actions in this AD are intended to detect and prevent a crack in a T/R blade which could lead to failure of a T/R blade and subsequent loss of control of the helicopter.

(3) Within 25 hours TIS, and thereafter at intervals not to exceed 25 hours TIS, visually inspect the T/R blade for a crack or damage that exceeds the limits of the applicable maintenance manual. Inspect in the area depicted in the following figure using a mirror, magnifying glass (5X or greater), and light source, or borescope.

Inspect in hatched area.

(4) If there is a crack, or if there is damage that exceeds the limits of the applicable maintenance manual, before further flight, replace the T/R blade with an airworthy T/R blade.
