Airworthiness Directives; Eurocopter Deutschland GmbH Helicopters

ACTION: Notice of proposed rulemaking (NPRM).

EUROCOPTER DEUTSCHLAND GmbH (ECD): Docket No. FAA-2012-0887; Directorate Identifier 2009-SW-02-AD.

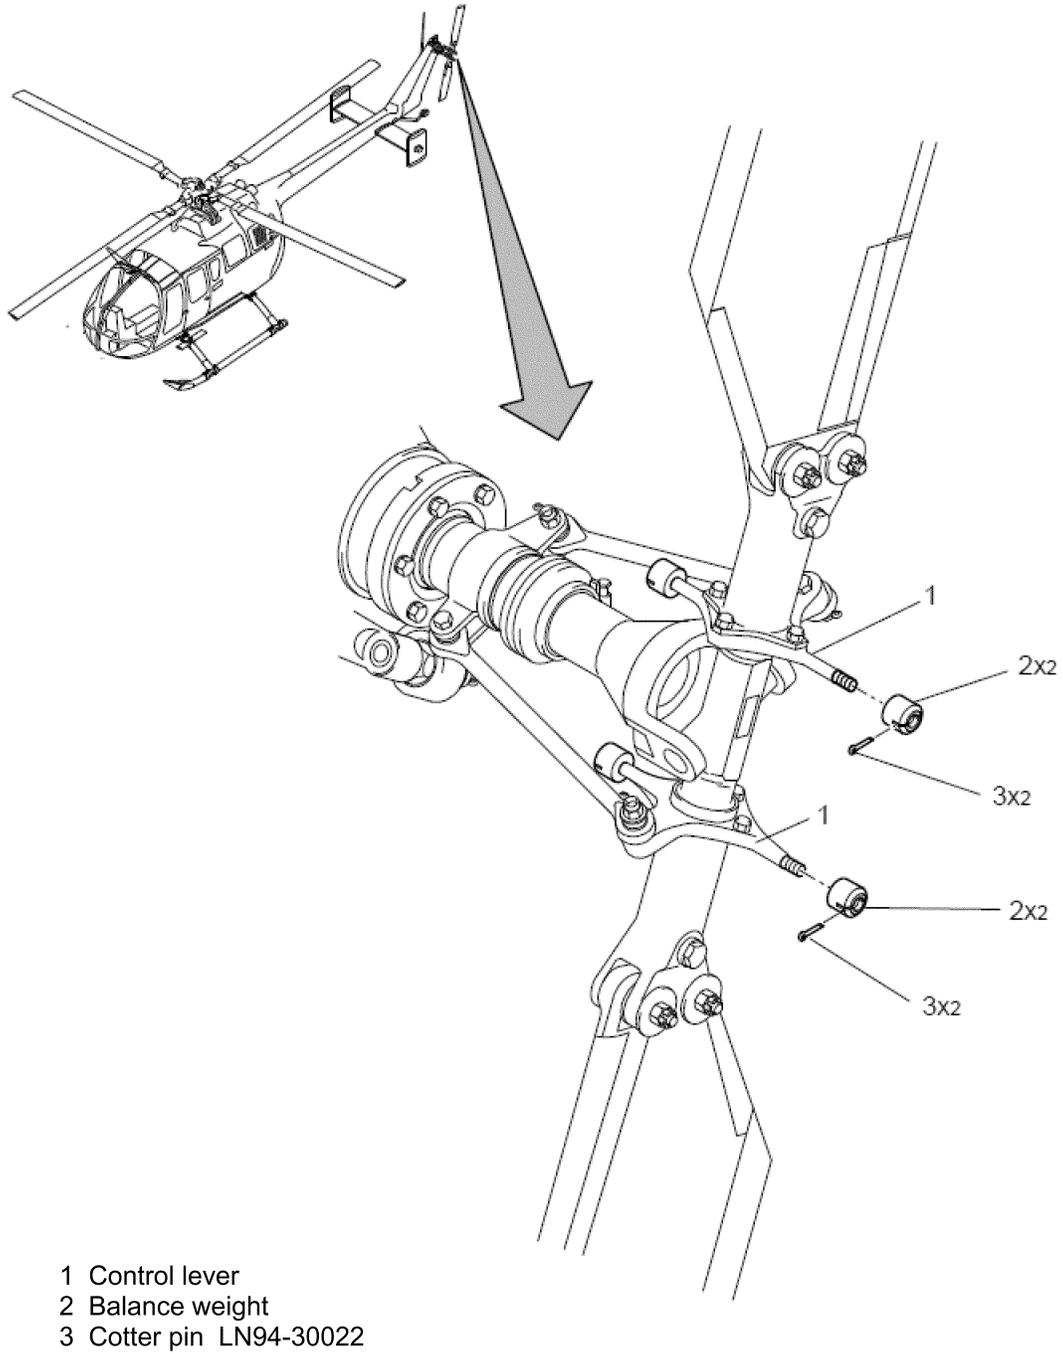
Figure 1 to paragraph (d) Tail Rotor Balance Weights

- (1) Remove the weights from the lever as depicted in Figure 1 to paragraph (d) of this AD. Apply marks to the weights before they are removed in order to be able to re-establish the correct assignment and the old installation position towards the lever when the weights are installed.

(3) Apply corrosion preventive paste onto the thread of the lever and install weights to

the lever as depicted in Figure 1 to paragraph (d) of this AD. Ensure during installation of the weights that the weights are correctly assigned and installed to the control lever in accordance with the applied marks.

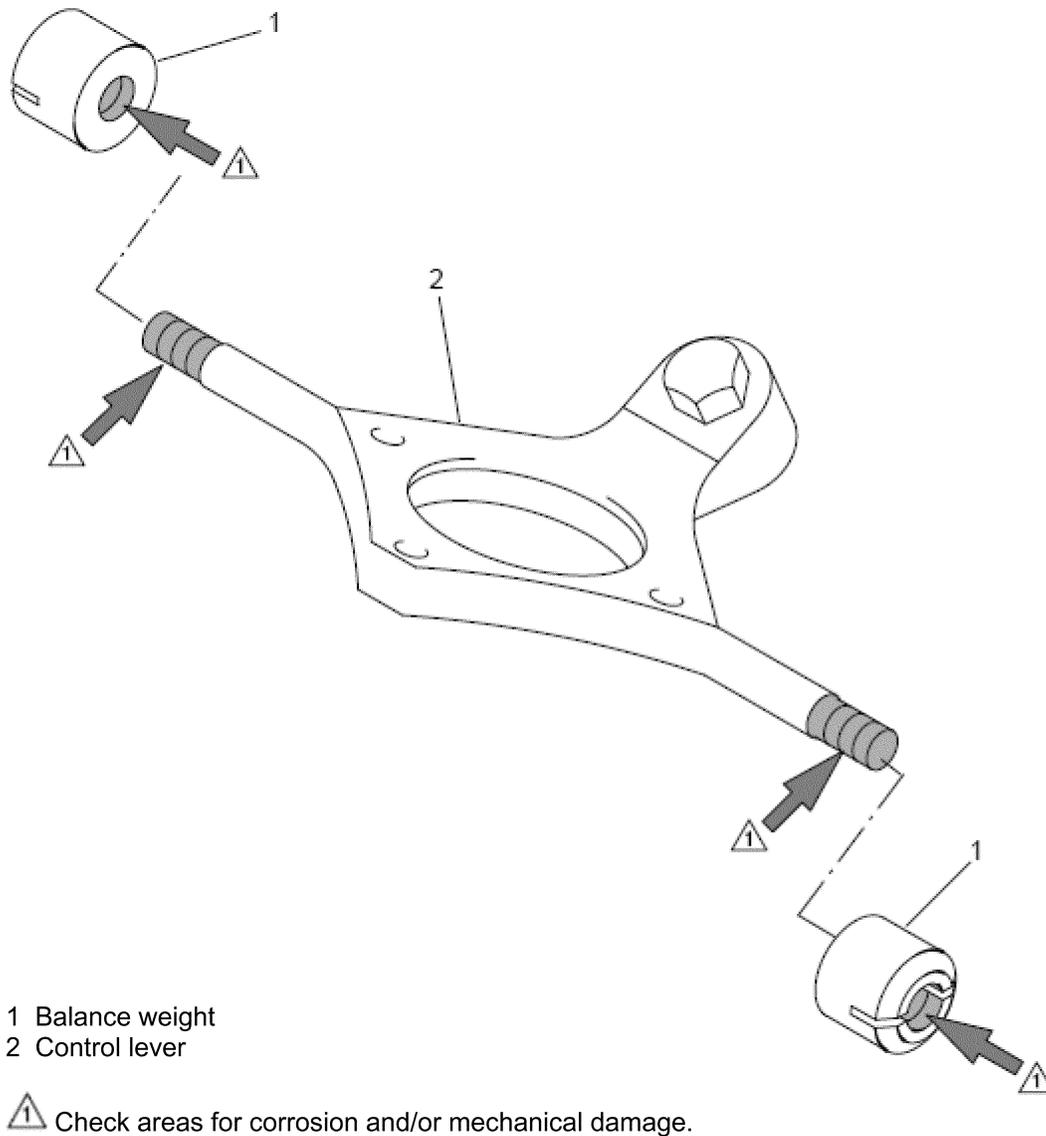
Figure 2 to paragraph (d) Inspection of Balance Weights and Control Lever

This AD defines the unsafe condition as corrosion or thread damage in the threaded area of a lever or weight. This condition could result in failure of a weight or lever, separation of a tail rotor part, severe tail rotor vibration, and subsequent loss of control of the helicopter.

(2) Visually inspect each weight and lever for corrosion and damage in the threaded

areas as depicted in Figure 2 to paragraph (d) of this AD.

(i) If there is no corrosion or thread damage on either the weight or lever, before further flight, reinstall the weight by following paragraph (d)(3) of this AD.

(A) If the total area of corrosion or thread damage, or both, covers less than 25 percent of the length of the threaded area, the weight can be threaded (screwed) onto the lever, and the cylindrical mating surface has no damage, before further flight, remove the

corrosion and reinstall the weight by following paragraph (d)(3) of this AD.

(B) If the total area of corrosion or thread damage, or both, covers 25 percent or more of the length of the threaded area, the weight cannot be threaded (screwed) onto the lever, or the cylindrical mating surface has damage, before further flight, replace the weight with an airworthy weight by following paragraph (d)(3) of this AD.

(iii) If there is corrosion or thread damage on the threaded portion of the *lever*, polish out the corrosion and thread damage using a polishing cloth 600 and:

(A) If the thread depth does not exceed 0.3 millimeter (mm) and the diameter of the lever in the area before the threaded area is not less than 9.95 mm after polish out, before further flight, install airworthy weights to the lever by following paragraph (d)(3) of this AD.

(B) If the thread depth is 0.3 mm or greater or the diameter of the lever in the area before the threaded area is less than 9.95 mm after polish out, before further flight, replace the lever with an airworthy lever.
