14 CFR Part 39

[Docket No. FAA-2012-0008; Directorate Identifier 2011-NE-43-AD; Amendment 39-17115; AD 2012-14-01]

Airworthiness Directives; Rolls-Royce Deutschland Ltd & Co KG Turbofan Engines

ACTION: Final rule.

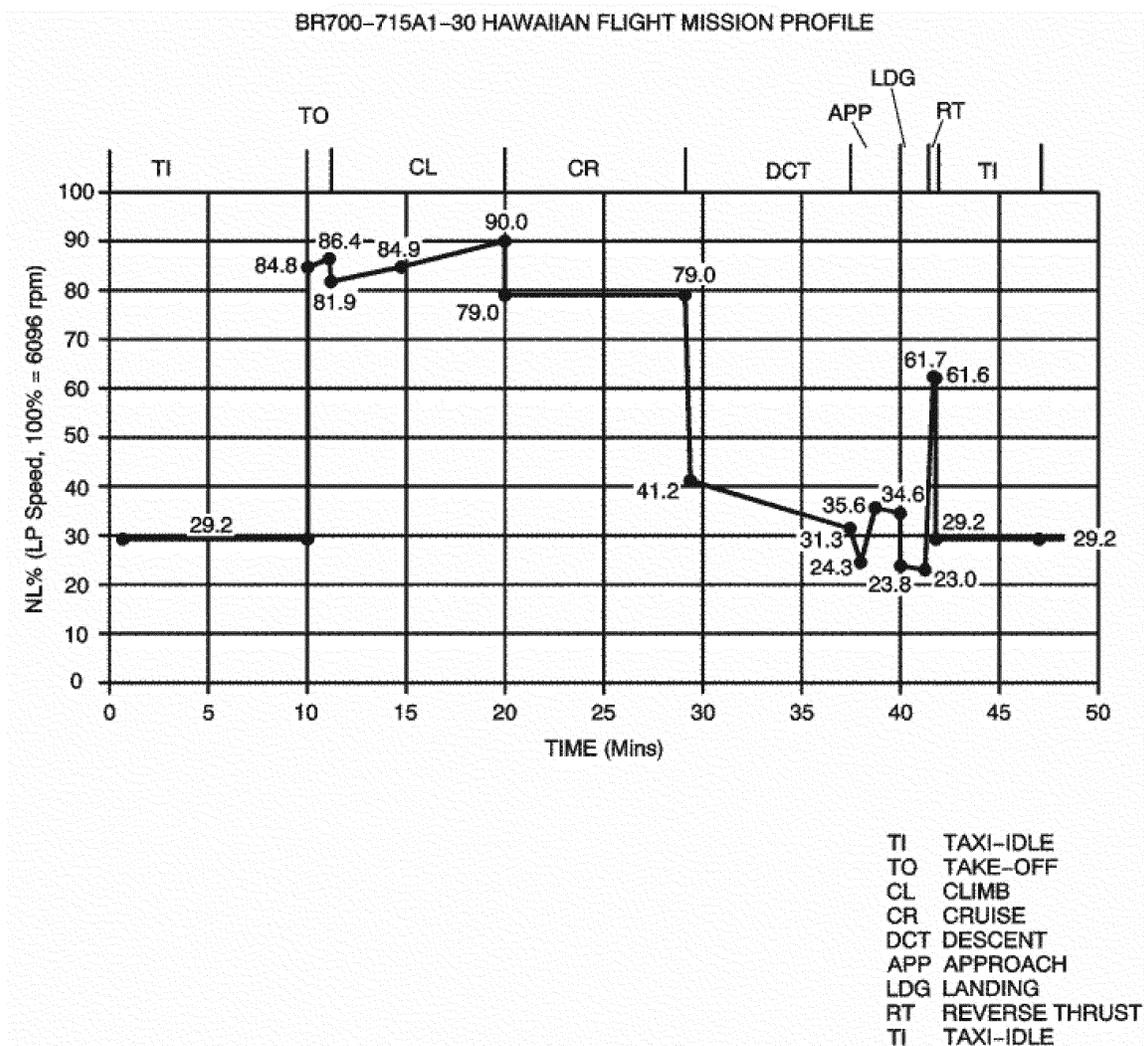
Figure 1 to paragraph (f)(2)

(2) The Hawaiian Flight Mission referenced in Table 1 to paragraph (e) is shown in Figure 1 to paragraph (f)(2):
