DEPARTMENT OF TRANSPORTATION

[Docket No. FAA-2012-1135; Directorate Identifier 2012-SW-097-AD; Amendment 39-17281; AD 2012-21-52]

Airworthiness Directives; Agusta S.p.A. (Type Certificate Currently Held by AgustaWestland S.p.A.) (Agusta) Helicopters

2012–21–52 Agusta S.P.A. Helicopters (Type Certificate Currently Held By AgustaWestland S.P.A.) (Agusta): Amendment 39–17281; Docket No. FAA–2012–1135; Directorate Identifier 2012–SW–097–AD.

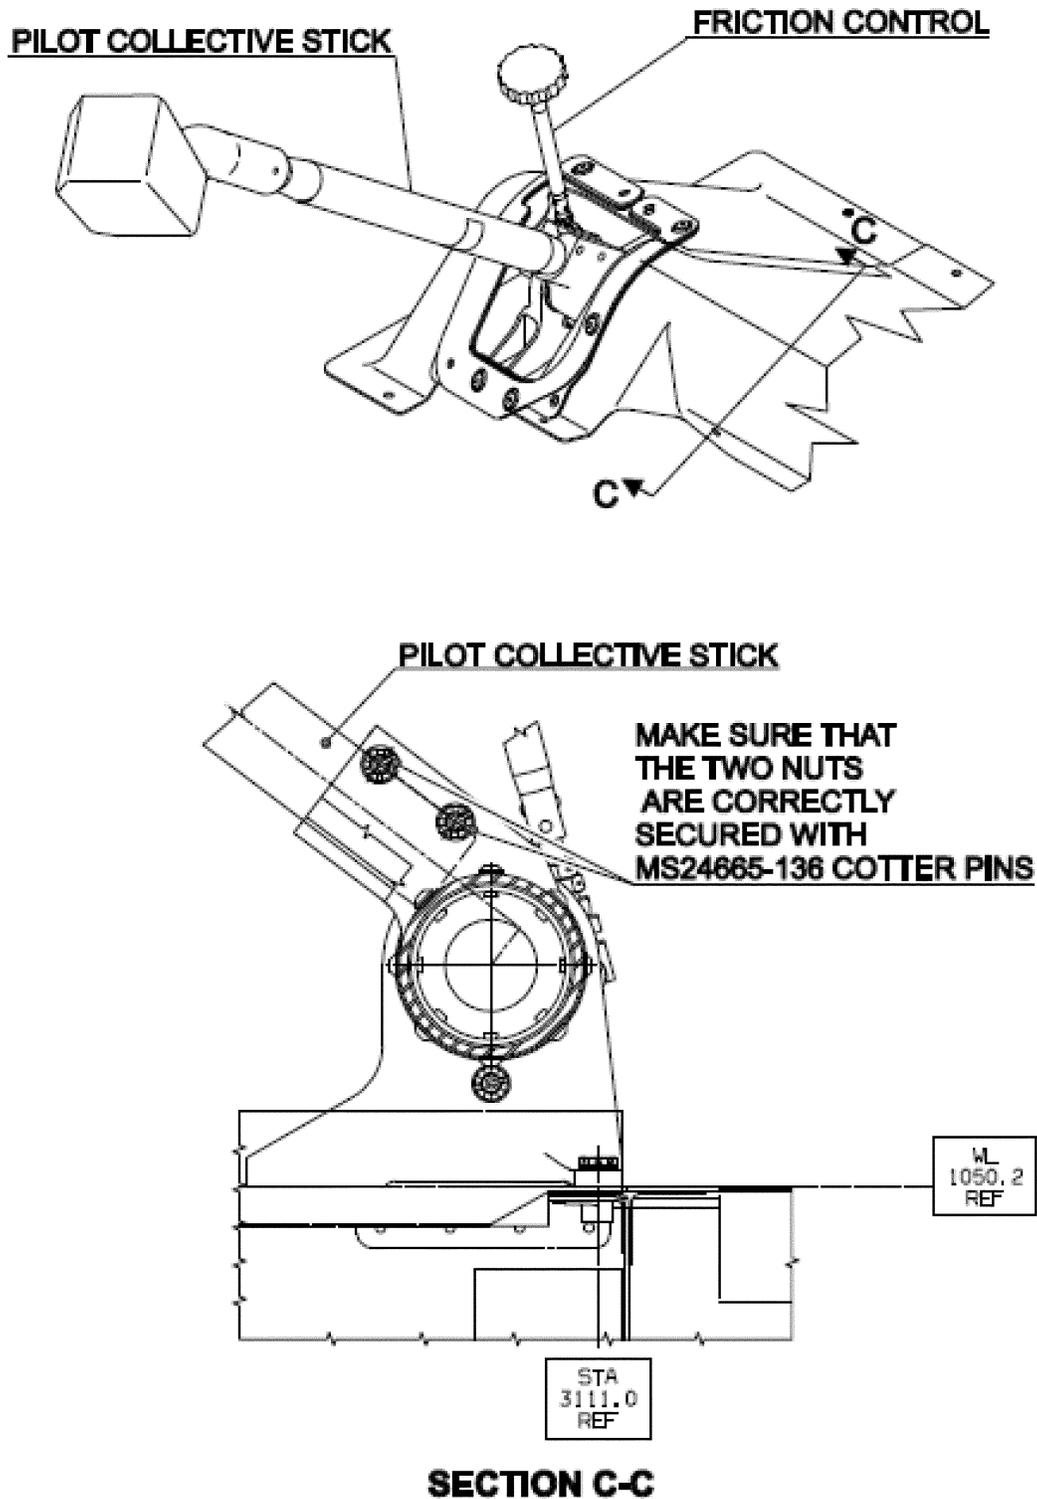
(1) Inspect the pilot collective stick installation to determine whether the self-locking nuts, part-number (P/N) MS17825–4, are secured with cotter pins, P/N MS24665–136, as depicted in Figure 1 to paragraph (e) of this AD. If the self-locking nuts are not secured with cotter pins, before further flight, reinstall the pilot collective stick.

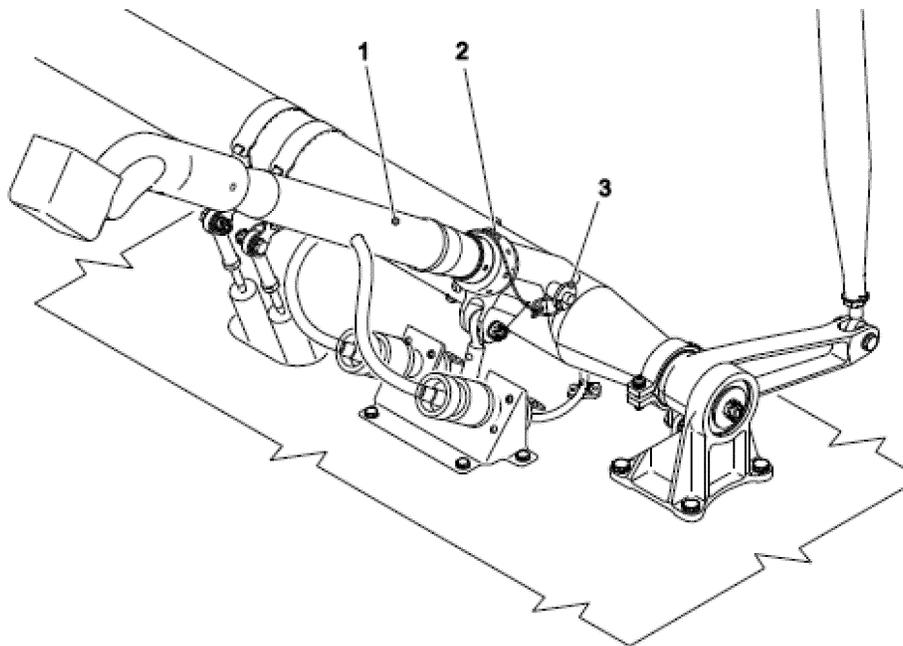
(2) Inspect the co-pilot collective stick installation to determine whether the ring nut (item 2) is loose and the quick-release pin

(item 3) is installed as depicted in Figure 2 to paragraph (e) of this AD. If the ring nut is loose or the quick-release pin is not installed,

before further flight, reinstall the co-pilot collective stick.

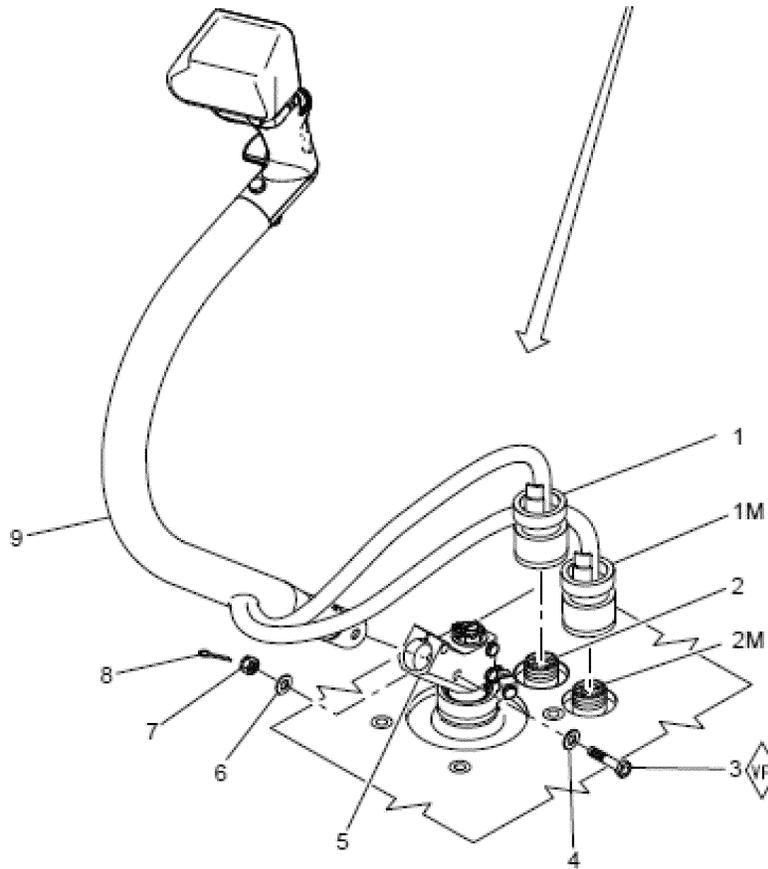
(3) Inspect the pilot cyclic stick installation for proper installation of the bolt (item 3), washer (item 4), self-locking nut (item 7),

washer (item 6), and the cotter pin (item 8), as depicted in Figure 3 to paragraph (e) of this AD. If the pilot cyclic stick is not

installed as depicted, before further flight, reinstall the pilot cyclic stick.
