[Docket No. FAA-2013-0340; Directorate Identifier 2010-SW-081-AD; Amendment 39-17630; AD 2013-21-06]

#### Airworthiness Directives; Eurocopter Deutschland GmbH Helicopters

##### 2013-21-06 Eurocopter Deutschland GmbH

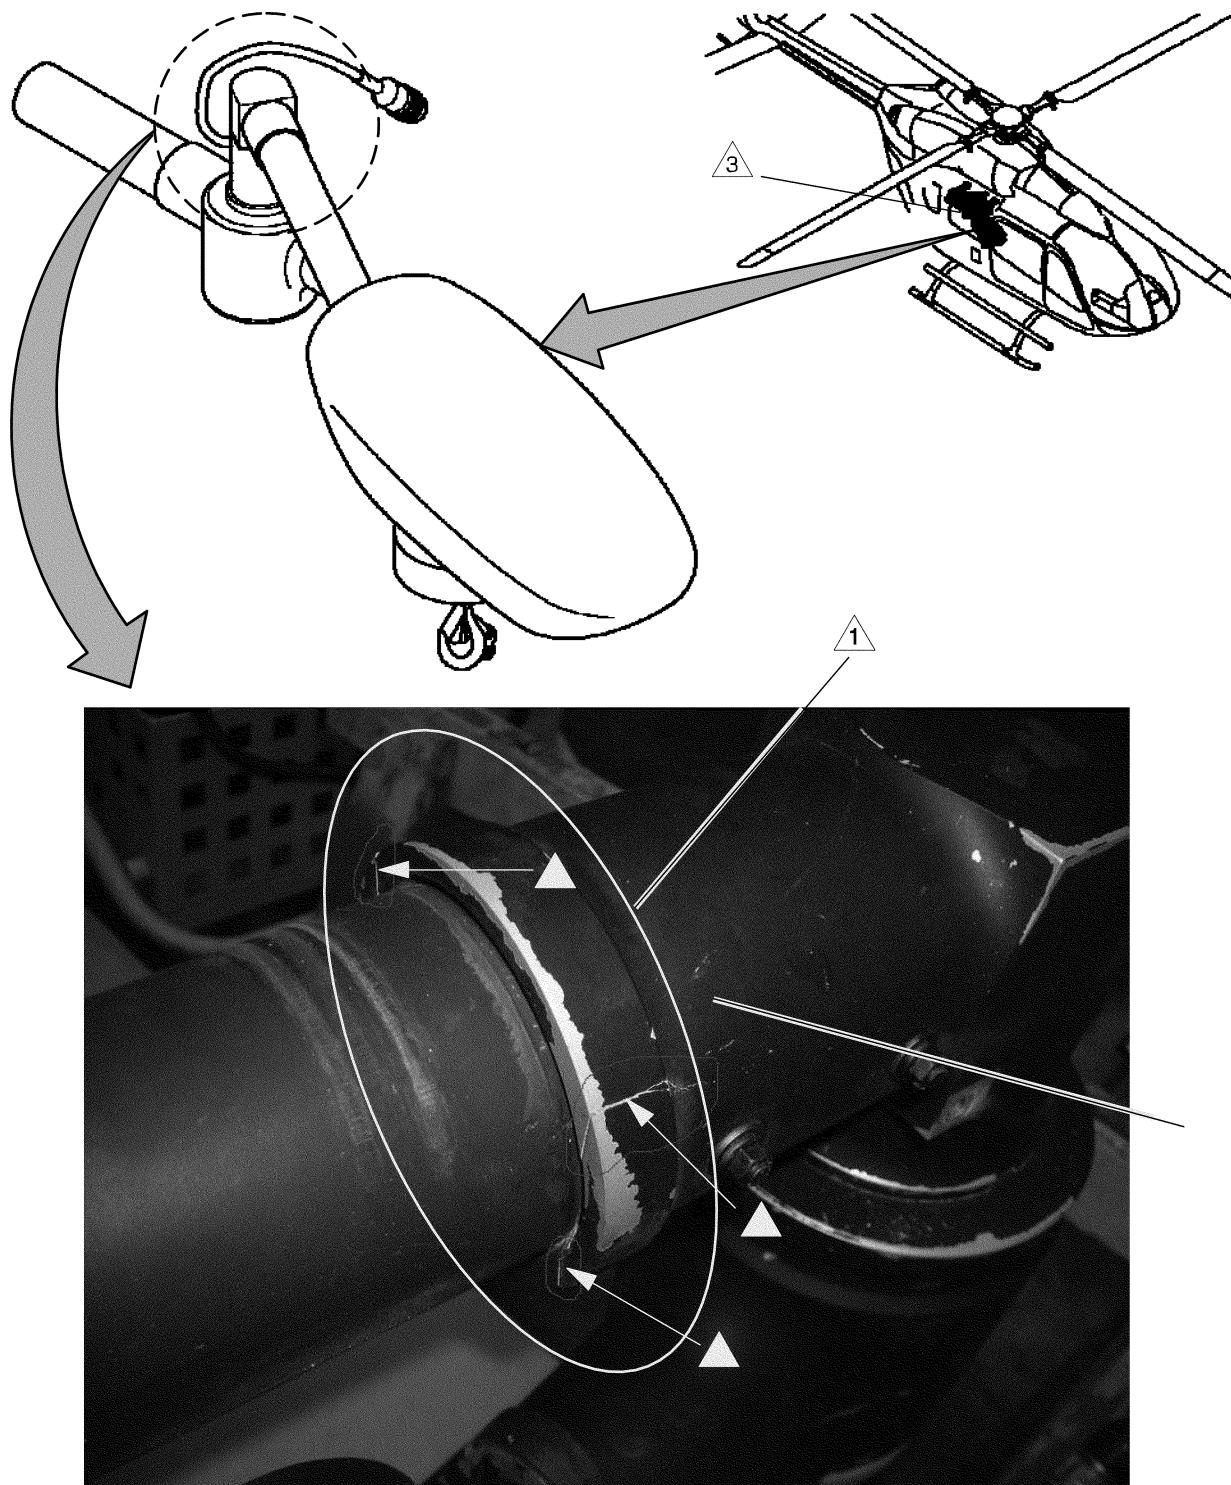
Figure 1 to Paragraph (e)

This AD defines the unsafe condition as a crack in the boom. This condition could result in loss of the boom and attached loads, and subsequent loss of helicopter control.

(1) Before further flight, and thereafter before the first flight of each day until you have performed the inspection required by paragraph (e)(2) of this AD, clean the hoist and visually check for a crack, paying particular attention to the areas that are circled as depicted in Figure 1 to paragraph (e) of this AD. The actions required by this paragraph may be performed by the owner/operator (pilot) holding at least a private pilot certificate, and must be entered into the aircraft records showing compliance with this AD in accordance with 14 CFR 43.9(a)(1)-(4) and 14 CFR 91.417(a)(2)(v). The record must be maintained as required by 14 CFR 91.417, 121.380, or 135.439.

(2) Within 30 days, perform a dye penetrant inspection of the boom in accordance with the Accomplishment Instructions, Section 2.D, of the Goodrich Service Bulletin 44307-500-03, Revision 2, dated April 30, 2010 (SB).

(3) If a crack exists in the boom, replace the cracked boom with an airworthy boom before further flight.
