## DEPARTMENT OF TRANSPORTATION

#### Airworthiness Directives; Airbus Helicopters (Type Certificate Previously Held by Eurocopter France) (Airbus Helicopters)

**2014–05–10 Airbus Helicopters (Type Certificate Previously Held By Eurocopter France):** Amendment 39–17783; Docket No. FAA–2013–0822; Directorate Identifier 2013–SW–004–AD.

This AD defines the unsafe condition as severe vibrations due to failure of laminated half-bearings (bearings). This condition could result in failure of the tail rotor and subsequent loss of control of the helicopter.

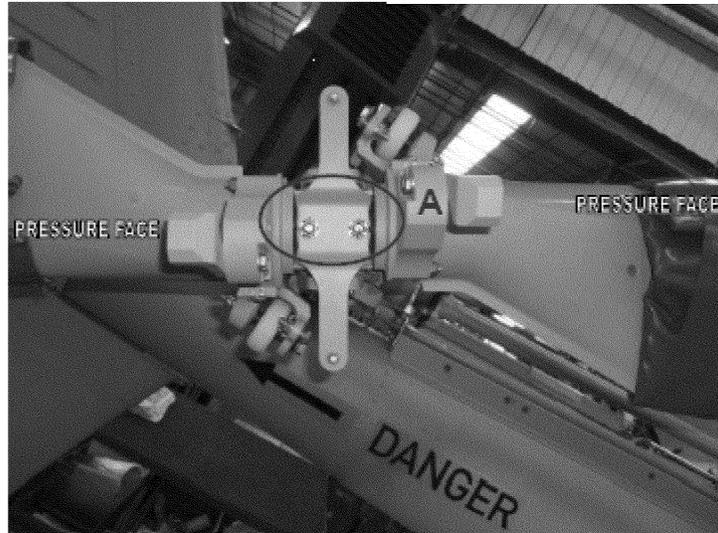
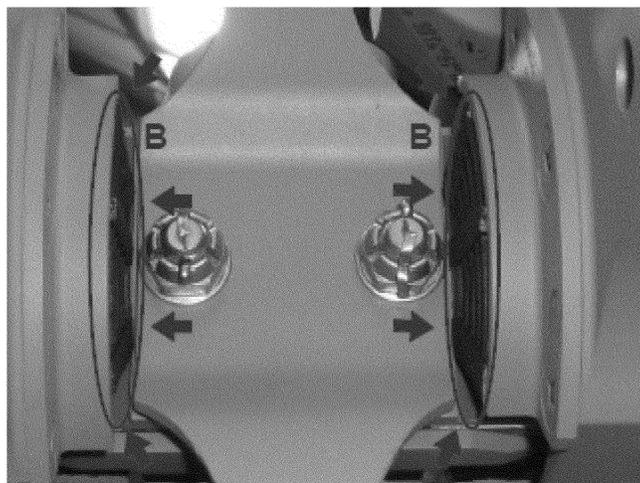
(B) Apply load (F) by hand, perpendicular to the pressure face of one tail rotor blade (a), as shown in Figure 3 to paragraph (f) of this AD, taking care not to reach the extreme position against the tail rotor hub. The load will deflect the tail rotor blade towards the tail boom.

(C) While maintaining the load, check all the visible faces of the bearings (front and side faces) in area B of DETAIL A of Figure 3 to paragraph (f) of this AD for separation between the elastomer and metal parts, a crack in the elastomer, or an extrusion (see example in Figure 4 to paragraph (f) of this AD). A flashlight may be used to enhance the check.

(v) If there is an extrusion on any bearing, before further flight, replace the four bearings with airworthy bearings.

(vi) If there is a separation or a crack on the pressure side bearing, measure the separation or the crack. If the separation or crack is greater than 5 millimeters (.196 inches) as indicated by dimension “L” in Figure 6 to paragraph (f) of this AD, before further flight, replace the four bearings with airworthy bearings.

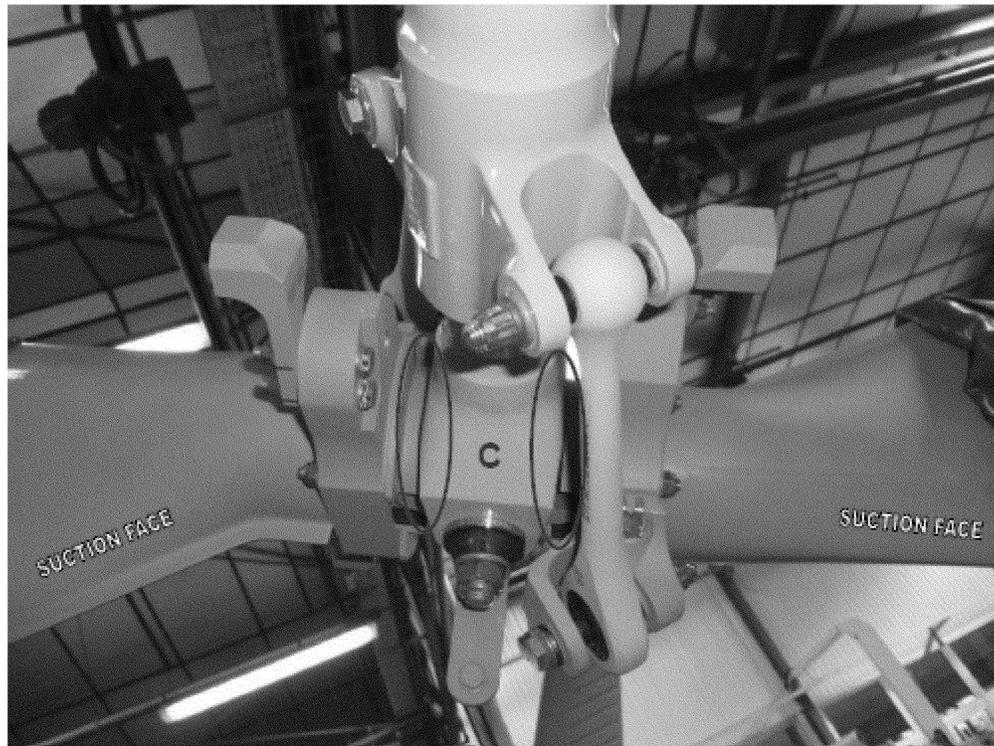
(E) Apply load (G) by hand perpendicular to the suction face of one tail rotor blade as shown in Figure 5 to paragraph (f) of this AD.

(F) While maintaining the load, check visible faces of Area C as shown in Figure 5 to paragraph (f) of this AD for any extrusion. A flashlight may be used to enhance the check.

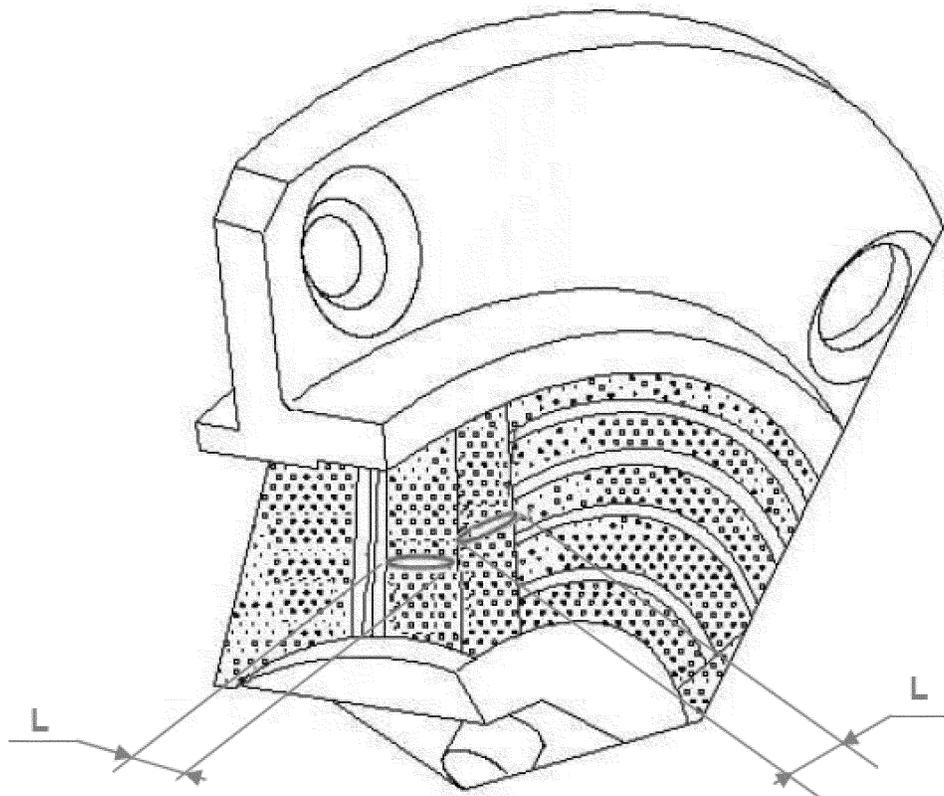
Figure 6 to paragraph (f)

(iii) If there is a separation or a crack on the bearing, measure the separation or the crack. If the separation or crack is greater than 5 mm (.196 inches) as indicated by dimension "L" and greater than 2 mm (.078 inches) as indicated by dimension "P" in Figure 3 of Eurocopter Emergency Alert Service Bulletin (EASB) No. 05.00.71 or No. 05.00.63, both Revision 2 and both dated December 19, 2012, as applicable to your model helicopter, before further flight, replace the bearing.
