[Docket No. FAA–2015–0497; Directorate Identifier 2012–NM–192–AD; Amendment 39–18128; AD 2015–06–10]

#### Airworthiness Directives; ATR–GIE Avions de Transport Régional Airplanes

**SUMMARY:** We are adopting a new airworthiness directive (AD) for certain ATR–GIE Avions de Transport Régional Model ATR72–212A airplanes. This AD requires inspection of the shock mount pick-up fittings and cone bolts, and replacement of certain shock mount pick-up fittings if necessary. This AD was prompted by reports of several cases of engine shock mount pick-up fittings with cracks or failure on the engine left-hand (LH) aft side attachment. We are issuing this AD to detect and correct an aft side attachment

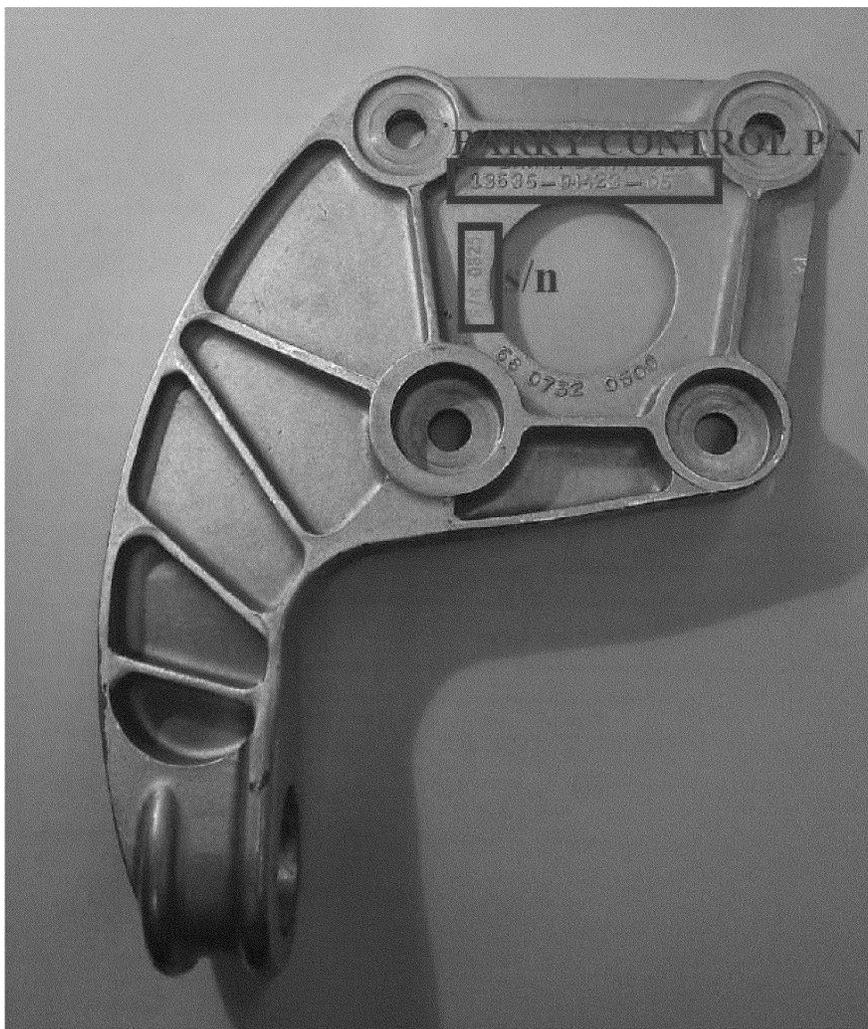
**Figure 1 to paragraph (g)(1) of this AD - Location of Fitting Part Number and Serial Number**

- (1) Identify the serial number (S/N) of the part number (P/N) S54210394200 (Barry Control P/N 94423-05) LH and right-hand (RH) shock mount pick-up fittings installed on both engine nacelles. Figure 1 to paragraph (g)(1) of this AD identifies the fitting part number and serial number locations.

(2) If the serial number of the LH shock mount pick-up fitting, identified during any inspection required by paragraph (g)(1) of this AD, is lower than 2451 or is unreadable, and no crack has been found during any

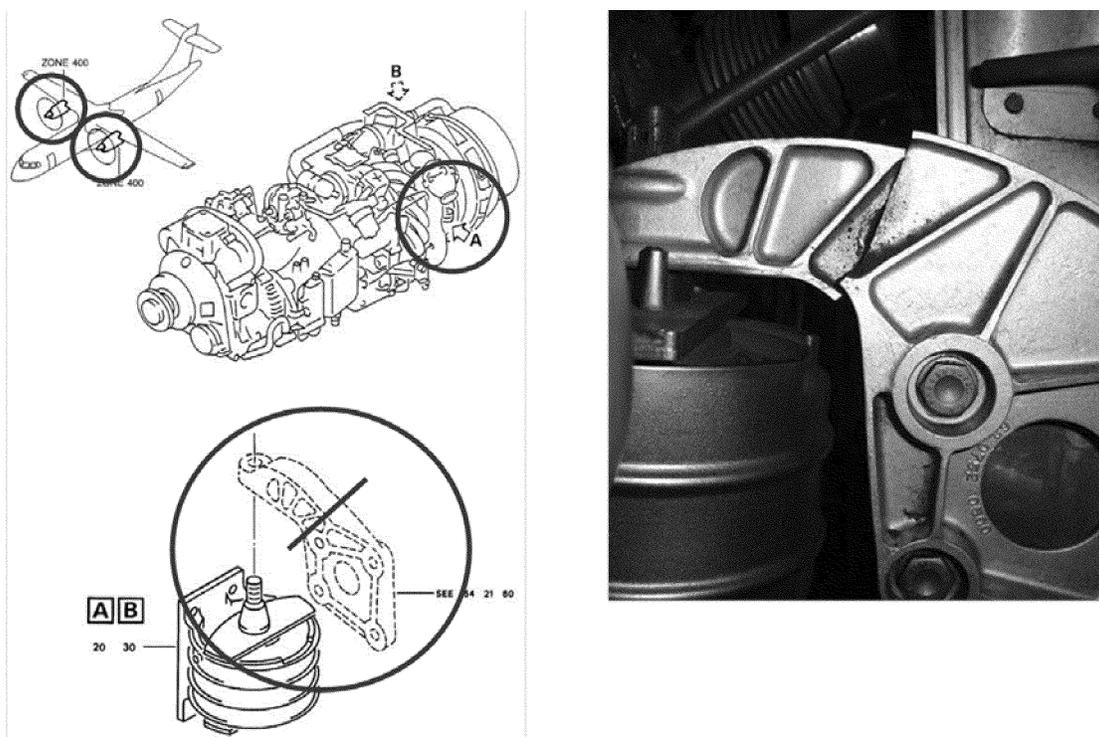
**Figure 2 to Paragraph (g)(2) of this AD - Shock Mount Pick-up Fitting**

(2) Do a detailed inspection of both LH and RH aft side isolator pick-up fittings on both engines to detect cracks, in accordance with

paragraph 004.1 of ATR ATR72 Aircraft Maintenance Manual (AMM) Job Instruction Card (JIC) 54-11-61 DVI 10000, dated March

1, 2012. Refer to figure 2 to paragraph (g)(2) of this AD for potential crack location.

(1) If any crack is found during any inspection required by paragraphs (g)(2) and (g)(3) of this AD: Before further flight, repair in accordance with a method approved by

the Manager, International Branch, ANM-116, Transport Airplane Directorate, FAA; or EASA; or ATR's EASA Design Organization Approval (DOA).

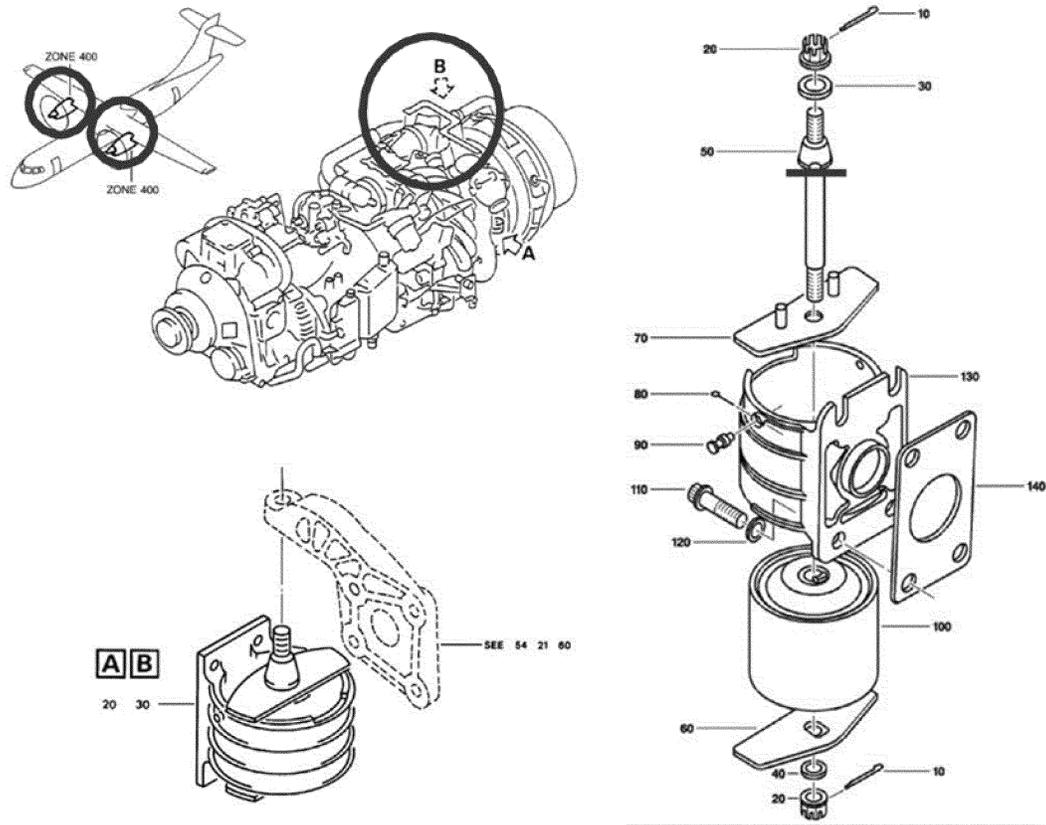
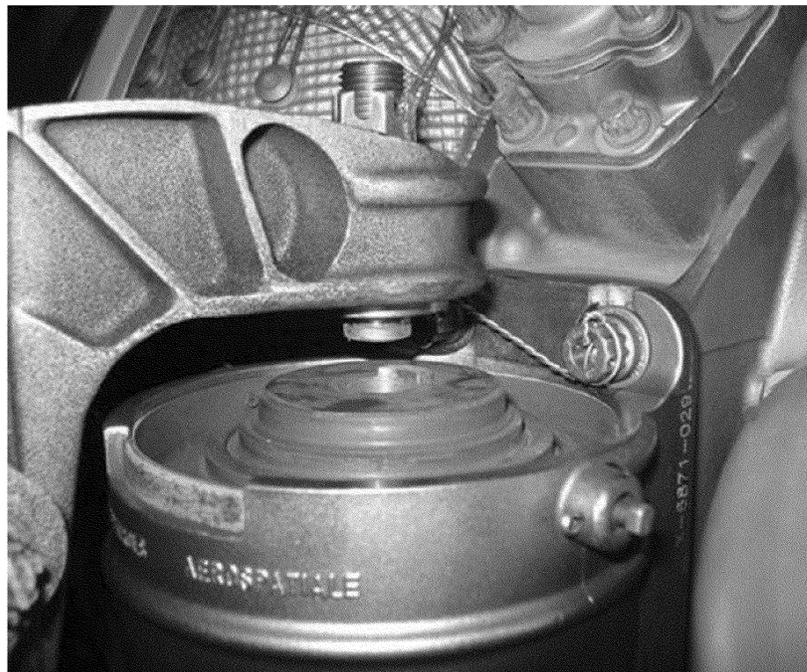
**Figure 3 to paragraph (g)(3) of this AD - Shock Mount Cone Bolt**

(3) Do a detailed inspection of both LH and RH aft shock mount cone bolts on both engines to detect cracks, in accordance with

paragraph 006.3.A. of ATR ATR72 AMM JIC 71-20-00 DVI 10000. Refer to figure 3 to

paragraph (g)(3) of this AD for potential crack location.
