**[Docket No. FAA-2017-0288; Product Identifier 2017-CE-007-AD; Amendment 39-19231; AD 2018-06-11]**

#### **Airworthiness Directives; Textron Aviation Inc. Airplanes**

**ACTION:** Final rule.

**2018-06-11 Textron Aviation Inc.:**  
Amendment 39-19231; Docket No. FAA-2017-0288; Product Identifier 2017-CE-007-AD.

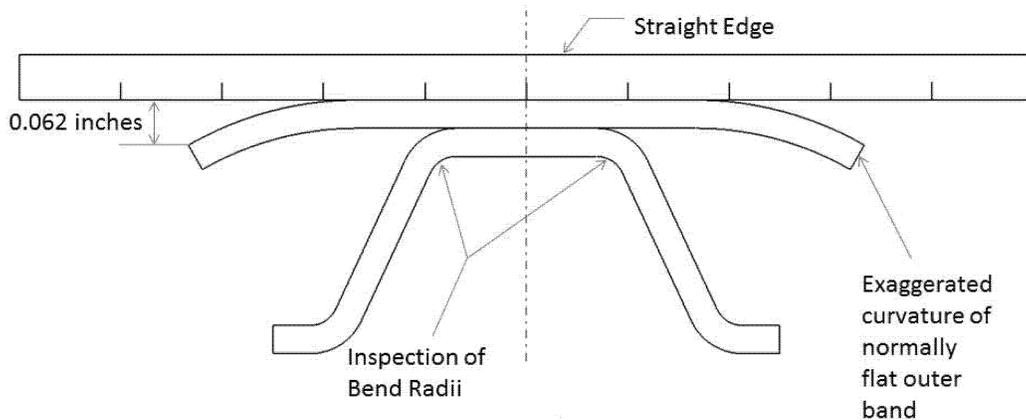
Figure 1 to paragraphs (k)(1)(iii) and (v) of this AD: Cross section of v-band coupling

(iii) Visually inspect the flatness of the outer band using a straight edge. Lay the straight edge across the width of the outer band. The gap must be less than 0.062 inches. See figure 1 to paragraphs (k)(1)(iii) and (v) of this AD. If the gap exceeds 0.062 inches between the outer band and the straight edge, do not re-install the v-band coupling. Before further flight, you must install a new v-band coupling and restart the hours TIS for the repetitive replacement of the v-band coupling.

(v) Visually inspect the bend radii of the coupling v-retainer coupling segments for cracks. Inspect the radii throughout the length of the segment. See figure 1 to paragraphs (k)(1)(iii) and (v) of this AD. If any cracks are found, do not re-install the v-band coupling. Before further flight, you must install a new v-band coupling and restart the hours TIS for the repetitive replacement of the v-band coupling.
