Connecticut Embayments Study

Phase I Inventory & Problems Analysis

CONNECTICUT EMBAYMENTS STUDY

PHASE I - INVENTORY AND PROBLEMS ANALYSIS

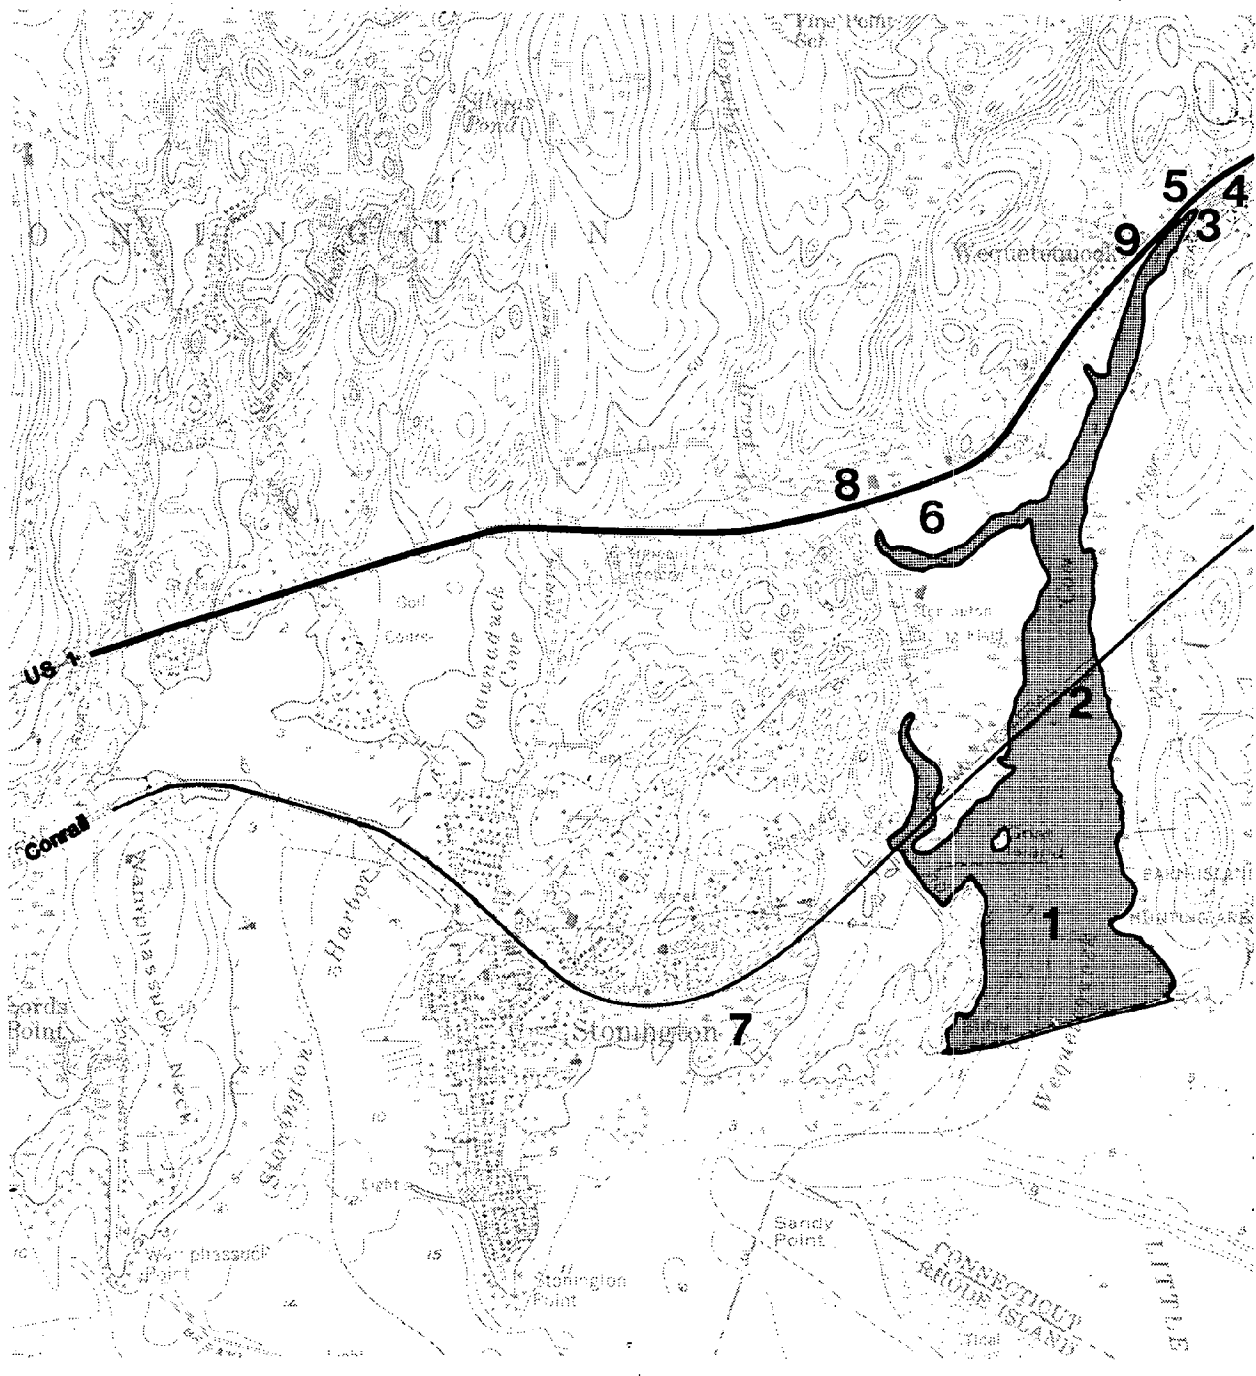
Responses and interviews indicated that the Old Conrail bridge and causeway have had a major impact on the tidal circulation and flushing of the cove. The narrow horizontal clearance of the bridge (64 feet) is only 8 percent of the natural embayment width. This restricts flushing and probably has changed the salinity characteristics of the inner cove. Limited flushing increases the potential impact of pollutants (such as the suspected septic tank leachate and highway runoff) entering the cove.

1. Closed shellfish beds
2. Restricted flow from Conrail bridge and causeway
3. Restricted flow from weir across Anguilla Brook
4. Area of known septic failures
5. Area of suspected septic failures
6. New 80,000 commercial building and large parking lot
7. American Velvet Co. industrial discharge
8. U.S. 1 bridge restricts flow of Oxecosset Brook
9. Some debris along shoreline

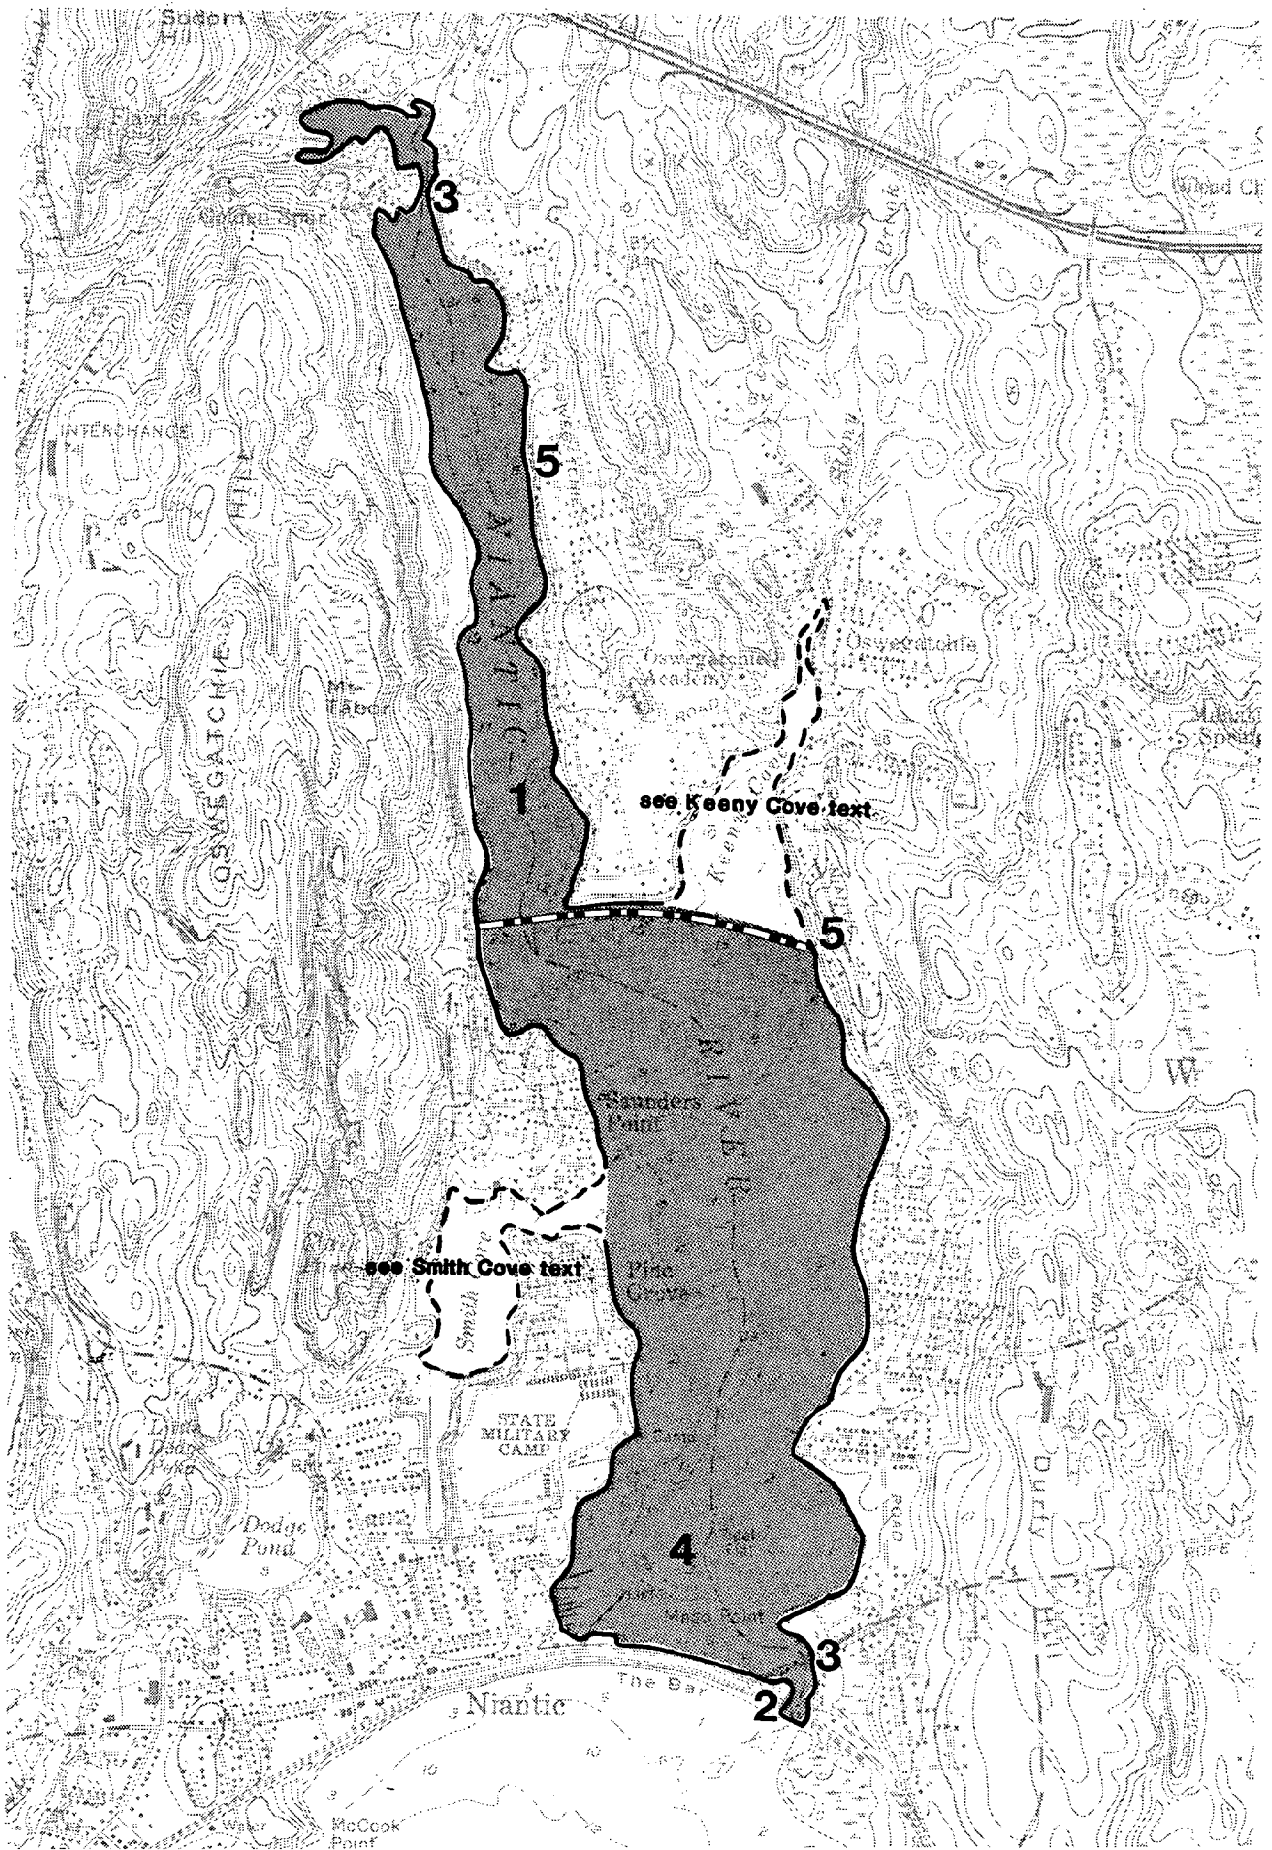
1. Upper half of bay is closed to shellfishing
2. Railroad bridge constricts flow
3. Highway bridge (Rt. 1) constricts flow
4. Shellfish loss associated with low tides in winter
5. Wastewater problem area
