[Docket No. 95–CE–14–AD]

Airworthiness Directives; Cessna Aircraft Company 150 and A150 Series and Models 152 and A152 Airplanes

ACTION: Notice of proposed rulemaking (NPRM).

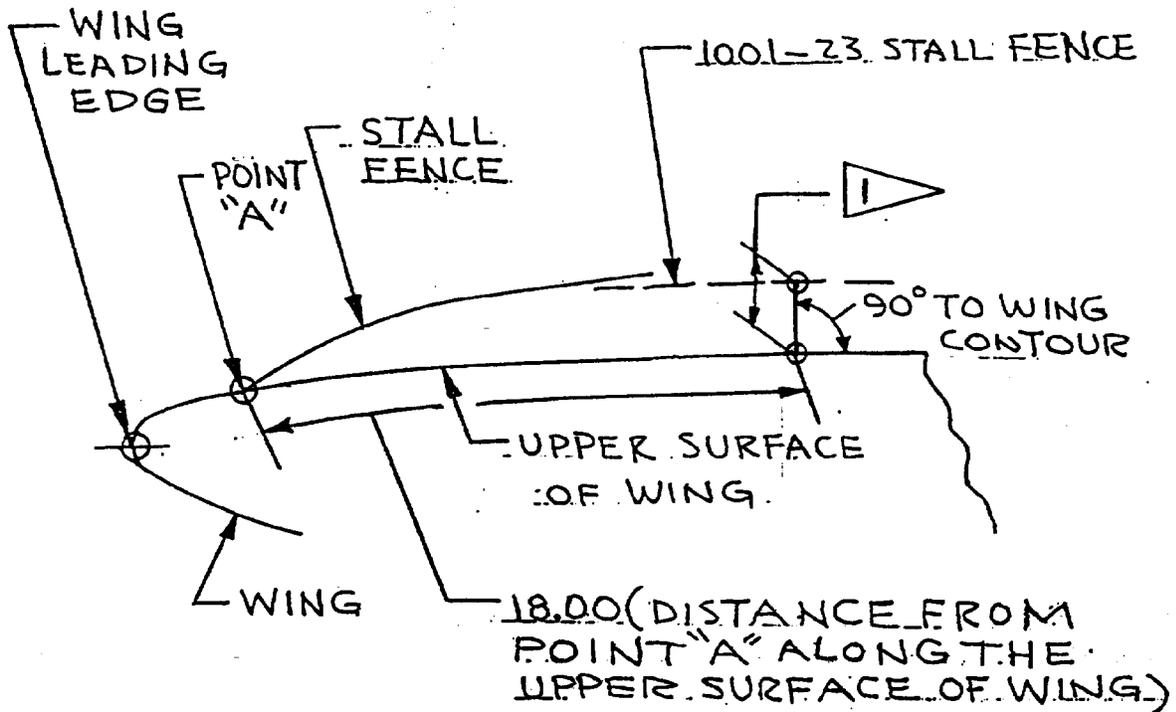
FIGURE 1
MID-AMERICA DWG No. 1001
(STC SA1371 SW)

installed in accordance with Supplemental Type Certificate (STC) SA1371SW. This kit includes a wing leading edge cuff and stall fence on each wing that is installed on the top of the wing chordwise in line with the aileron/flap juncture. The wing stall fence on this Cessna Model 152 airplane measured 1.625 inches in height at its trailing edge and maintained that height through approximately 70 percent of the fence's length, gradually tapering to the contour of the wing's leading edge.

The FAA approved the fence height of the Bush Conversions, Inc., STOL kit at a height of 1.16 inches (plus or minus .12 inches) for Cessna 150 and A150 series and Models 152 and A152 airplanes. Mid-America Drawing No. 1001 references this height and is included as part of STC SA1371SW. Mid-America Drawing No. 1001 is included as Figure 1 of the proposed AD.

1 ▽ IF STALL FENCE IS $1.16 \pm .12$ HIGH, THAT IS CORRECT HEIGHT FOR STALL FENCE. IF GREATER THAN 1.28 HIGH, REMOVE STALL FENCES AND INSTALL THE CORRECT ONE.

(a) Measure the height of the wing stall fence at its trailing edge to ensure that the height does not exceed 1.28 inches. (See Figure 1 of this AD).

(b) If the wing stall fence height exceeds 1.28 inches, prior to further flight, install a smaller fence in accordance with instructions obtained from the Wichita Aircraft Certification Office (ACO), FAA, 1801 Airport Road, Mid-Continent Airport, Wichita, Kansas 67209.
