[Docket No. 98–SW–29–AD; Amendment 39–10899; AD 98–24–13]

Airworthiness Directives; Eurocopter Deutschland GmbH (ECD) (Eurocopter) Model MBB–BK117 A–1, A–3, A–4, B–1, B–2, and C–1 Helicopters

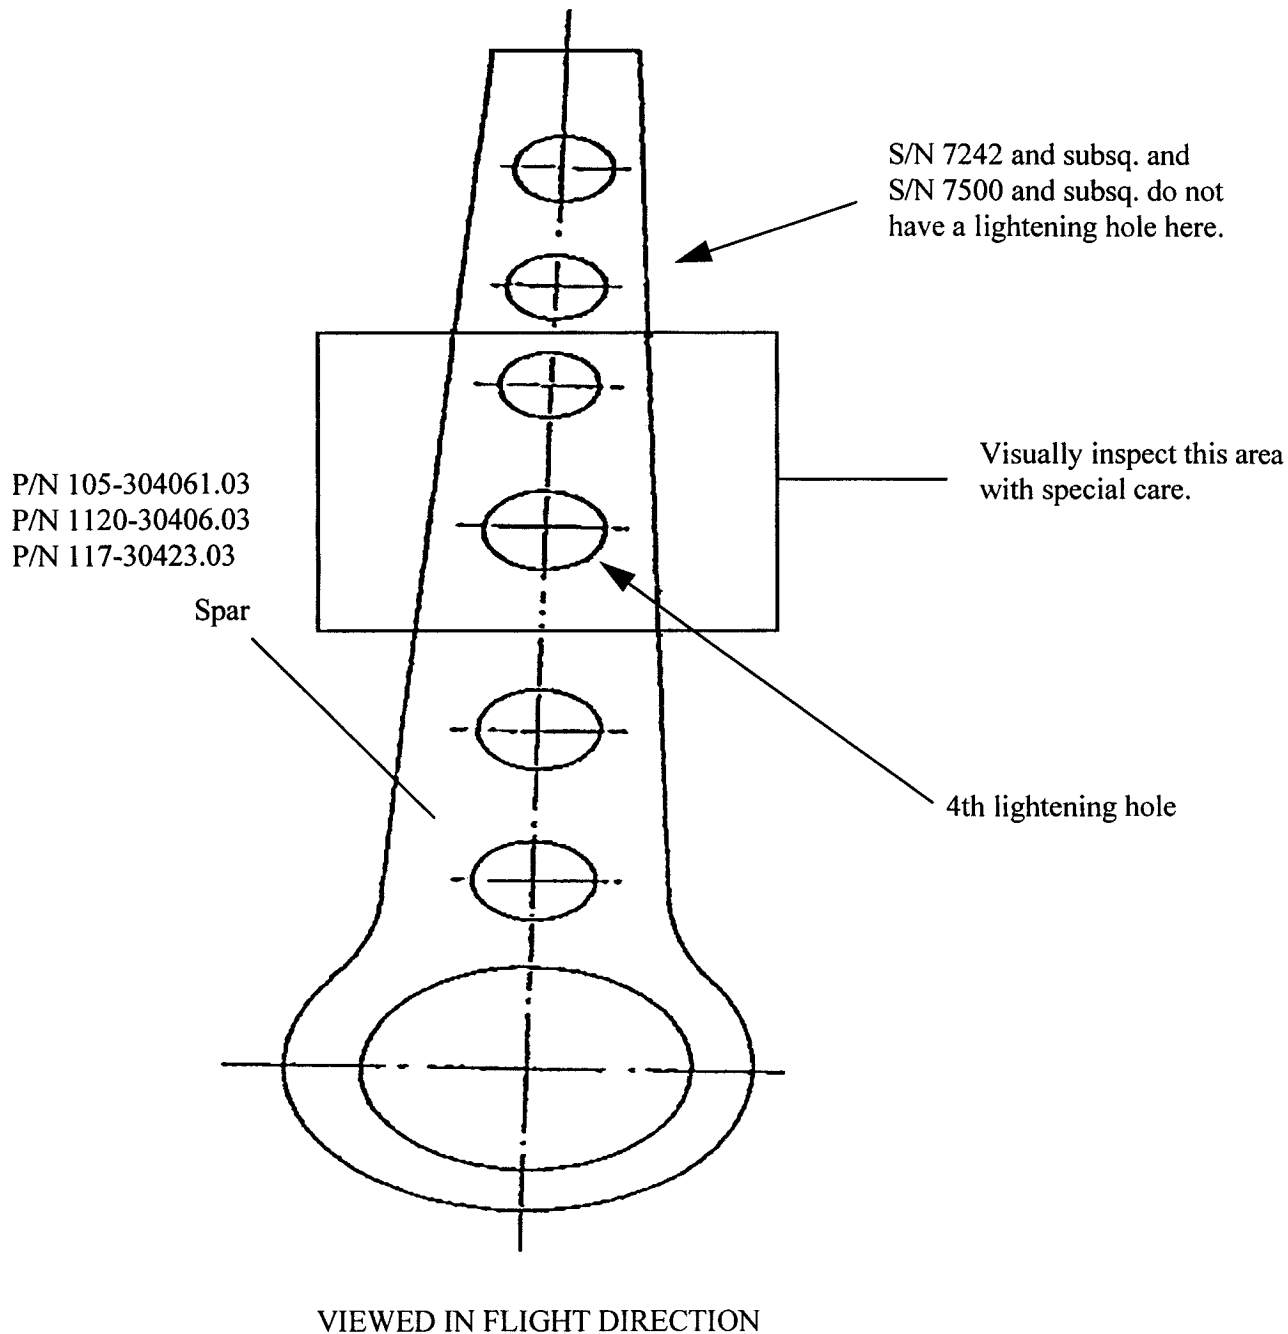
Figure 1

hours time-in-service (TIS). That action was prompted by an accident involving a Eurocopter Model MBB-BK117 series helicopter that occurred on April 15, 1997, resulting in one fatality. A subsequent investigation revealed that the vertical fin had failed as a result of a fatigue crack that initiated on the left side of the vertical fin. The crack propagated across the spar cap and spar. A crack in the skin propagated horizontally toward the vertical fin leading edge until catastrophic overstress occurred. Inspections of other helicopters of the same type design revealed cracks in the vertical fin spars of three additional helicopters. That condition, if not corrected, could result in failure of the vertical fin and subsequent loss of control of the helicopter.

(1) Both surfaces of the vertical fin spar, part number (P/N) 105-304061.03, P/N 1120-30406.03, or P/N 117-30423-03, paying particular attention to the area extending from the top edge of the third lightning hole from the top of the vertical fin spar to halfway between the fourth and fifth lightning hole (see Figure 1).

(b) If a crack or loose rivet is found in the area described in paragraph (a) of this AD (see Figure 1), before further flight, repair in accordance with the Appendix, "Repair of BK117 Vertical Fin", to Eurocopter Alert Service Bulletin (ASB) MBB-BK 117 No. ASB-MBB-BK 117-30-106, Revision 4, dated December 19, 1997, or in accordance with Eurocopter ASB No. MBB-BK 117-30-106, Revision 3, dated May 5, 1997, except use of blind rivets is not permitted.
