[Docket No. 99-NM-87-AD; Amendment 39-11138; AD 99-08-51]

Airworthiness Directives; McDonnell Douglas Model MD-11 Series Airplanes

99-08-51 BOEING: Amendment 39-11138. Docket 99-NM-87-AD.

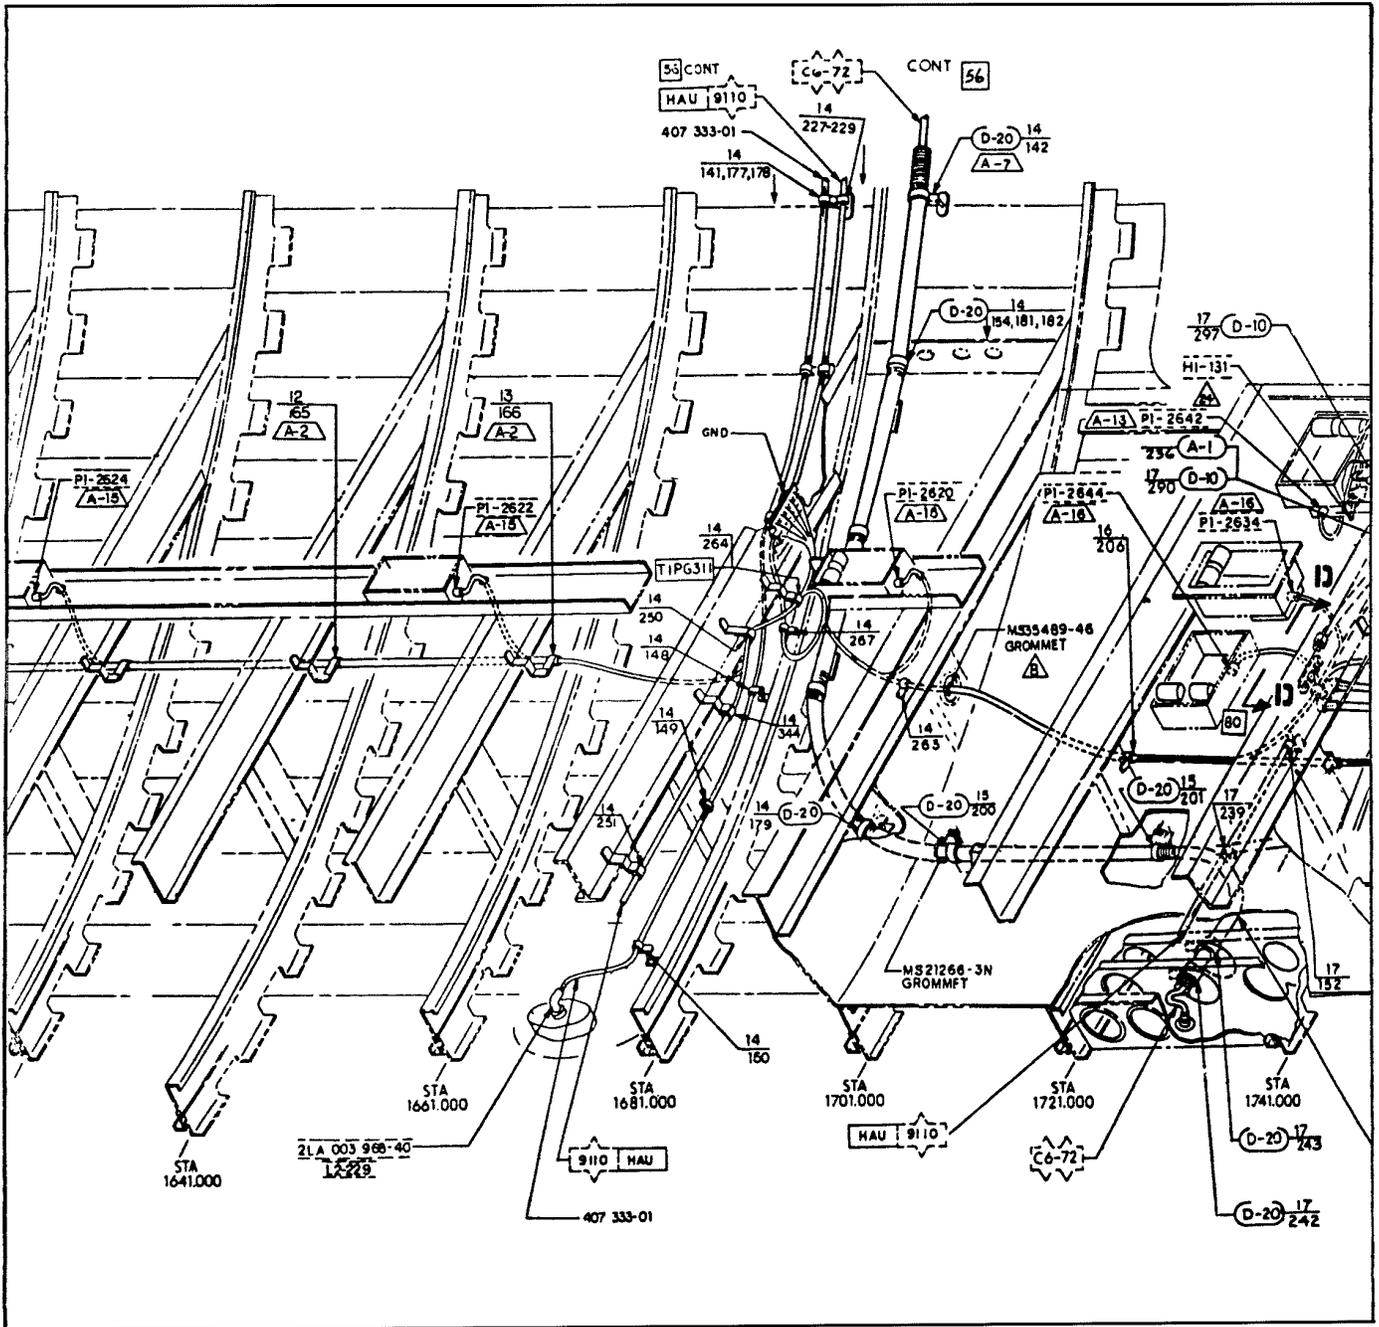
Figure 1

Investigation revealed that a wiring harness (including wires with a 115 volt alternating current) of the aft cargo loader control unit was contacting the insulation blanket and rubbing against frame 1681 above stringer R46. A wire was cut, and three other wires were missing insulation. In addition, frame 1681 had signs of arcing damage. Furthermore, the exposed moisture barrier material of the insulation blanket was burnt, and a hole was detected on the insulation blanket where the wiring harness was chafing against frame 1681. Further investigation revealed that a wiring harness support bracket/clamp on the wire bundle at frame 1681 may not have been installed during production of the airplane.

A missing wiring harness support bracket/clamp on the wire bundle at frame 1681 could cause the wire bundle to chafe against the frame, which could result in sparks, smoke, and possible fire in the lower center cargo compartment.

(a) Within 15 days after the effective date of this AD: Perform a one-time visual inspection under the floorboards in the lower center cargo compartment at frame 1681 (approximately one inch outboard of longeron R46) to verify that a bracket having part number P/N 9D0062-3-16-24 (or equivalent), and an open face nylon clamp having P/N NMC1001-1 or 383-1 (see Figure 1, Item 14/267), are installed to support wire bundle No. AGS9110.

(1) If the bracket and clamp are installed: Prior to further flight, perform a visual inspection to detect damage of the subject wire bundle. If any damage is detected, prior to further flight, accomplish paragraphs (a)(1)(i) and (a)(1)(ii) of this AD.

(i) Repair in accordance with Chapter 20-30-01 of the McDonnell Douglas MD-11 Airplane Maintenance Manual. And

(ii) Install a silicone rubber coated with a glass cloth protective wrap [Douglas Material Specification (DMS) 2109 or equivalent] around the wire bundle in the area over frame 1681 above stringer R46 in accordance with Chapter 20-10-01 of the McDonnell Douglas MD-11 Wiring Diagram Manual.

(2) If the bracket or clamp is not installed: Prior to further flight, perform a visual inspection to detect damage (i.e., chafing, damage, or missing wire insulation) of the subject wire bundle.

(i) If no damage is detected: Prior to further flight, install a silicone rubber coated with a glass cloth protective wrap (DMS 2109 or equivalent) around the wire bundle in the area over frame 1681 above stringer R46 in accordance with Chapter 20-10-01 of the McDonnell Douglas MD-11 Wiring Diagram Manual.

(ii) If any damage is detected: Prior to further flight, accomplish the actions required by paragraphs (a)(1)(i) and (a)(1)(ii) of this AD.
