[Docket No. 99-NM-87-AD; Amendment 39-11138; AD 99-08-51]

Airworthiness Directives; McDonnell Douglas Model MD-11 Series Airplanes

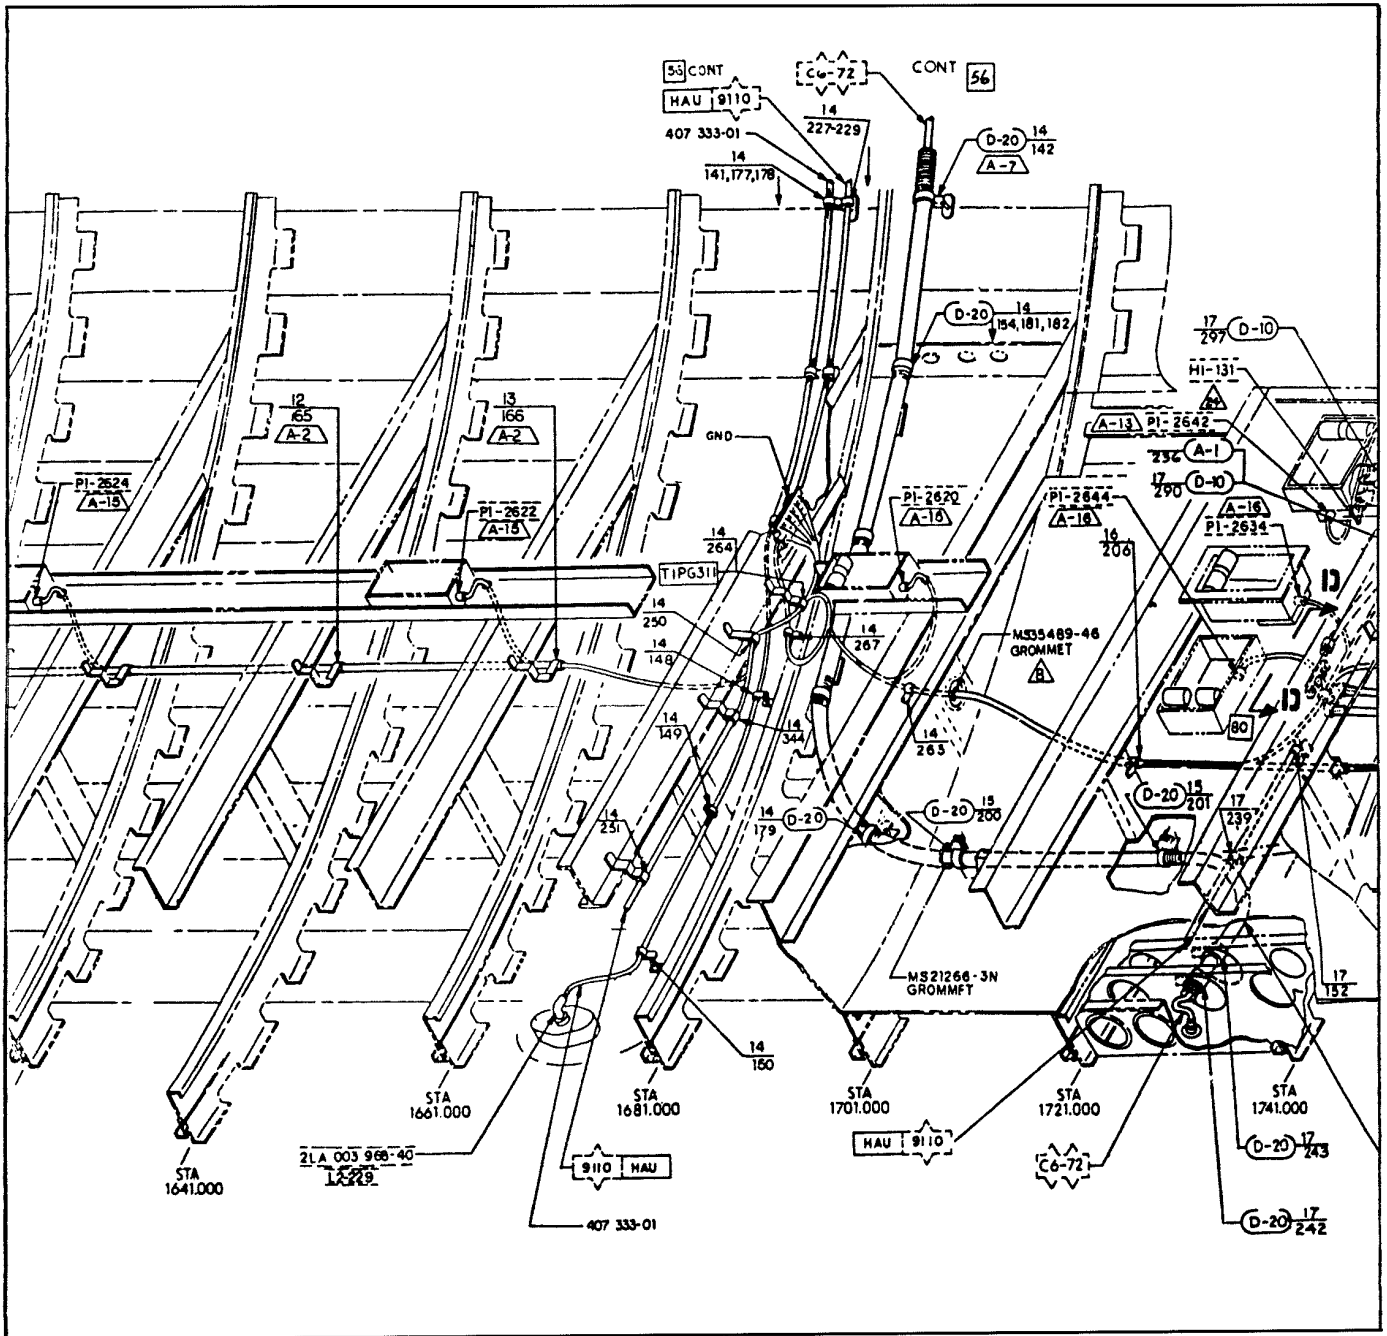
Figure 1

Investigation revealed that a wiring harness (including wires with a 115 volt alternating current) of the aft cargo loader control unit was contacting the insulation blanket and rubbing against frame 1681 above stringer R46. A wire was cut, and three other wires were missing insulation. In addition, frame 1681 had signs of arcing damage. Furthermore, the exposed moisture barrier material of the insulation blanket was burnt, and a hole was detected on the insulation blanket where the wiring harness was chafing against frame 1681. Further investigation revealed that a wiring harness support bracket/clamp on the wire bundle at frame 1681 may not have been installed during production of the airplane.

A missing wiring harness support bracket/clamp on the wire bundle at frame 1681 could cause the wire bundle to chafe against the frame, which could result in sparks, smoke, and possible fire in the lower center cargo compartment.

(a) Within 15 days after the effective date of this AD: Perform a one-time visual inspection under the floorboards in the lower center cargo compartment at frame 1681 (approximately one inch outboard of longeron R46) to verify that a bracket having part number P/N 9D0062-3-16-24 (or equivalent), and an open face nylon clamp having P/N NMC1001-1 or 383-1 (see Figure 1, Item 14/267), are installed to support wire bundle No. AGS9110.

(1) If the bracket and clamp are installed: Prior to further flight, perform a visual inspection to detect damage of the subject wire bundle. If any damage is detected, prior to further flight, accomplish paragraphs (a)(1)(i) and (a)(1)(ii) of this AD.

(i) Repair in accordance with Chapter 20-30-01 of the McDonnell Douglas MD-11 Airplane Maintenance Manual. And

(ii) Install a silicone rubber coated with a glass cloth protective wrap [Douglas Material Specification (DMS) 2109 or equivalent] around the wire bundle in the area over frame 1681 above stringer R46 in accordance with Chapter 20-10-01 of the McDonnell Douglas MD-11 Wiring Diagram Manual.

(2) If the bracket or clamp is not installed: Prior to further flight, perform a visual inspection to detect damage (i.e., chafing, damage, or missing wire insulation) of the subject wire bundle.

(i) If no damage is detected: Prior to further flight, install a silicone rubber coated with a glass cloth protective wrap (DMS 2109 or equivalent) around the wire bundle in the area over frame 1681 above stringer R46 in accordance with Chapter 20-10-01 of the McDonnell Douglas MD-11 Wiring Diagram Manual.

(ii) If any damage is detected: Prior to further flight, accomplish the actions required by paragraphs (a)(1)(i) and (a)(1)(ii) of this AD.
