[Docket No. 99-NM-22-AD]

Airworthiness Directives; Boeing Model 747 Series Airplanes

ACTION: Notice of proposed rulemaking (NPRM).

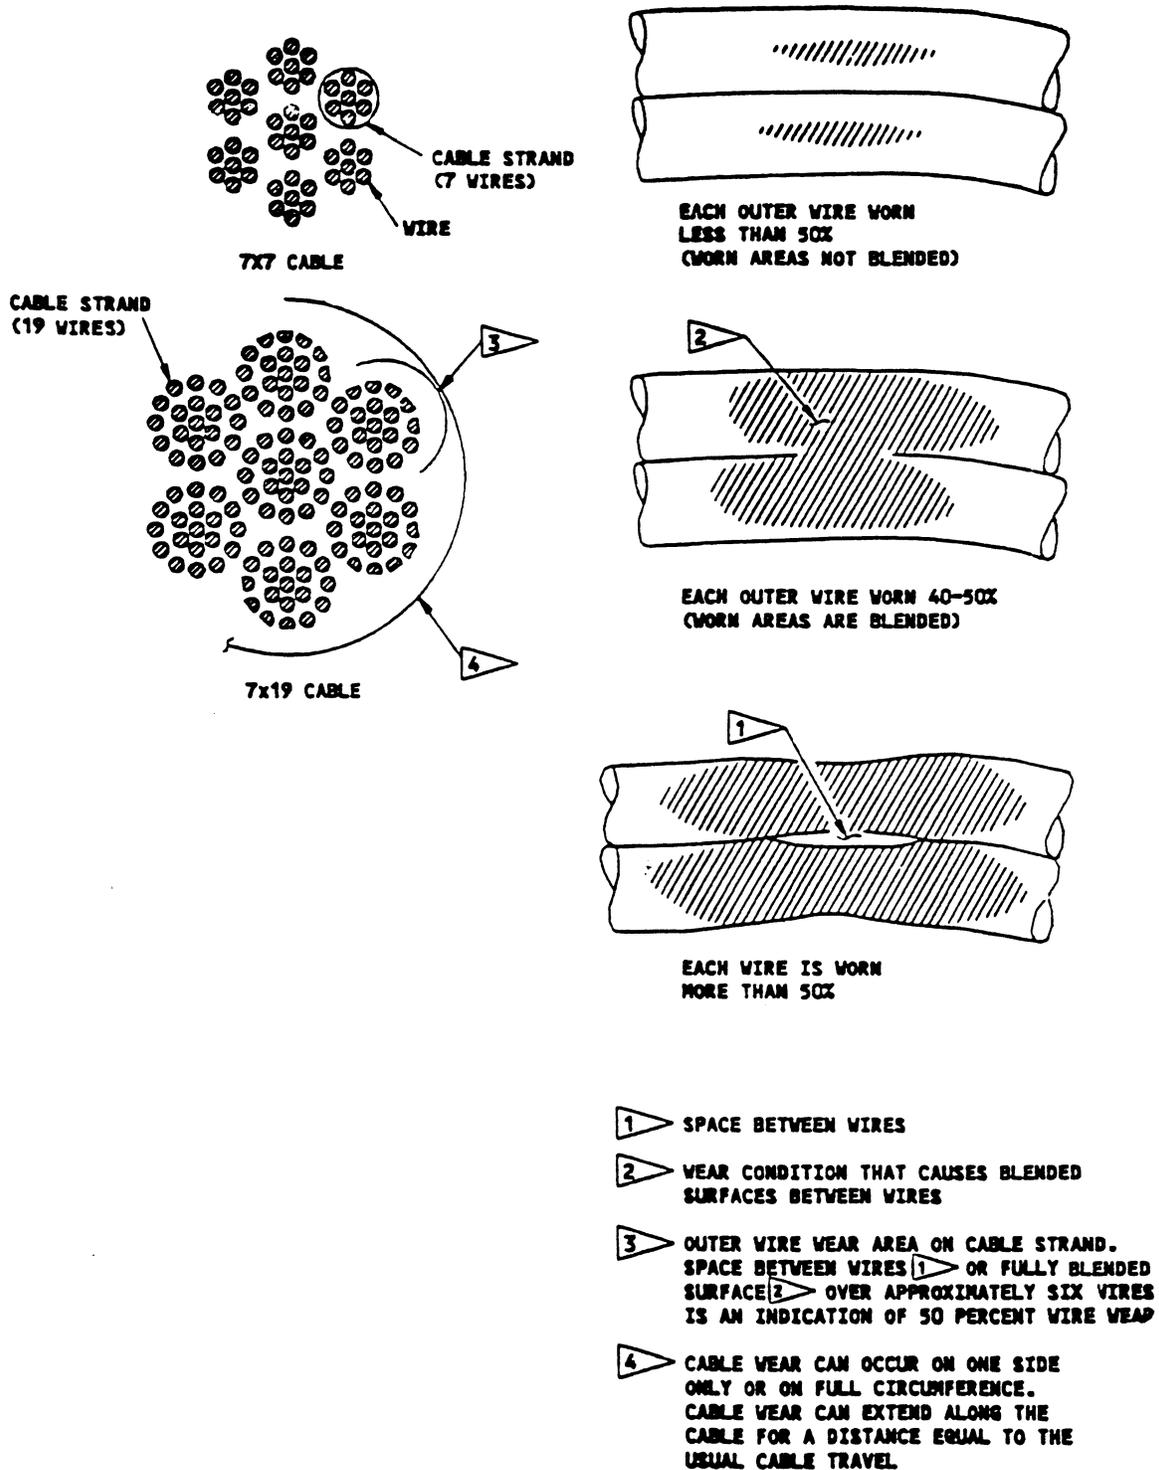
FIGURE 1

(1) One cable strand had worn wires where one wire cross section is decreased by more than 40 percent (see Figure 1),

B. Perform a detailed inspection of the cable runs to detect incorrect routing, kinks in the wire rope, or other damage. Replace the cable assembly if:
