Federal Aviation Administration

[Docket No. 99-NM-22-AD]

Airworthiness Directives; Boeing Model 747 Series Airplanes

ACTION: Notice of proposed rulemaking (NPRM).

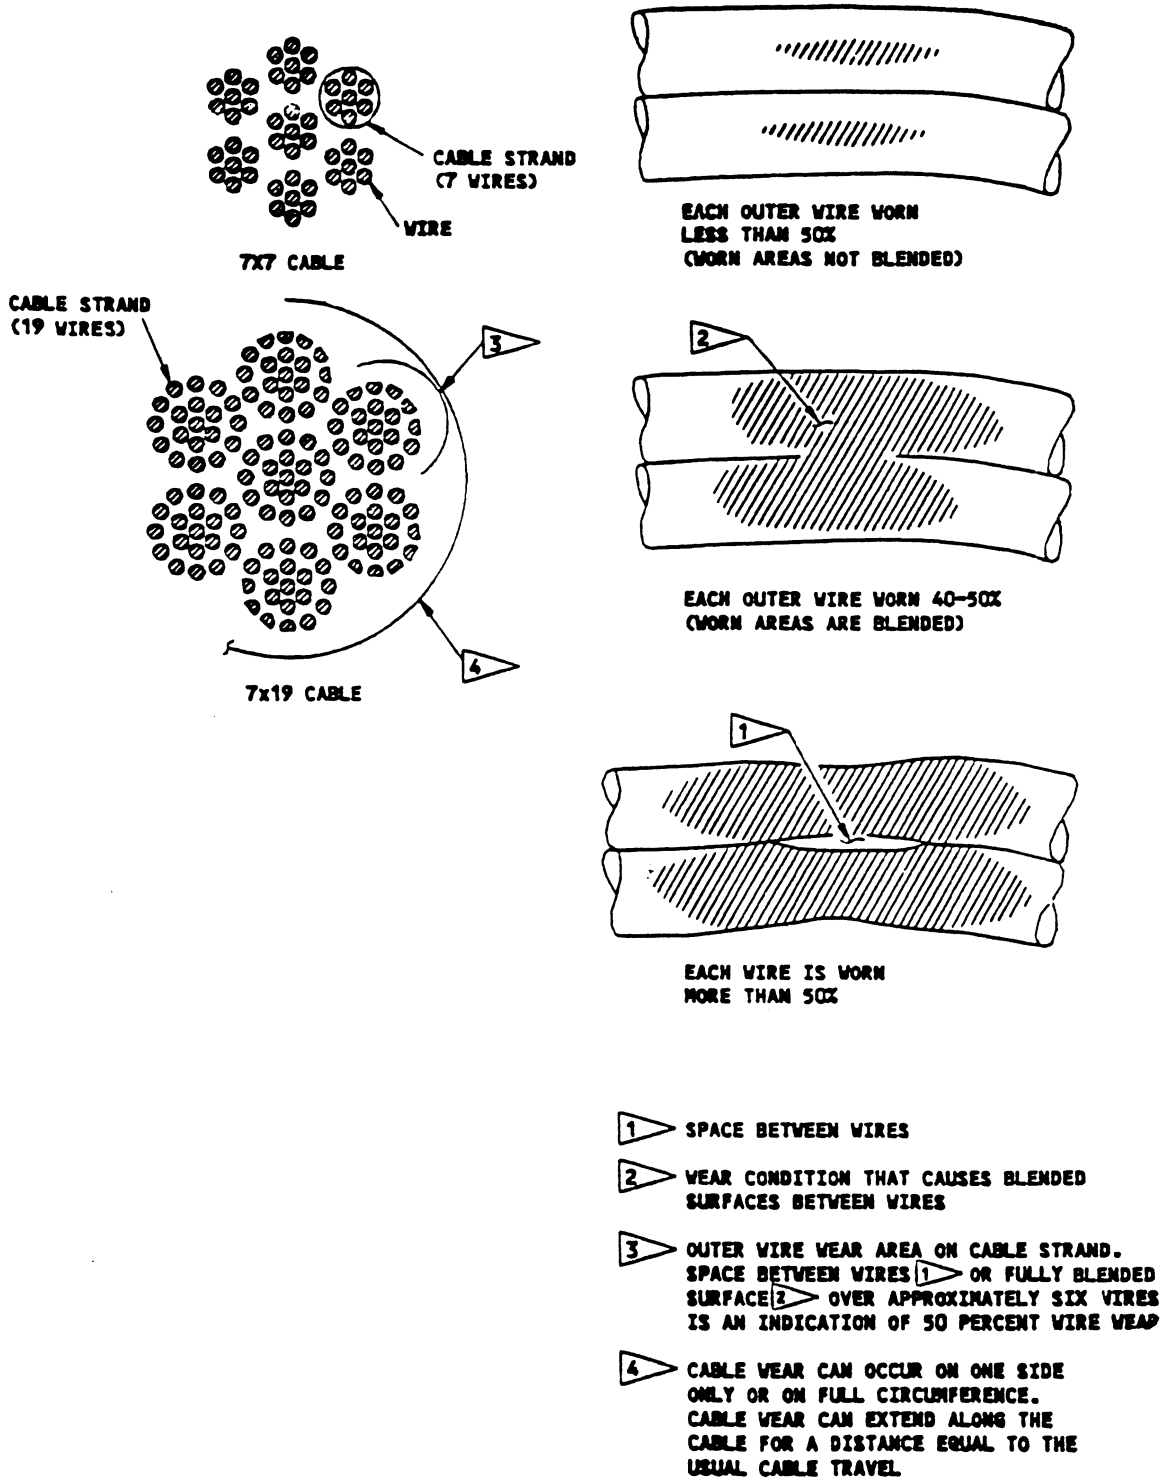
FIGURE 1

(1) One cable strand had worn wires where one wire cross section is decreased by more than 40 percent (see Figure 1),

B. Perform a detailed inspection of the cable runs to detect incorrect routing, kinks in the wire rope, or other damage. Replace the cable assembly if:
