#### [Docket No. 98-SW-74-AD]

#### Airworthiness Directives; Eurocopter Deutschland GmbH Model EC 135 Helicopters

**ACTION:** Notice of proposed rulemaking (NPRM).

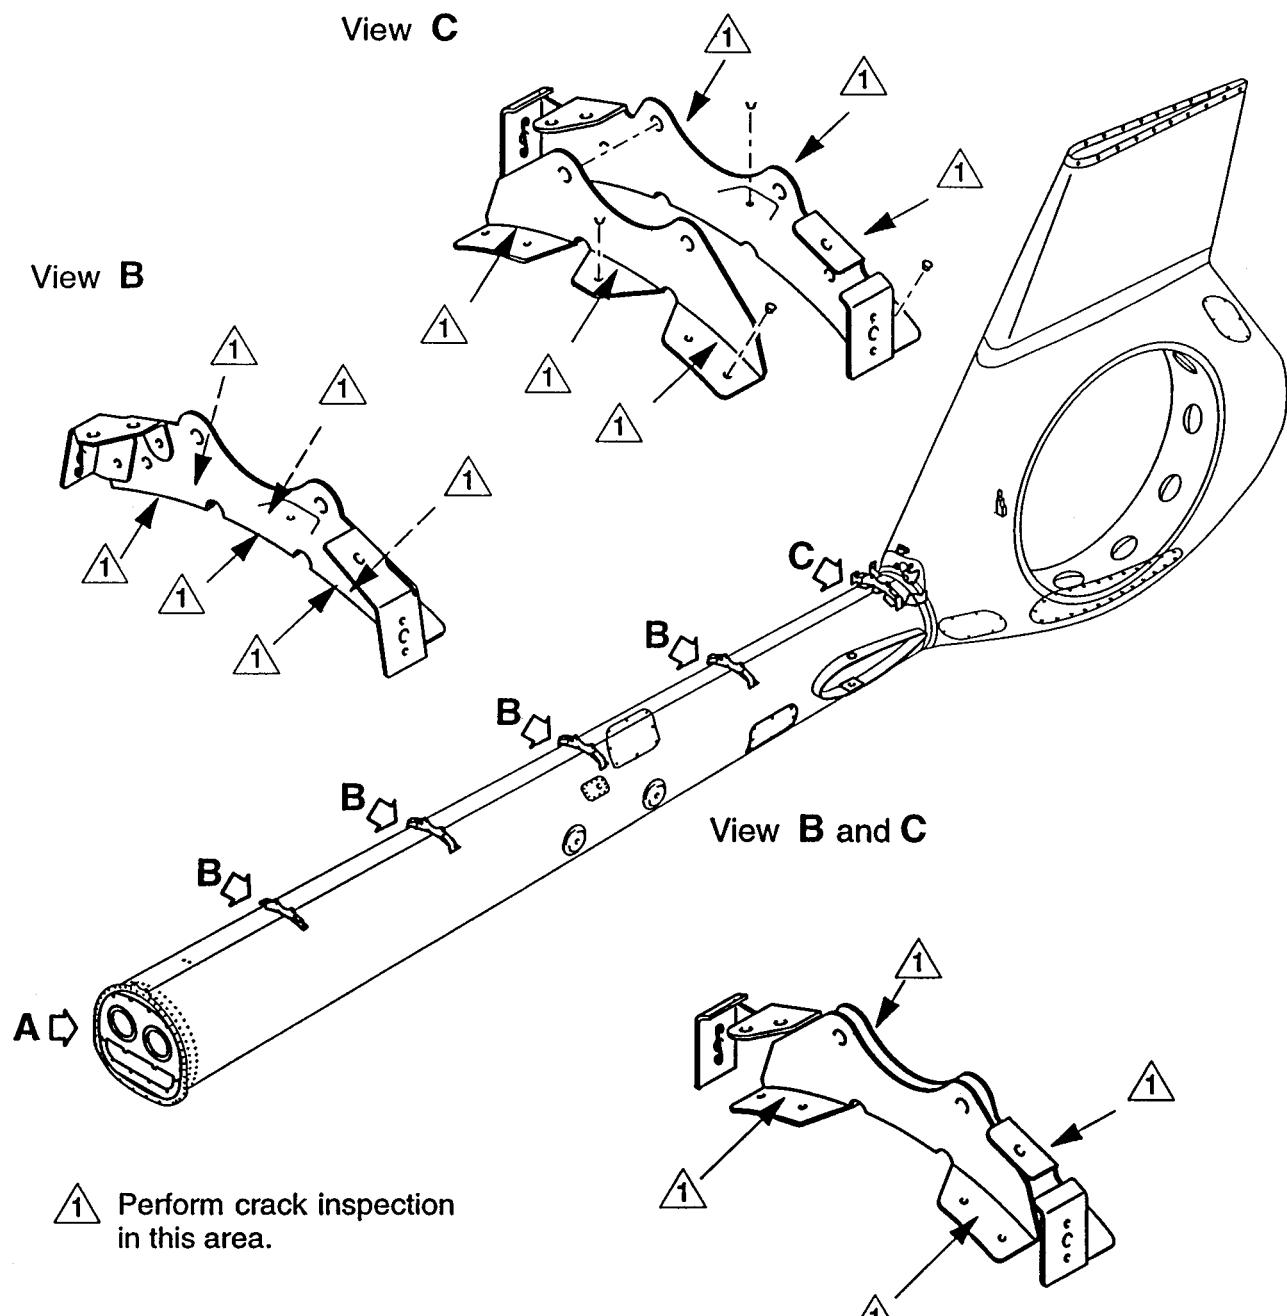
**Figure 1**

Since the issuance of AD 98-15-25, additional reports of misaligned, cracked, or corroded bearing supports, and loose bearing attachment bolts have been received. The original bearing supports have been redesigned to enable more precise alignment with the tail rotor driveshaft and have been strengthened to prevent cracking. In addition, they are now fabricated of corrosion-resistant material. Struts have been added to the tail boom to improve airframe vibration characteristics and further minimize bearing support cracking.

The Luftfahrt-Bundesamt (LBA), the airworthiness authority for the Federal Republic of Germany, notified the FAA that an unsafe condition may exist on ECD Model EC 135 helicopters. The LBA advises that misaligned, corroded, or cracked bearing supports and loose bearing attachment bolts may lead to a tail rotor failure and subsequent loss of the helicopter.

(1) Clean each tail rotor drive shaft bearing support. Using a 6-power or higher magnifying glass and a bright light, visually inspect the attach lugs of the bearing supports B and C (shown in Figure 1) for cracks, particularly in the area extending from the bend radius to the attaching screws and rivets connecting the bearing supports to the tail boom. Before further flight, replace each cracked bearing support with an airworthy bearing support.

(b) Before further flight, install double bearing supports for the tail rotor driveshaft and tail boom struts in accordance with ASB EC 135-53A-004, dated August 14, 1998.

(2) Inspect each bearing attach hardware lock plate for bent-open tabs and slippage marks for attach hardware looseness or rotation. Before further flight, replace any loose bearing attach hardware (including lock plates found bent or open due to bolt rotation) with airworthy hardware.
