[Docket No. 98-SW-74-AD; Amendment 39-11807; AD 2000-13-08]

Airworthiness Directives; Eurocopter Deutschland GmbH Model EC 135 Helicopters

2000-13-08 Eurocopter Deutschland

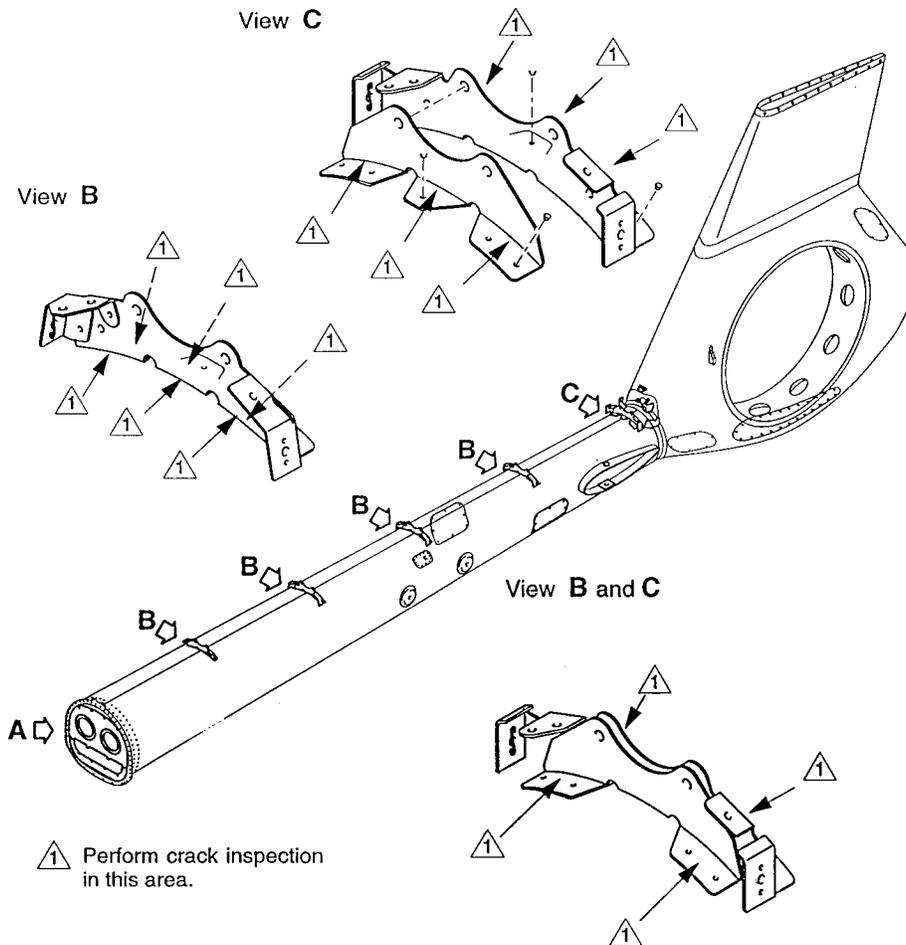
Figure 1

(1) Clean each tail rotor drive shaft bearing support. Using a 6-power or higher magnifying glass and a bright light, visually inspect the attach lugs of the bearing supports B and C (shown in Figure 1) for cracks, particularly in the area extending from the bend radius to the attaching screws and rivets connecting the bearing supports to the tail boom. Before further flight, replace each cracked bearing support with an airworthy bearing support.
