[Docket No. 98-SW-74-AD; Amendment 39-11807; AD 2000-13-08]

Airworthiness Directives; Eurocopter Deutschland GmbH Model EC 135 Helicopters

ACTION: Final rule.

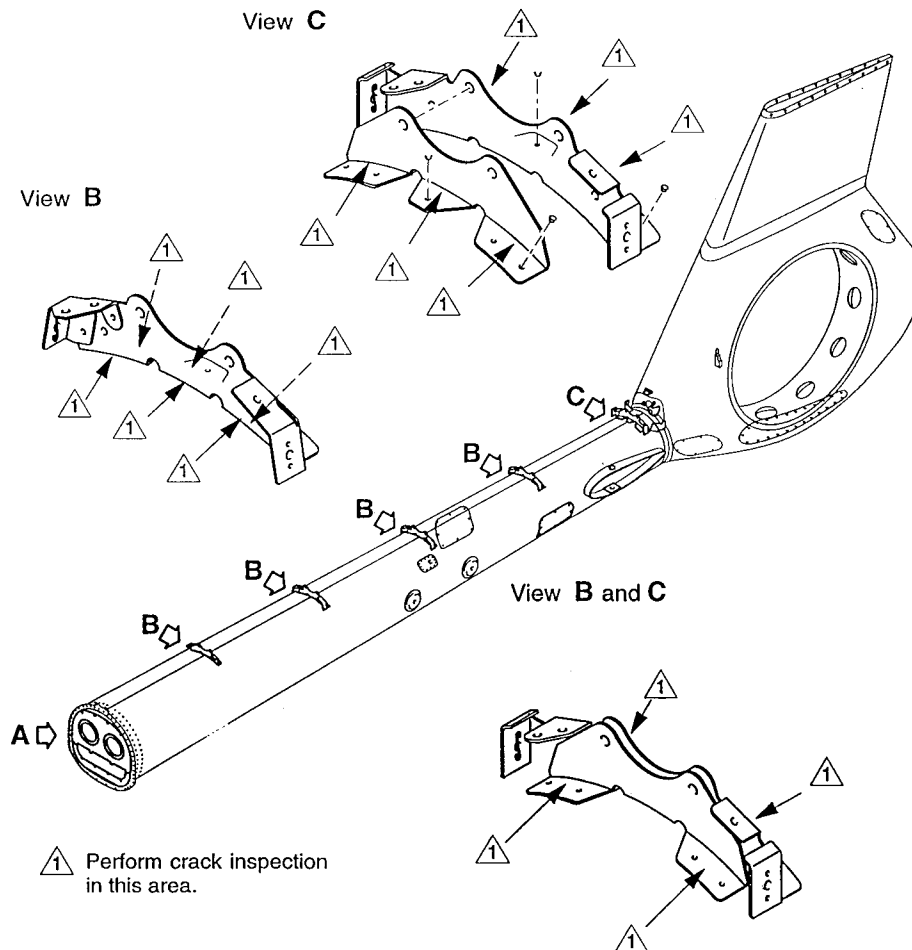
Figure 1

revising the required compliance time for the repetitive inspections of the bearing attach hardware and supports, and removing the requirement to contact the FAA if a lock plate tab is bent open or if slippage marks are broken or missing. This amendment is prompted by continued reports of misaligned or cracked bearing supports and loose bearing attachment bolts. The actions specified by this AD are intended to prevent loss of drive to the tail rotor and subsequent loss of control of the helicopter.

(1) Clean each tail rotor drive shaft bearing support. Using a 6-power or higher magnifying glass and a bright light, visually inspect the attach lugs of the bearing supports B and C (shown in Figure 1) for cracks, particularly in the area extending from the bend radius to the attaching screws and rivets connecting the bearing supports to the tail boom. Before further flight, replace each cracked bearing support with an airworthy bearing support.

(2) Inspect each bearing attach hardware lock plate for bent-open tabs and slippage marks for attach hardware looseness or rotation. Before further flight, replace any loose bearing attach hardware (including lock plates found bent or open due to bolt rotation) with airworthy hardware.
