14 CFR Part 39

[Docket No. 2001-NE-03-AD; Amendment 39-12097; AD 2001-02-12]

Airworthiness Directives; CFM International (CFMI) Model CFM56-7B Turbofan Engines

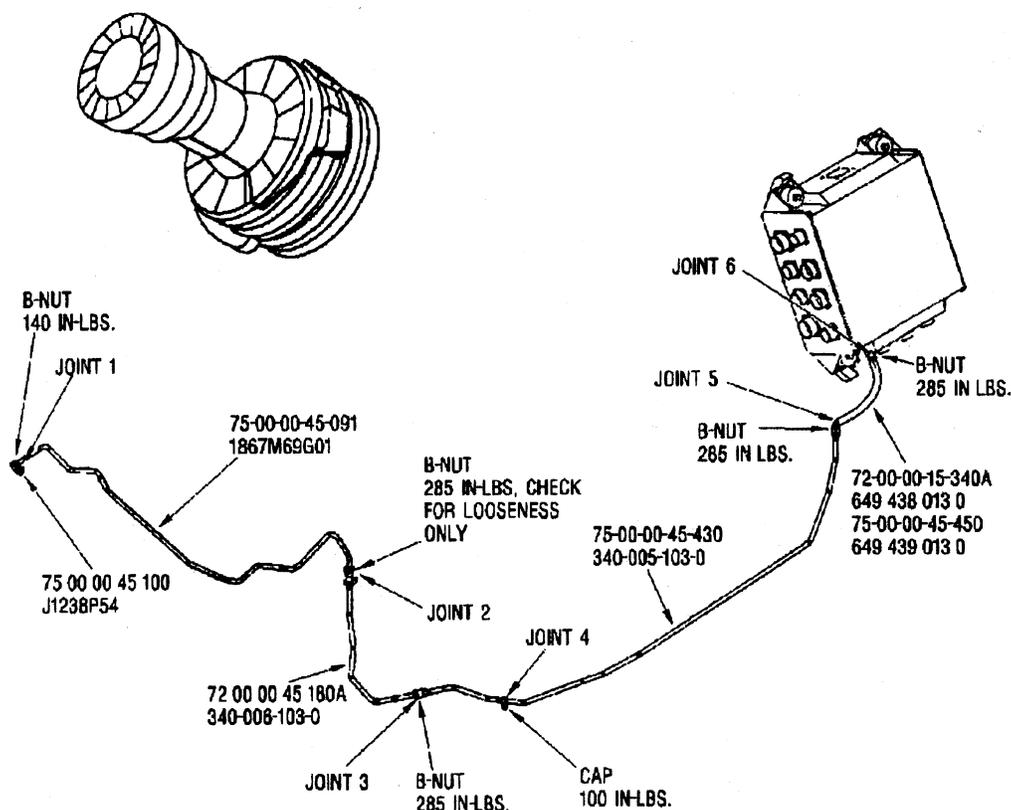
SUMMARY: This amendment adopts a new airworthiness directive (AD) that is applicable to CFMI model CFM56-7B turbofan engines. This action requires a one-time on-wing torque inspection, and torque if needed, of all the PS3 pressure line fittings to insure proper torque. This amendment is prompted by service events which resulted in two in-flight shutdowns (IFSD's) and an aborted takeoff due to the disconnection of one of the PS3 line fittings. The actions specified in this AD are intended to prevent air leakage from incorrectly torqued fittings of the PS3 line, which could result in engine power loss.

SUPPLEMENTARY INFORMATION: The FAA has received reports of two in-flight shutdowns and one aborted take-off on three different Boeing 737NG airplanes powered by CFM56-7B turbofan engines. In all of these cases, the engine rolled back to idle speed and would not accelerate. The investigation revealed that the PS3 pressure line B-nut fitting at the 6 o'clock position had disconnected in two of these events and the PS3 pressure B-nut fitting at the combustion case port location had disconnected in the third event. An operator, involved in one of the IFSD events, completed on-wing torque inspections of the PS3 pressure line fittings of its CFMI CFM56-7B fleet. As a result of these inspections, one engine was found with a loose B-nut fitting at the 6 o'clock location and two engines were found with loose cap fittings at the 6 o'clock location. The two engines with loose caps were on the same airplane. The investigation also initiated PS3 pressure line fitting torque inspections on 10 engines that were on Boeing's flight line. These inspections revealed one engine with a loose B-nut fitting at the 6 o'clock position and one engine with a loose cap fitting at the 6 o'clock position. General Electric and SNECMA also inspected CFM56-7B engines that were in assembly. No loose fittings were found. The investigation to determine the cause of the loose PS3 pressure line fittings continues. Action to insure correct torque of these fittings on current production engines has been initiated by adding a new torque inspection requirement for the PS3 pressure line fittings at the end of the main engine assembly process. However, based on the inspection results indicated above, it has been determined that mandating action on in-service engines to ensure that the PS3 pressure line fittings are correctly torqued is required.

To prevent air leakage from incorrectly torqued fittings of the PS3 pressure line, which could result in engine power loss, do the following:

(a) Check for and apply the correct torque in the tightening direction of all PS3 pressure line fittings as identified in Figure 1 of this AD as Joint 1, Joint 2, Joint 3, Joint 4, Joint 5, and Joint 6 as follows:

(1) Torque Joint 1 to ensure a torque value of 140 inch-pounds.

(2) Due to accessibility limitations, check Joint 2 for finger looseness, and only if loose, torque to a value of 285 inch-pounds.

(3) Torque Joint 3, Joint 5, and Joint 6 to ensure a torque value of 285 inch-pounds.

(4) Torque Joint 4 to ensure a torque value of 100 inch-pounds.
