[Docket No. 2000-SW-13-AD; Amendment 39-12132; AD 2001-04-13]

Airworthiness Directives; Eurocopter France Model SA.315B, SA.316B, SA.316C, SE.3160, and SA.319B Helicopters

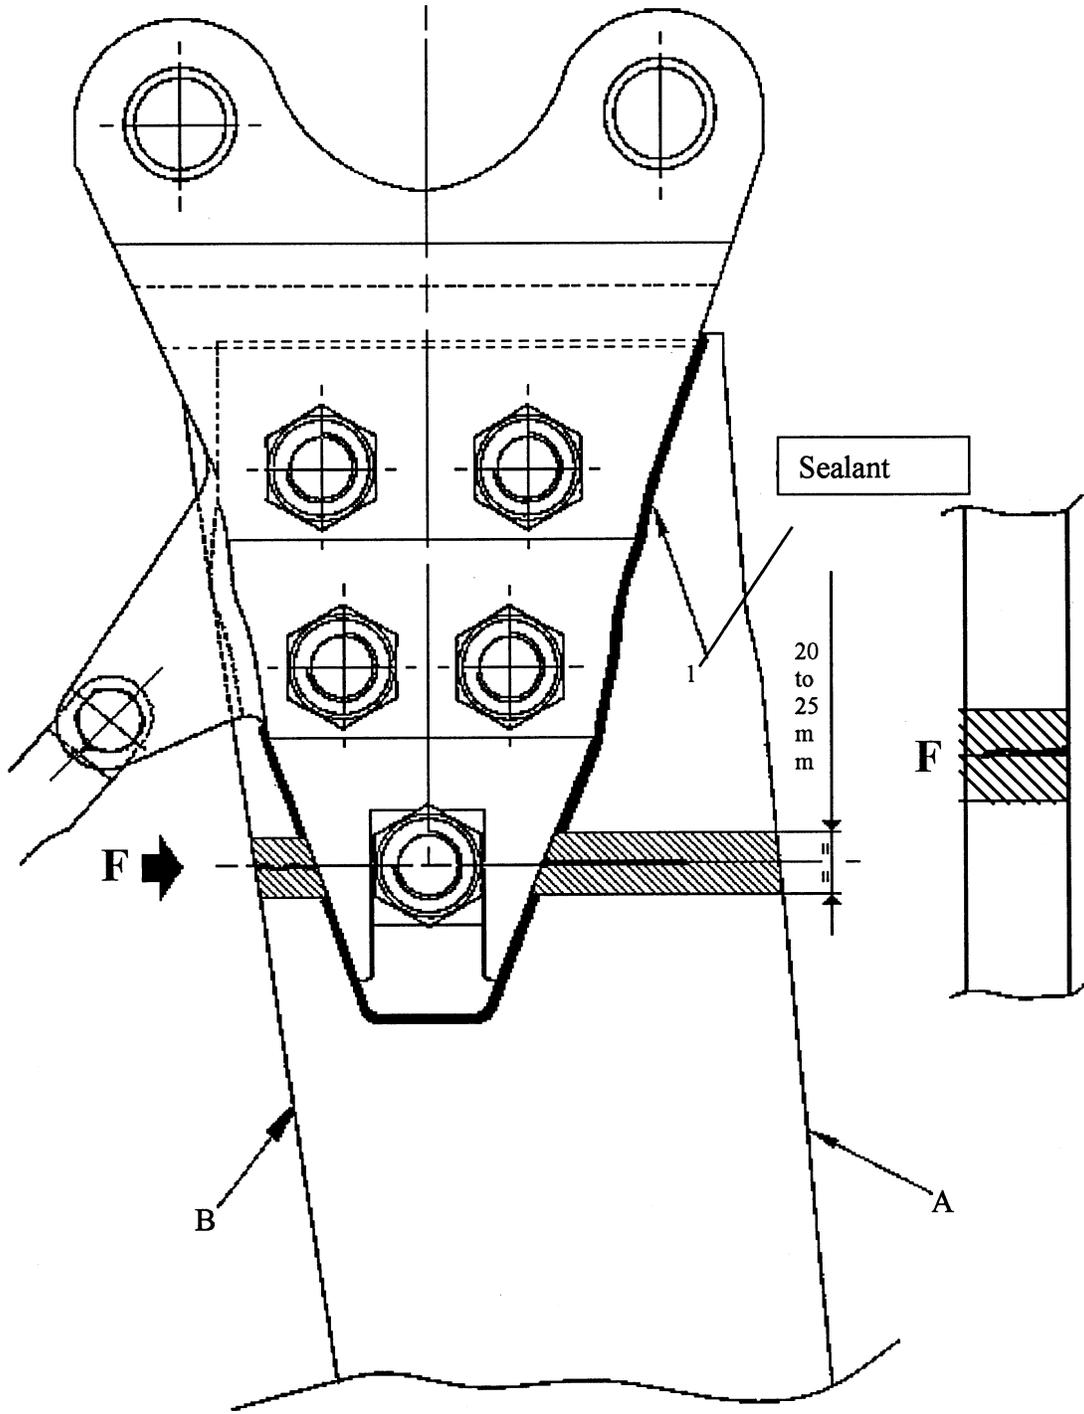
Figure 1

(1) Inspect each blade spar for a crack.

(iii) By either a dye penetrant or eddy current method, inspect each blade along the hatched area indicated in Figure 1, beginning on the blade lower surface, then on the flat section of the trailing edge (B), on the blade upper surface, and then on the flat section of the leading edge (A).

(iv) If a crack is found, replace the blade with an airworthy blade before further flight.

(2) Ensure that there is a sealant bead (1) around the edge of each blade cuff. If no sealant bead exists or if a sealant bead shows excessive wear, before further flight, apply a sealant bead in accordance with paragraph 2.2 of the Accomplishment Instructions of Eurocopter France SB 65.137 R1, dated November 17, 1993.
