DEPARTMENT OF TRANSPORTATION

Federal Aviation Administration

[Docket No. 99-SW-34-AD]

Airworthiness Directives; Eurocopter France Model SA-365N1, AS-365N2, and SA-366G1 Helicopters

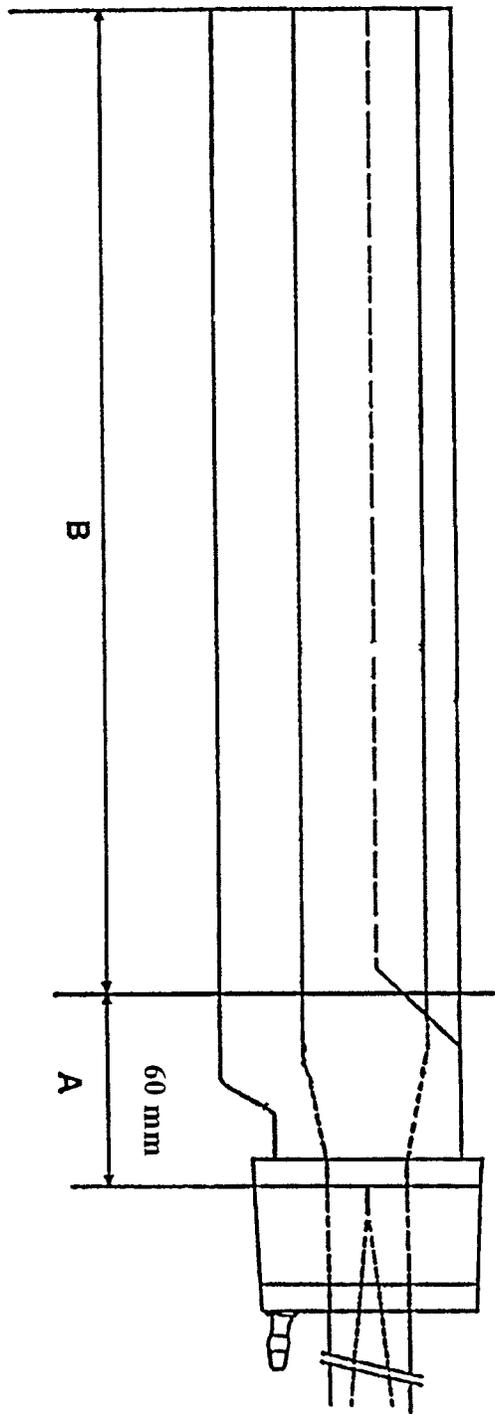
FIGURE 1

(a) Within 10 hours time-in-service (TIS) and thereafter before the first flight of each day, visually check each blade (see Figure 1) for a crack, blister, or wrinkling. An owner/operator (pilot), holding at least a private pilot certificate, may perform the visual check and must enter compliance into the aircraft maintenance records in accordance with 14 CFR sections 43.11 and 91.417(a)(2)(v).

(b) If a crack, blister, or wrinkling is found as a result of the visual check, accomplish the following before further flight (see Figure 1):

(1) Zone A: If a blister is detected on the blade suction face, conduct a tapping test inspection on the whole blade for bonding separation.

(i) For blades, P/N 365A33-2131-all dash numbers, 365A12-0010-all dash numbers, and 365A12-0020-00, and -01, if bonding separation or a crack is found, replace the blade with an airworthy blade before further flight.

(ii) For blades, P/N 365A12-0020-02, and -03, if bonding separation exceeds 900 mm² in a 30 x 30 mm square or if there is a crack, replace the blade with an airworthy blade before further flight.

(2) Zone B: If a crack, wrinkling, or a blister is found, replace the blade with an airworthy blade before further flight.

(c) Within 10 hours TIS, conduct a tapping test inspection on each blade. If there is bonding separation that exceeds the criteria in paragraph b(1) of this AD, replace the blade with an airworthy blade before further flight.

(d) Within 10 hours TIS, and thereafter at intervals not to exceed 100 hours TIS or 200 cycles, whichever occurs first, measure the blade-to-air duct clearance. If the clearance is less than 3 mm, replace the blade with an airworthy blade before further flight.
