[Docket No. 2001-SW-40-AD; Amendment 39-12793; AD 2002-13-05]

Airworthiness Directives; MD Helicopters, Inc. Model 369D, 369E, 369F, and 369FF Helicopters

SUMMARY: This amendment adopts a new airworthiness directive (AD) for specified MD Helicopters, Inc. (MDHI) helicopters with a tailboom modified according to Aerometals Supplemental Type Certificate (STC) SH5055NM or SH4801NM. This AD requires an inspection to identify the part number (P/N) of the bolts that attach the tail rotor gearbox to the tailboom and replacing any bolt of inadequate grip length with an airworthy bolt. This AD also requires determining the number of bolt threads protruding from each nutplate and adding an additional washer if more than four threads protrude. This amendment is prompted by the discovery that bolts of inadequate grip length were specified to attach the tail rotor gearbox to the tailboom. The actions specified by this AD are intended to prevent loss of a tail rotor gearbox due to attaching bolts of inadequate grip length and subsequent loss of control of the helicopter.

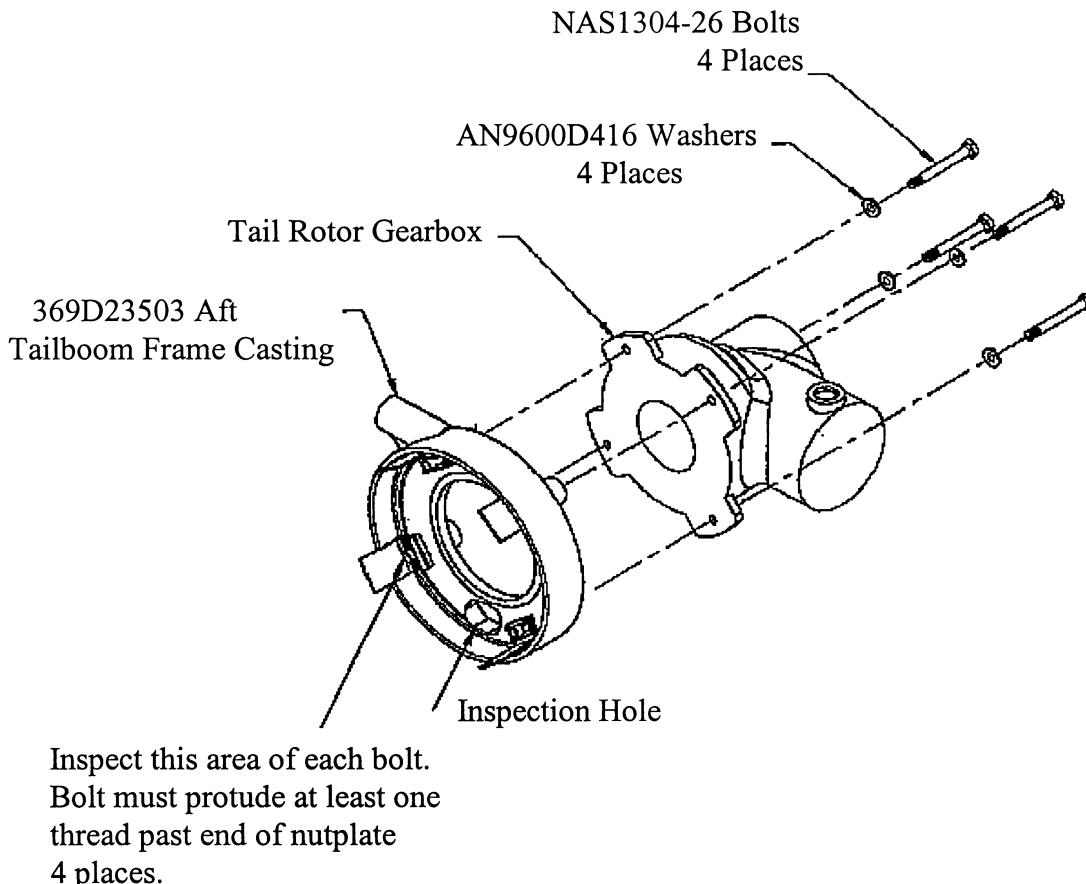
Figure 1 - Inspection Location

(2) Remove the tailboom control rod and determine the number of bolt threads protruding from each nutplate on the internal surface of the aft tailboom frame casting, P/N 369D23503, as shown in Figure 1 of this AD. At least one thread must protrude. If more than four threads protrude, add an additional washer, P/N AN960D416, under the bolt head. Torque the bolt to 100–110 in-lbs, and reapply a slippage mark. See Figure 1:

(b) Between 2 and 10 hours TIS after accomplishing the requirements of paragraph (a) of this AD, inspect the torque on each bolt by applying 100 in-lbs. If any bolt movement occurs, retorque the bolt to 100–110 in-lbs and reapply a slippage mark. Reinspect the torque between 2 and 10 hours TIS thereafter until no bolt movement occurs.
