[Docket No. 99-CE-85-AD; Amendment 39-12917; AD 2002-21-11]

Airworthiness Directives; EXTRA Flugzeugbau GmbH Model EA-300S Airplanes

ACTION: Final rule.

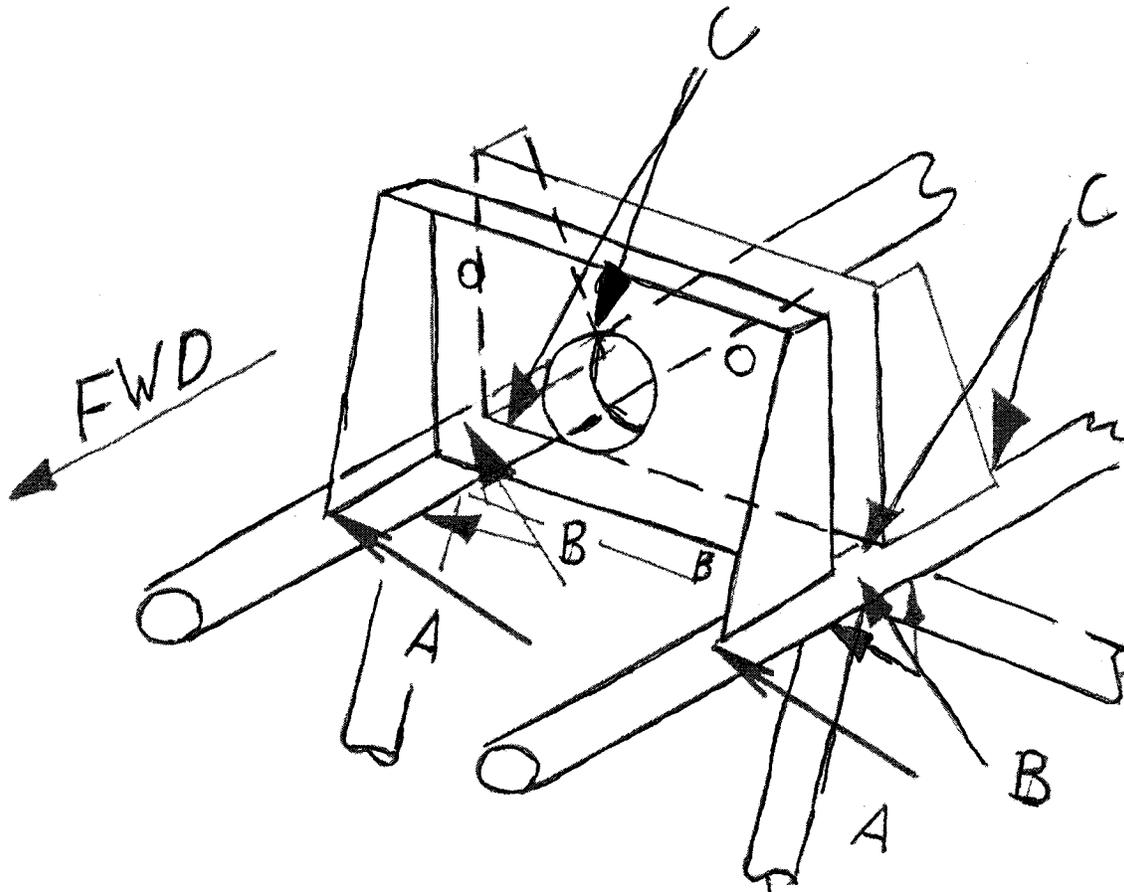
Actions	Compliance	Procedures
(1) For all affected airplanes, inspect, using a fluorescent dye penetrant method, the upper longeron at the horizontal stabilizer attachment for cracks in the areas depicted in Figure 1 of this AD.	Upon accumulating 250 hours time-in-service (TIS) or within the next 50 hours TIS after December 17, 2002 (the effective date of this AD), whichever occurs later.	In accordance with Part I of Extra Service Bulletin No. 300-2-95 (pages 2-6 at Issue: C, dated July 15, 1998; and pages 1 and 7 through 11 at Issue: D, dated January 30, 2001). No further action is required by this paragraph if the modification is already accomplished in accordance with Part II of Extra Service Bulletin No. 300-2-95 (all pages at Issue: C, dated July 15, stabilizer 1998).

(3) For all affected airplanes, if any crack is found during the inspection required by this AD and the cracks(s) is (are) in Area A or Area B as depicted in Figure 1 of this AD, accomplish the following: (i) Repair and modify the upper longeron at the horizontal stabilizer attachment; and (ii) Weld the cracks tight during repair.	Prior to further flight after the inspection where any crack is found in Area A or Area B as depicted in Figure 1 of this AD.	In accordance with Part II of Extra Service Bulletin No. 300-2-95, Issue: D, dated January 30, 2001. No further action is required by this paragraph if already accomplished in accordance with Part II of Extra Service Bulletin No. 300-2-95 (all pages at Issue: C, dated July 15, 1998).

(4) For all affected airplanes, if any crack is found during the inspection and the crack(s) is (are) in Area C as depicted in Figure 1 of this AD, accomplish the following: (i) Obtain a repair scheme from the manufacturer; (ii) Incorporate this repair scheme; and (iii) Accomplish any follow-up actions as directed by the FAA.	Prior to further flight after the inspection where any crack is found.	In accordance with a repair scheme obtained from EXTRA Flugzeugbau GmbH, Flugplatz Dinslaken, D-46569 Hünxe, Federal Republic of Germany; telephone: (0 28 58) 91 37-00; facsimile: (0 28 58) 91 37-30. Obtain this repair scheme through the FAA at the address specified in paragraph (g) of this AD.

(2) For all affected airplanes, if no crack(s) is (are) found during the inspection required by this AD, modify the upper longeron at the horizontal stabilizer attachment.	Prior to further flight after the inspection required by paragraph (d)(1) of this AD.	In accordance with Part II of Extra Service Bulletin No. 300-2-95 (pages 2-6 at Issue: C, dated July 15, 1998; and pages 1 and 7 through 11 at Issue: D, dated January 30, 2001). No further action is required by this paragraph if already accomplished in accordance with Part II of Extra Service Bulletin No. 300-2-95 (all pages at Issue: C, dated July 15, 1998).
