[Docket No. 2002-SW-25-AD; Amendment 39-13217; AD 2003-13-15]

Airworthiness Directives; Schweizer Aircraft Corporation Model 269A, 269A-1, 269B, 269C, and TH-55A Helicopters

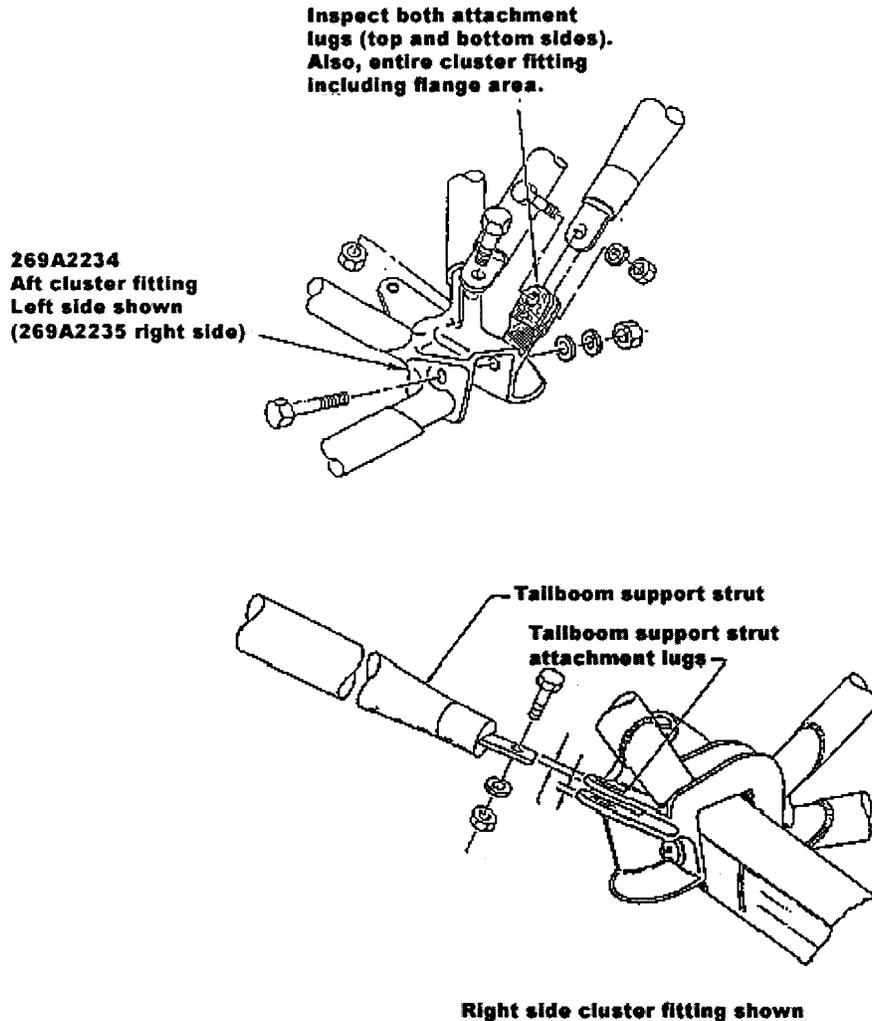
Figure 1

(2) Dye-penetrant inspect the lugs on each cluster fitting. See the following Figure 1:

(3) If a crack is found, before further flight, replace the cracked cluster fitting with an airworthy cluster fitting.
