**[Docket No. 2003-SW-23-AD]**

**Airworthiness Directives; Bell Helicopter Textron, a Division of Textron Canada Model 222, 222B, 222U and 230 Helicopters**

**ACTION:** Notice of proposed rulemaking (NPRM).

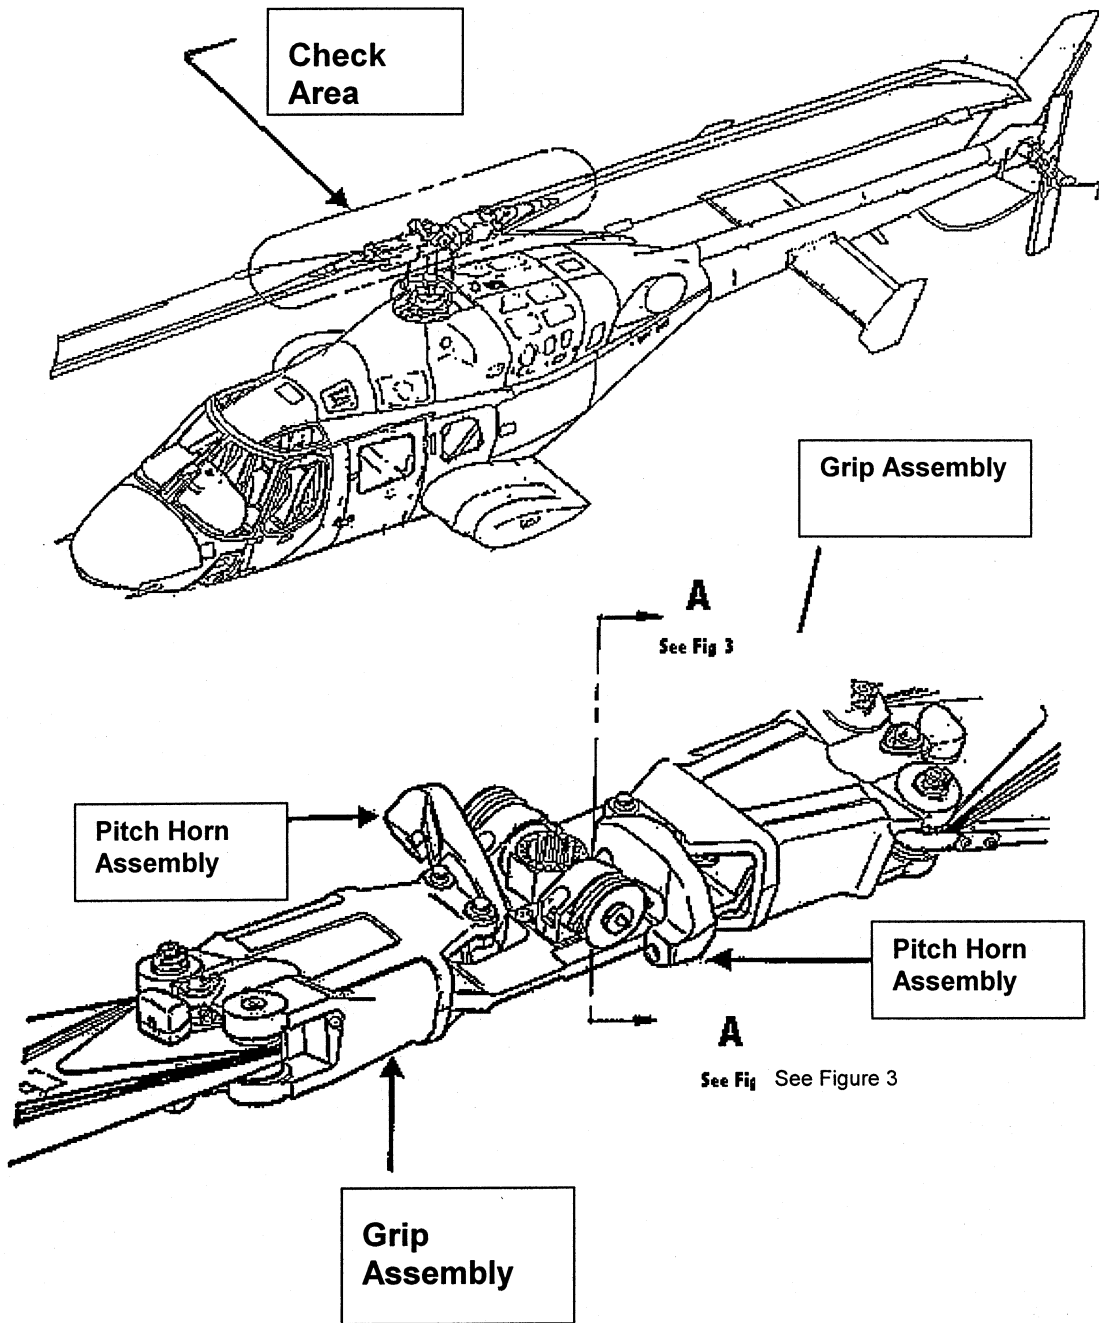
(1) Wipe clean the main rotor grip and pitch horn surfaces to remove grease and dirt

in the check area as shown in Figure 1 of this AD:

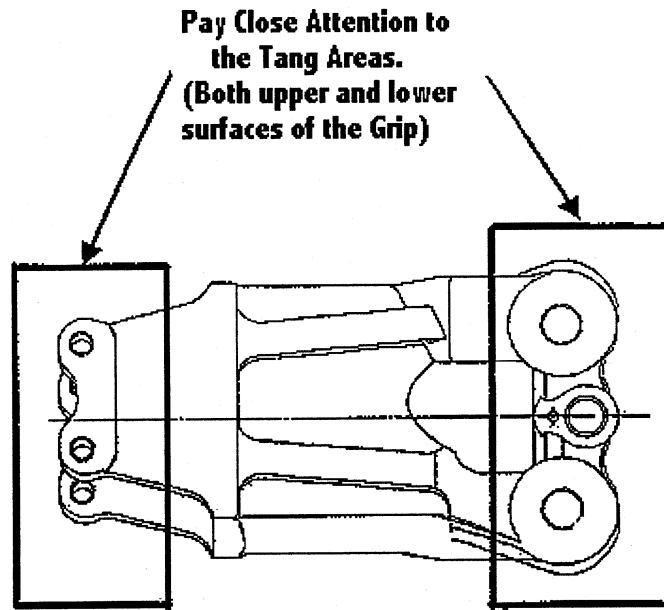
**Figure 2**

(2) Visually check both main rotor grips for a crack. Pay particular attention to the inboard and outboard tangs portions of the

grip, which are in direct contact with the pitch horns and the main rotor blades and check the area to at least 3 inches beyond the

grip to pitch and grip to blade contact areas as shown in Figure 2 of this AD:

**Entire surface of the grip must be checked**

(d) If a crack is found, replace the cracked part with an airworthy part before further flight.

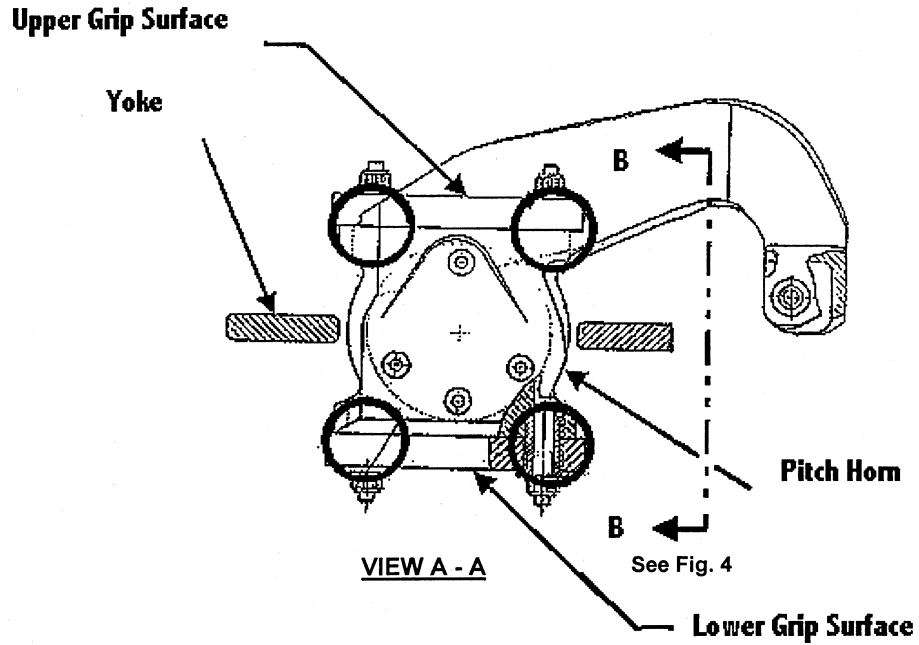
**Figure 3**

(3) Visually check all visible portions of each pitch horn for a crack. Pay particular attention to the attachment lugs of the pitch

horns, which are in direct contact with the inboard tangs of the main rotor grips, as shown in Figure 3 of this AD, and the four

**All visible portions of the pitch horn must be checked.  
Pay particular attention to the circled areas shown above and View B-B, Fig. 4.**

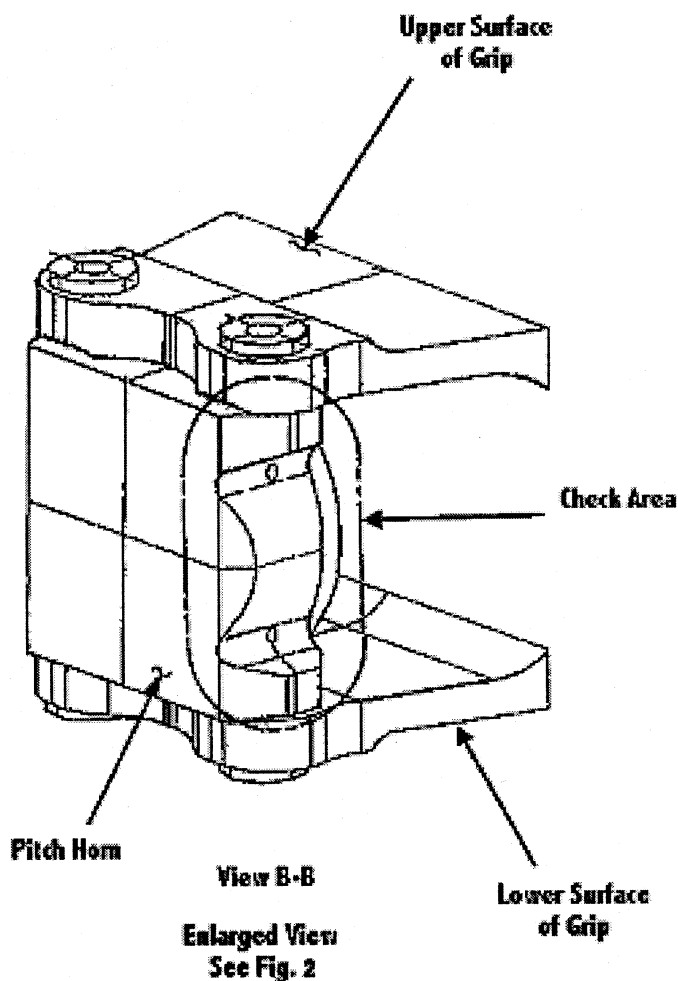
**Figure 4**

large bolt cutouts, as shown in Figure 4 of this AD:
