[Docket No. FAA-2004-18744; Directorate Identifier 2004-CE-24-AD]

Airworthiness Directives; Great Lakes Aircraft Company, LLC, Models 2T– 1A–1 and 2T–1A–2 Airplanes

ACTION: Notice of proposed rulemaking (NPRM).

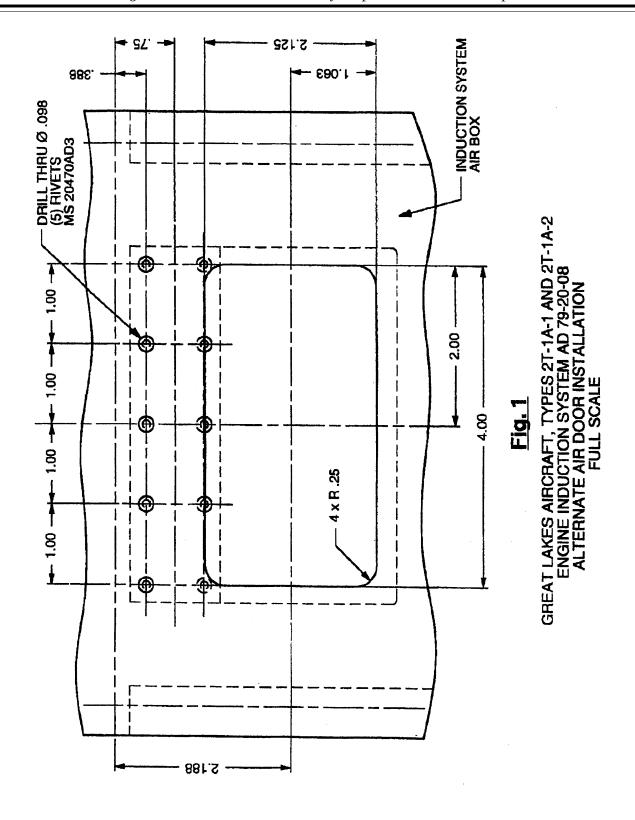
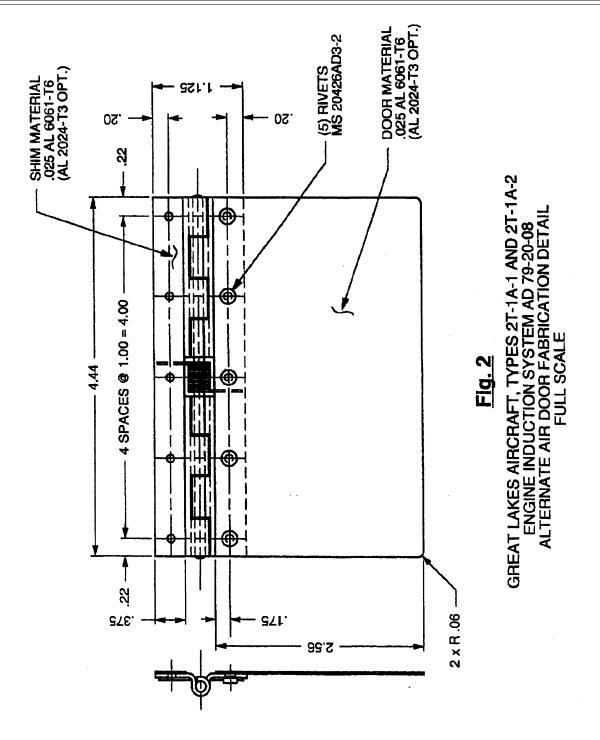
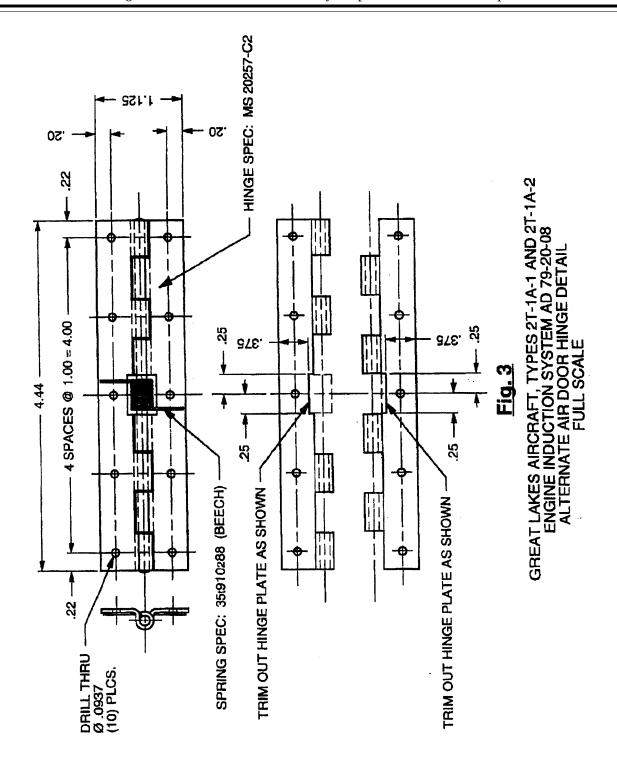
(d) This AD is the result of heat distortion, damage, and cracks found in the aircraft induction system on Lycoming IO–360–B1F6, AIO–360–B1G6, and AEIO–360–BIG6 engines. The actions specified in this AD are intended to prevent the aircraft induction system from becoming blocked or restricted, which could result in engine failure. This failure could lead to loss of control of the airplane.

| Actions | Compliance | Procedures |
|--|---|---|
| (2) Visually inspect the alternate air door for distortion, heat damage, and cracks. If any damage is found, repair or fabricate a new door following Figure 1, Figure 2, and Figure 3 in this AD. | For airplanes previously affected by Ad 79–20–08: Initially inspect at the next scheduled inspection required by Ad 79–20–08 or within the next 25 hours TIS after the effective date of this AD, whichever occurs later. Repetitively inspect thereafter at intervals not to exceed 100 hours TIS. For airplanes not previously affected by AD 79–20–08: Inspect within the next 25 hours TIS after the effective date of this AD. Repetitively inspect thereafter at intervals not to exceed 100 hours TIS. For all affected airplanes: If damage is found during any inspection, before further flight, repair or replace the damaged alternate air door. | Not applicable. |
