[Docket No. 2003-SW-23-AD; Amendment 39-13966; AD 2005-03-10]

Airworthiness Directives; Bell Helicopter Textron, A Division of Textron Canada Model 222, 222B, 222U and 230 Helicopters

ACTION: Final rule.

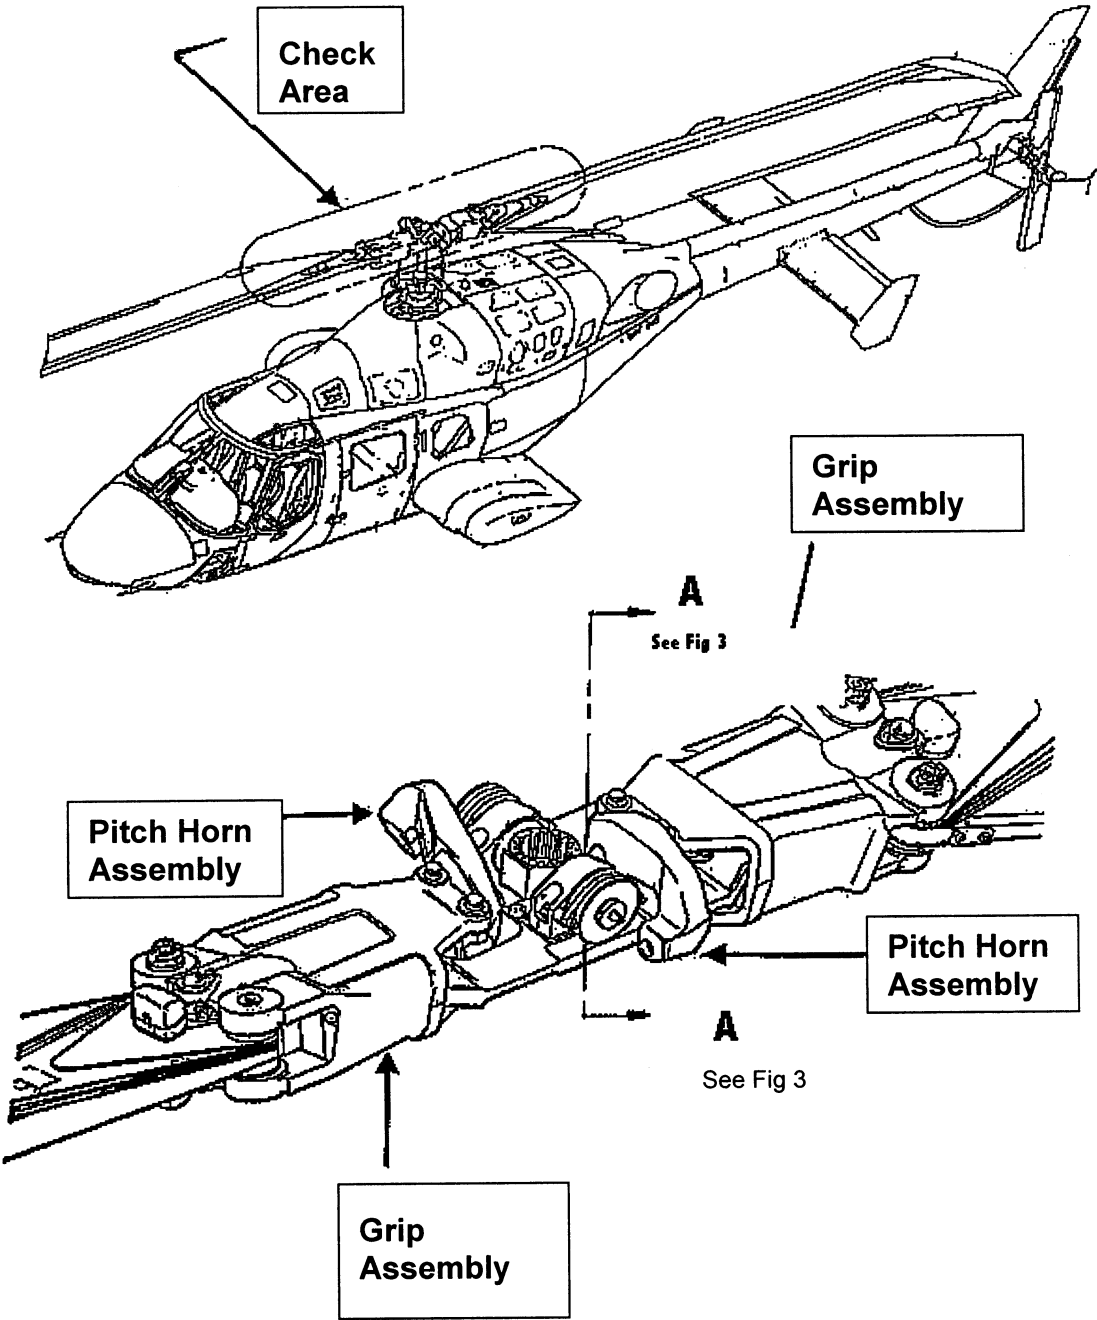
(1) Wipe clean the main rotor grip and pitch horn surfaces to remove grease and dirt in the check area as shown in Figure 1 of this AD:

(d) If a crack is found, replace the cracked part with an airworthy part before further flight.

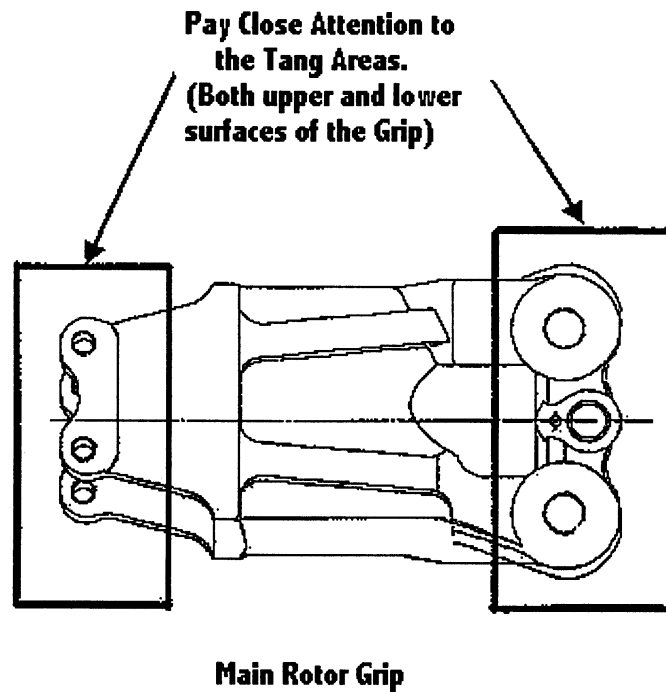
(2) Visually check both main rotor grips for a crack. Pay particular attention to the inboard and outboard tangs portions of the

grip, which are in direct contact with the pitch horns and the main rotor blades and check the area to at least 3 inches beyond the

grip to pitch and grip to blade contact areas as shown in Figure 2 of this AD:

Entire surface of the grip must be checked

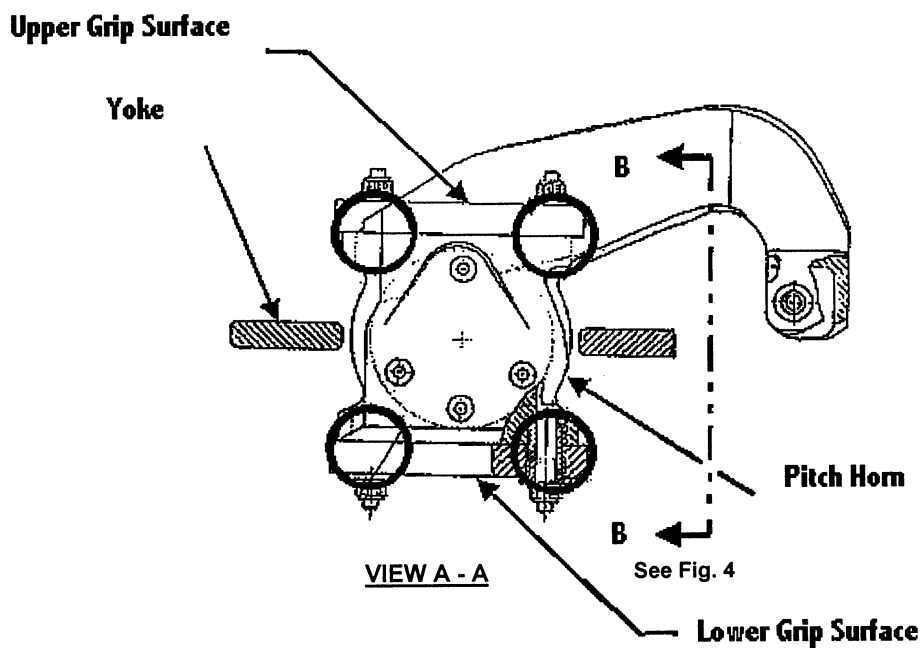
(3) Visually check all visible portions of each pitch horn for a crack. Pay particular attention to the attachment lugs of the pitch

horns, which are in direct contact with the inboard tangs of the main rotor grips, as shown in Figure 3 of this AD, and the four

**View from trunnion
looking outboard**

**All visible portions of the pitch horn must be checked.
Pay particular attention to the circled areas shown above and View B-B, Fig. 4.**
