[Docket No. 2003-SW-23-AD; Amendment 39-13966; AD 2005-03-10]

Airworthiness Directives; Bell Helicopter Textron, A Division of Textron Canada Model 222, 222B, 222U and 230 Helicopters

ACTION: Final rule.

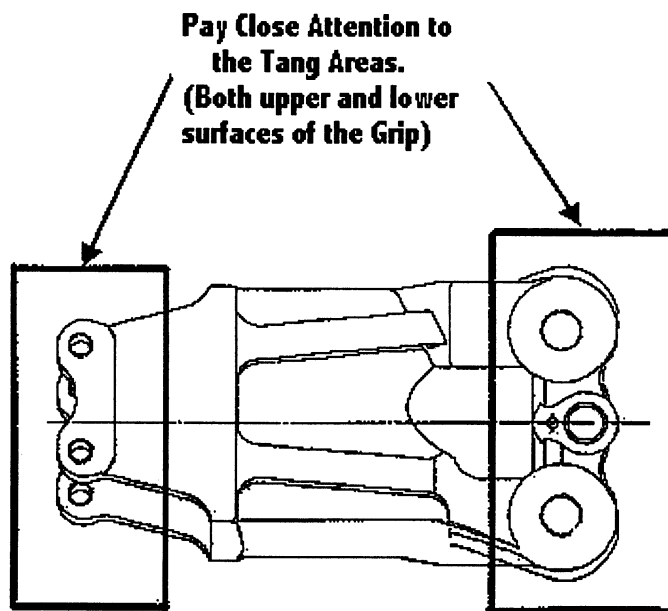
(2) Visually check both main rotor grips for a crack. Pay particular attention to the inboard and outboard tangs portions of the

grip, which are in direct contact with the pitch horns and the main rotor blades and check the area to at least 3 inches beyond the

grip to pitch and grip to blade contact areas as shown in Figure 2 of this AD:

Entire surface of the grip must be checked

(d) If a crack is found, replace the cracked part with an airworthy part before further flight.
