Federal Aviation Administration

[Docket No. 2003-SW-23-AD; Amendment 39-13966; AD 2005-03-10]

Airworthiness Directives; Bell Helicopter Textron, A Division of Textron Canada Model 222, 222B, 222U and 230 Helicopters

ACTION: Final rule.

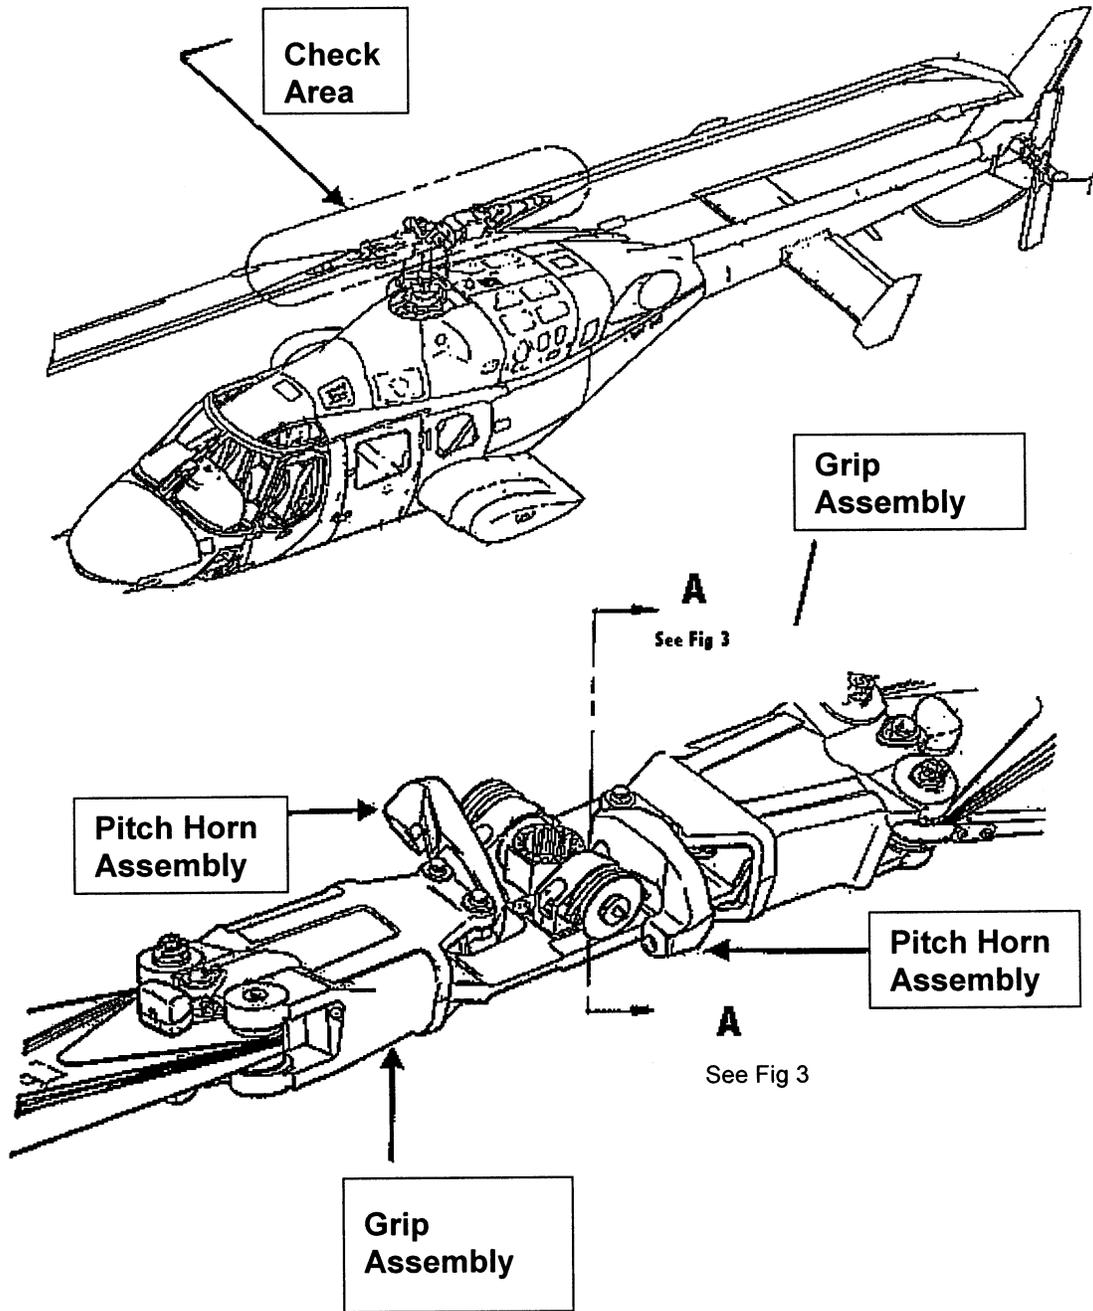
(1) Wipe clean the main rotor grip and pitch horn surfaces to remove grease and dirt in the check area as shown in Figure 1 of this AD:

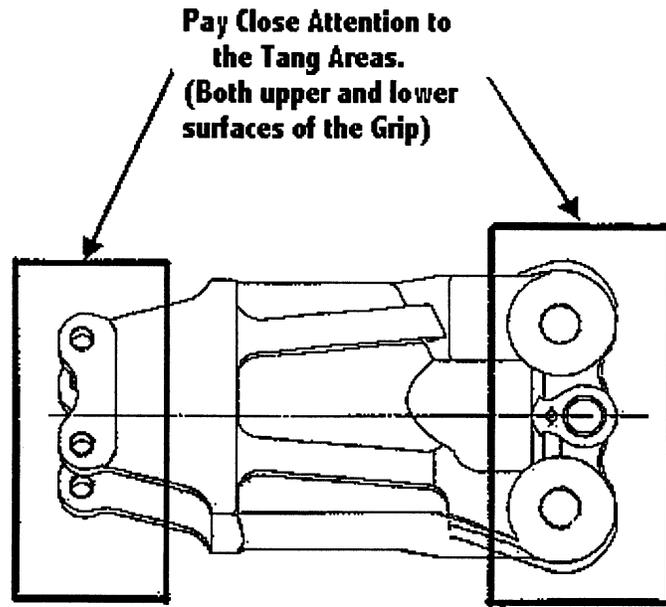
(2) Visually check both main rotor grips for a crack. Pay particular attention to the inboard and outboard tangs portions of the

grip, which are in direct contact with the pitch horns and the main rotor blades and check the area to at least 3 inches beyond the

grip to pitch and grip to blade contact areas as shown in Figure 2 of this AD:

Entire surface of the grip must be checked

(d) If a crack is found, replace the cracked part with an airworthy part before further flight.

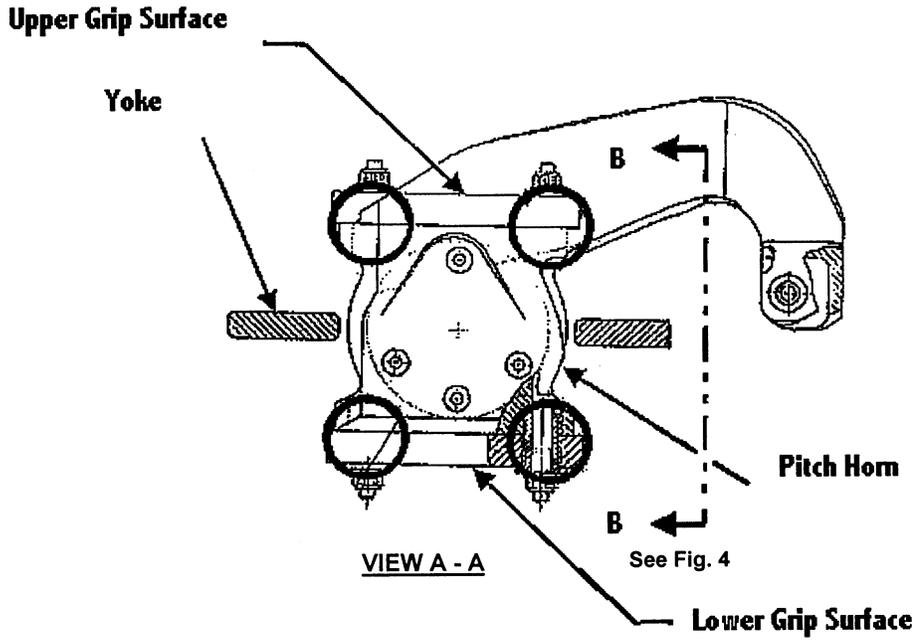
(3) Visually check all visible portions of each pitch horn for a crack. Pay particular attention to the attachment lugs of the pitch

horns, which are in direct contact with the inboard tangs of the main rotor grips, as shown in Figure 3 of this AD, and the four

**All visible portions of the pitch horn must be checked.
Pay particular attention to the circled areas shown above and View B-B, Fig. 4.**

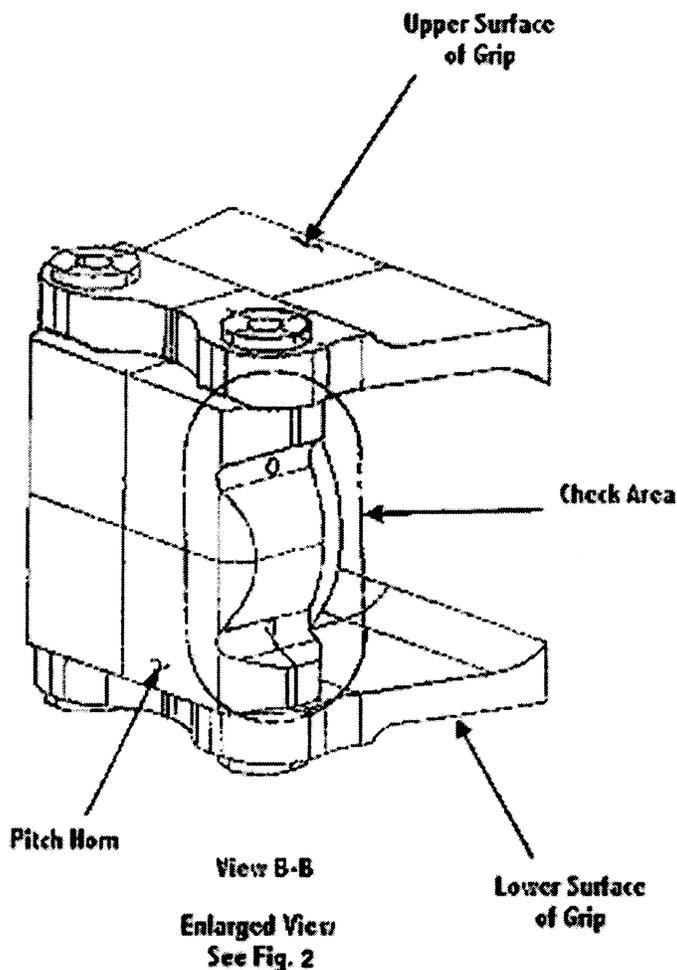
large bolt cutouts, as shown in Figure 4 of this AD:
