[Docket No. FAA–2005–22534; Directorate Identifier 2005–NE–27–AD; Amendment 39–14305; AD 2005–20–11]

**Airworthiness Directives; Rolls-Royce Corporation (RRC) (formerly Allison Engine Company, Allison Gas Turbine Division, and Detroit Diesel Allison) Models 250–C28, –C28B, and –C28C Turboshaft Engines**

**ACTION:** Final rule; request for comments.

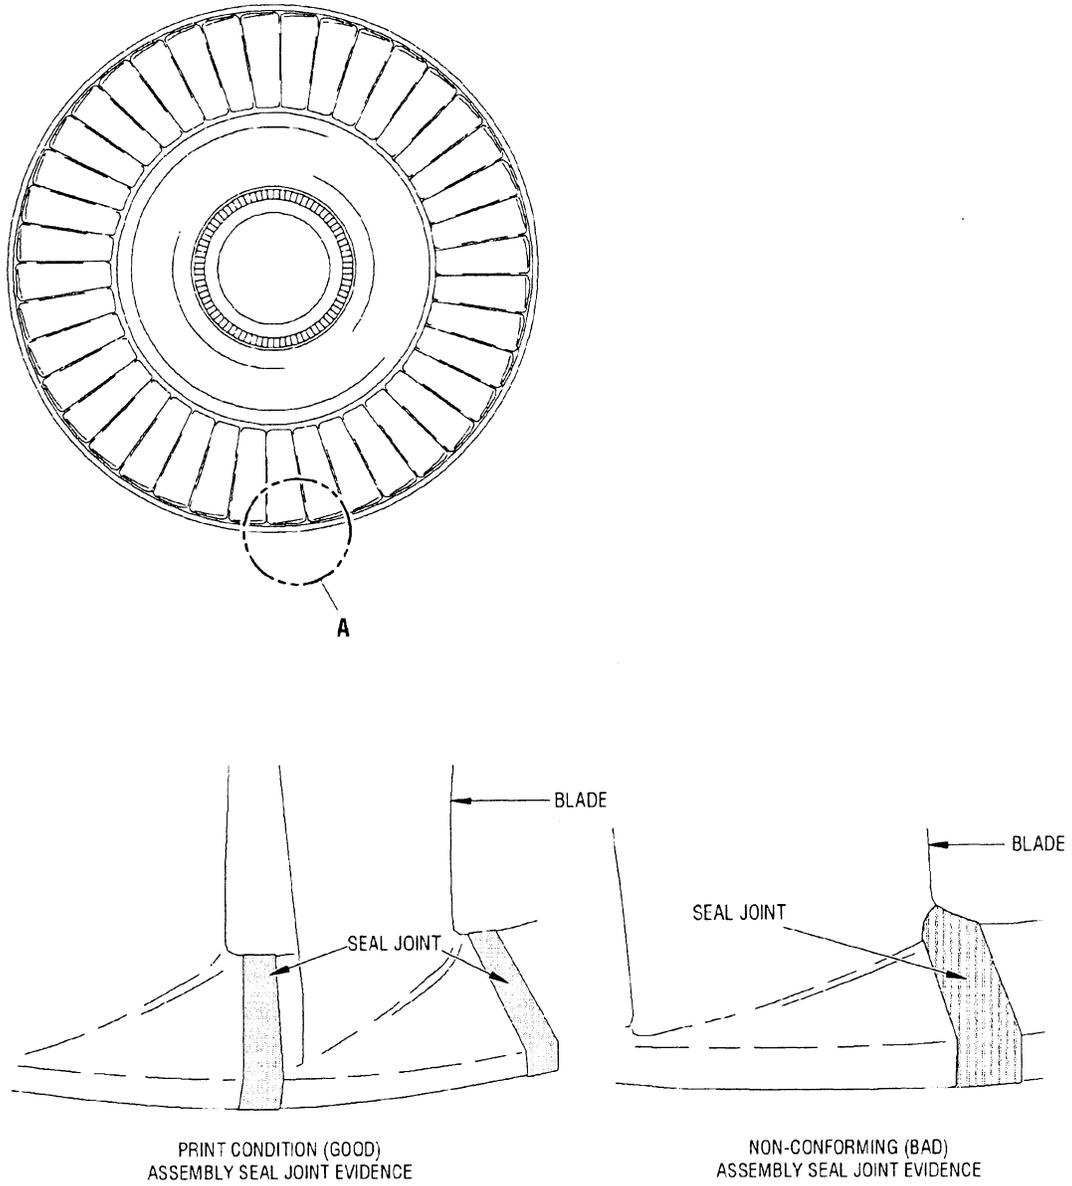
Figure 1.

**SUPPLEMENTARY INFORMATION:** In April 2005, we became aware of reports of three failed third-stage turbine wheels, P/N 6899383. The third-stage turbine wheels had partial loss of the blades and shroud. RRC conducted an analysis and found the failures were caused by compromised third-stage blade fillet radii, which led to increased stresses to the third-stage blades and shroud. RRC categorized this finding as a

(h) Remove the third-stage turbine wheel and perform a onetime visual inspection of the seal joint in each passage between airfoils at the hub and shroud. Seal joint evidence must not be present within blade fillet radii. See Figure 1 of this AD for reference.

(i) Remove from service any turbine wheel that has seal joint evidence present within blade fillet radii.
