DEPARTMENT OF TRANSPORTATION

Federal Railroad Administration

Safety Advisory 2006-01

SUMMARY: FRA is issuing Safety Advisory 2006-01, in order to provide the industry additional information on the potential catastrophic failure of certain railroad freight car side frame castings manufactured by National Castings of Mexico's (NCM) Sahagun, Mexico facility and Buckeye Steel Castings' (Buckeye) Columbus, Ohio facility. The purpose of this safety advisory is to recommend that the rail industry carefully inspect these specific side frames when equipped freight cars are in shops or on repair tracks.

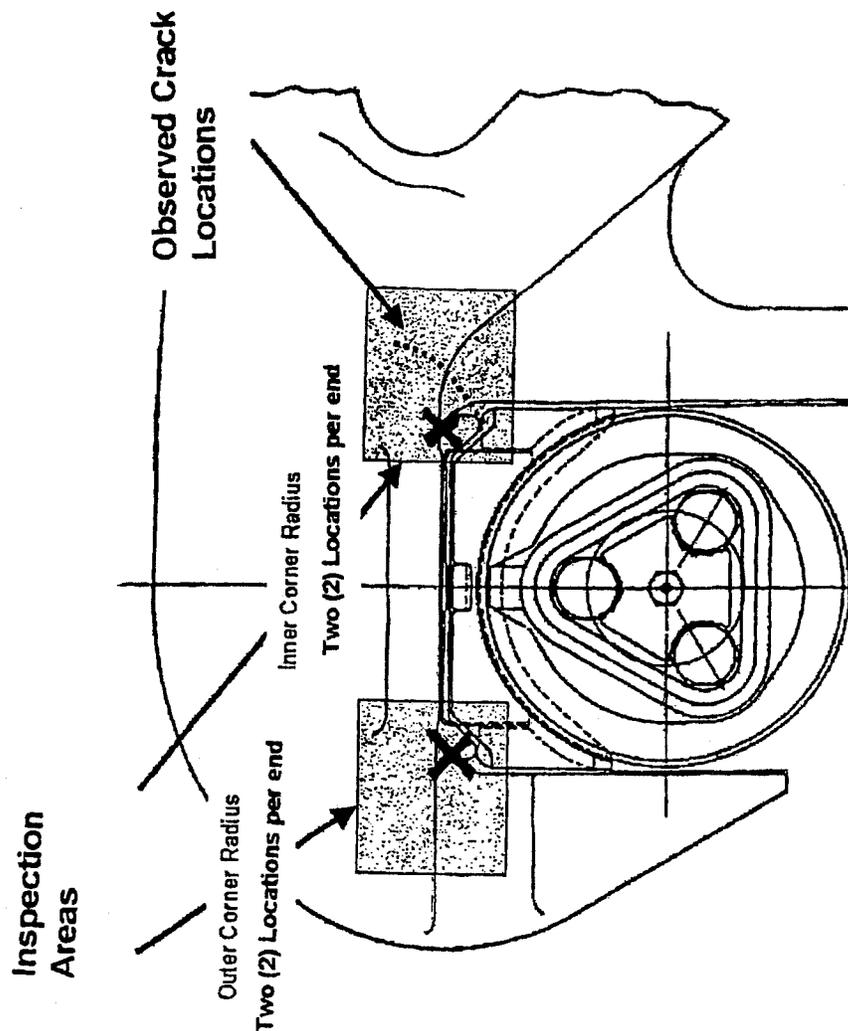
castings. The following table identifies the three pattern numbers of side frames manufactured by NCM and Buckeye that may have the potential to fail while in-service.

Fig. 1 Showing Eight Inspection Locations Per Side Frame

shop or repair track. Railroad freight cars equipped with side frames in these pattern numbers should receive a careful inspection of the side frames at the inner corner radius (spring nest and outboard sides) of the pedestal jaw opening (field or gage side) at the transition from the pedestal roof. There are eight (8) locations per side frame that should receive close visual inspection. (See Figure 1). Any evidence of cracking and/or missing material in the corner radius areas is cause for replacement.
