Federal Register

[Docket No. FAA-2006-25084; Directorate Identifier 2005-SW-38-AD]

Airworthiness Directives; Bell Helicopter Textron Canada Model 206L Series Helicopters

ACTION: Notice of proposed rulemaking (NPRM).

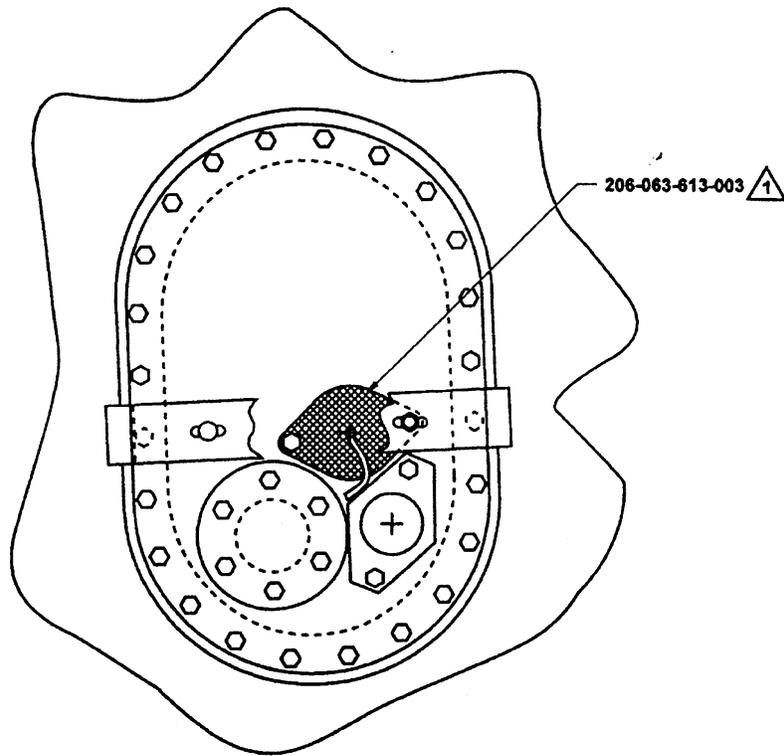
NOTE
1 Part number and serial number are located in the cross hatched area.

- (a) On or before the next 100-hour time-in-service inspection, determine whether the installed switch unit has a serial number listed in the applicability section of this AD. If the installed switch unit is one of the listed switch units, before further flight, replace it with an airworthy switch unit that has a serial number other than those listed in the applicability section of this AD. See Figure 1 of this AD for the location of the serial number.
