[Docket No. FAA–2004–18850; Directorate Identifier 2004–SW–19–AD; Amendment 39–14694; AD 2004–16–15 R1]

#### **Airworthiness Directives; Eurocopter France Model AS–365N2, AS 365 N3, EC 155B, EC155B1, SA–365N, N1, and SA–366G1 Helicopters**

**2004–16–15 R1 Eurocopter France:**

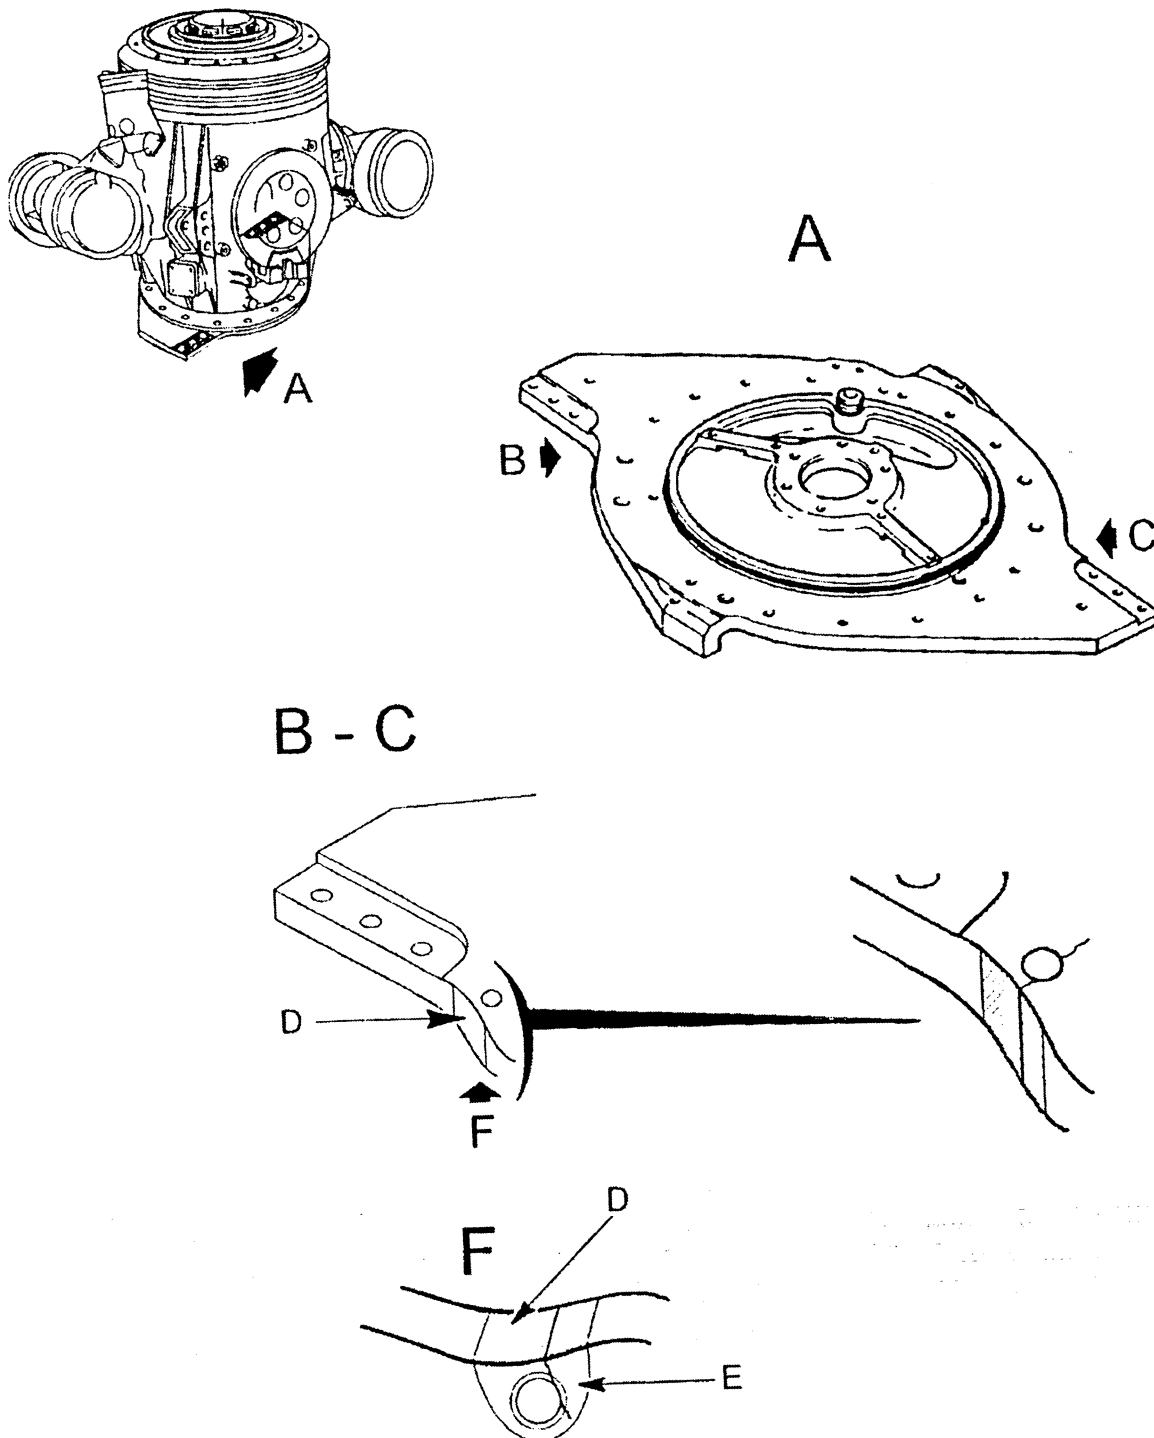
strip the paint from area “D” on both sides (“B” and “C”) of the MGB base plate as depicted in Figure 1 of this AD.

(b) At the times indicated in the compliance table, inspect area "D" of the MGB base plate for a crack using a 10x or higher magnifying glass. Area "D" to be inspected is depicted in Figure 1 of this AD.

(c) If a crack is found in a MGB base plate, remove and replace the MGB with an airworthy MGB before further flight.
