[Docket No. FAA-2004-18850; Directorate Identifier 2004-SW-19-AD; Amendment 39-14694; AD 2004-16-15 R1]

Airworthiness Directives; Eurocopter France Model AS-365N2, AS 365 N3, EC 155B, EC155B1, SA-365N, N1, and SA-366G1 Helicopters

2004–16–15 R1 Eurocopter France:

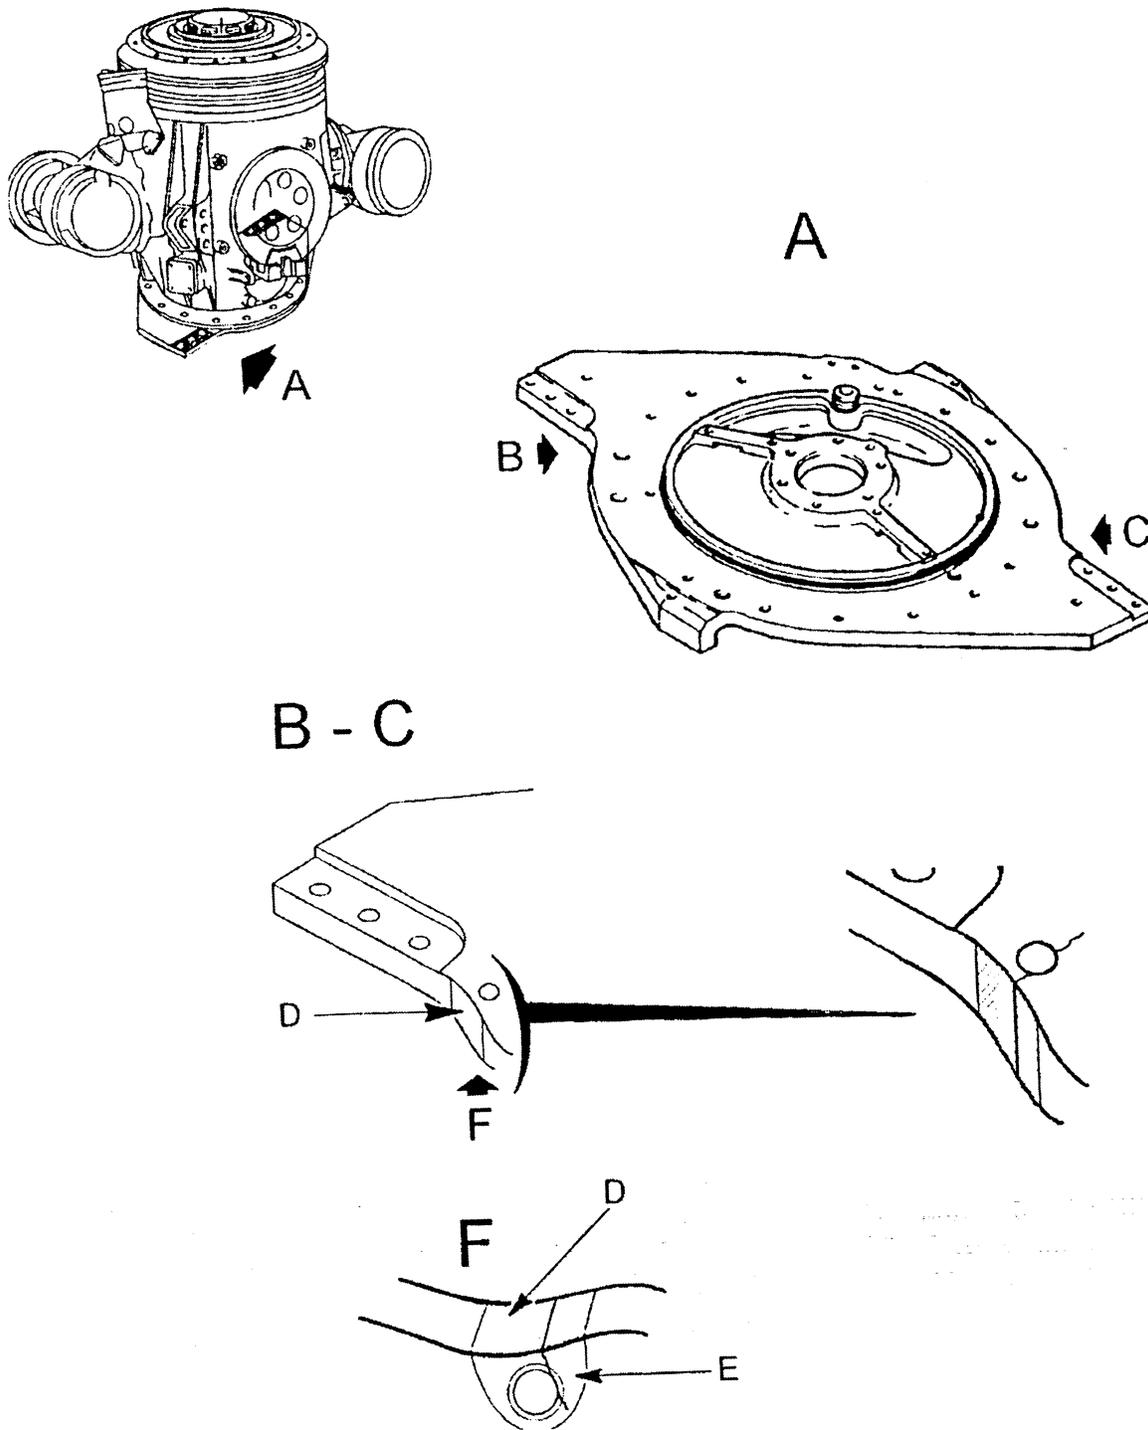
strip the paint from area “D” on both sides (“B” and “C”) of the MGB base plate as depicted in Figure 1 of this AD.

(b) At the times indicated in the compliance table, inspect area "D" of the MGB base plate for a crack using a 10x or higher magnifying glass. Area "D" to be inspected is depicted in Figure 1 of this AD.

(c) If a crack is found in a MGB base plate, remove and replace the MGB with an airworthy MGB before further flight.
